# Heritage Statement

## White Hull Farm, Blake Lea Lane, Marsden, HD7 6NJ

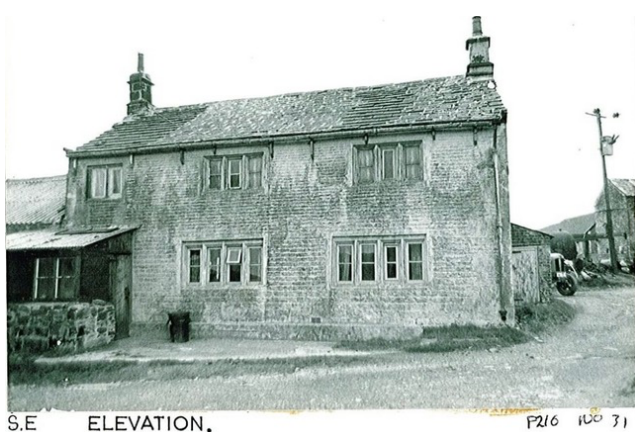
**Fig.1 – C.1980?**

**Fig.1** (provided by Kirklees Council) is said to be c.1980 (pre-listing). This image shows the front of property with a variety of window styles with differing frames, window light sizes and shapes, with a mix of narrow and wide 'sight lines', some with glazing bars and some without and appearing to be in poor condition (there are few windows to the rear of the property aside from 3 2-light mullioned windows to the kitchen, stairwell and what is now the Bathroom) – given the property was c.220 years old at this point, it is highly unlikely any of these windows were original. In the earlier image, the roof of the property appears to be in a significant state of disrepair with mortar pointing used

between the slates, likely due to weather ingress. To the right of the property is a stone porch around what is now the Lounge doorway – this construction no longer exists (See Fig.2). To the front of the property is a half stone/half lean to porchway over the Front doorway covering what is now the main entrance to the Kitchen of the property and over which the datestone doorway lintel is placed, this porch no longer exists (see Fig.2). To the left of the property is what is believed to be a former attached ‘mistal’ which appears to be of agricultural construction – this construction is known to have collapsed sometime during the 1980’s and has since been rebuilt, considerably increased in width, length and height and now forms approximately half of the floorspace of the entire property as habitable dwelling space (see Fig.2).

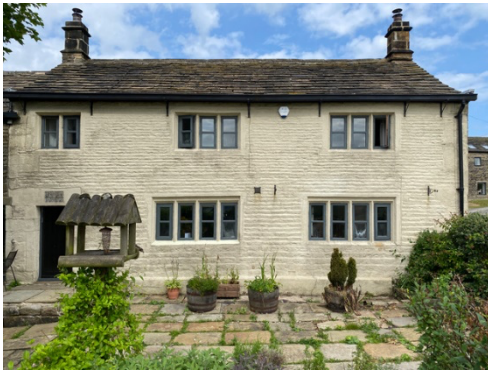
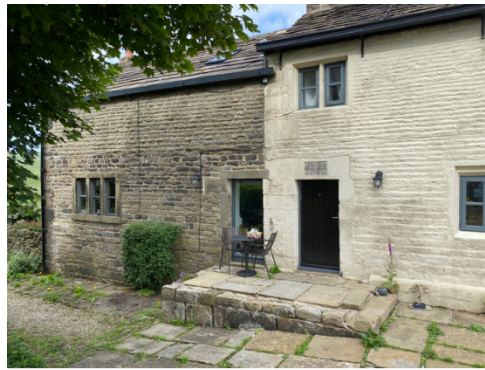
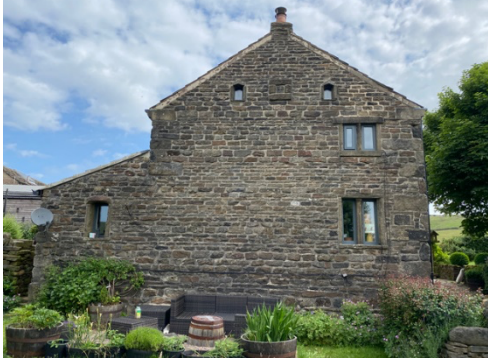
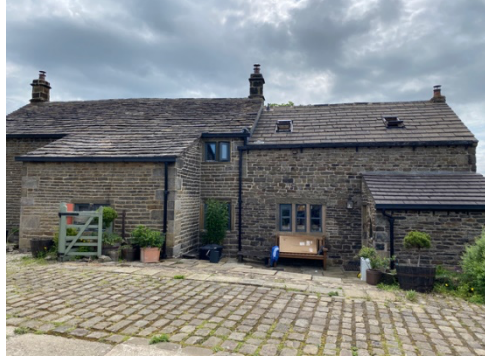
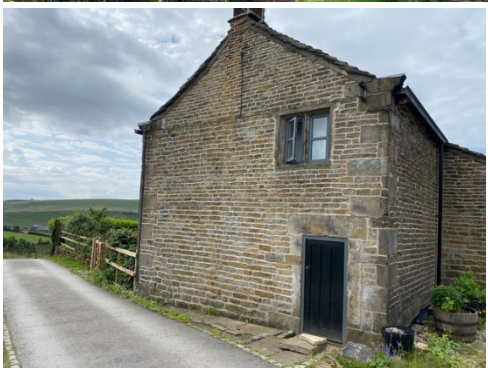
The following images, taken June 2023 – show all aspects of the property and the windows to be replaced:

The current condition of the majority of the windows is poor having succumb to the fairly severe weather that is often experienced in this location, driving rain and wind is common throughout most of the Autumn/Winter season and wood is known to hold moisture. Many of the frames are rotten and warped as a result of the constant inclement weather, wind and humidity experienced in this location which is enabling water ingress into the mullions when it rains causing damp and cold spots throughout the house. In the three winters we have owned this property, this has become increasingly apparent with all windows displaying varying degrees of water ingress and/or signs of damp. The stone mullions appear structurally sound but there are signs of damp and mould permeating the stone throughout the property. Around half of the double glazed units have 'blown' reducing or in some instances obscuring the view outside.

In this regard, we propose a design of window, manufactured and installed by Touchstone Glazing Solutions Ltd of Brighouse, that is specifically designed for properties of this Heritage and their Insulead<sup>®</sup> and Steelyte<sup>®</sup> solutions have been approved by Heritage England and adopted in properties of all Gradings and Historical significance. Further information about the company and their work can be found on their website: [Touchstone Glazing Solutions Ltd](https://www.touchstoneglazing.com). Specific design details are attached to this application.
