**St Mary's Primary School  
Batley – BS 5837:2012  
Arboricultural Report, Impact  
Assessment and Method  
Statement**

**Report Title:** St Mary's Primary School Batley – BS 5837:2012 Arboricultural Report, Impact Assessment and Method Statement

**Version:** V1.0  
**Issue Date:** January 2024  
**Report Ref:** 22796

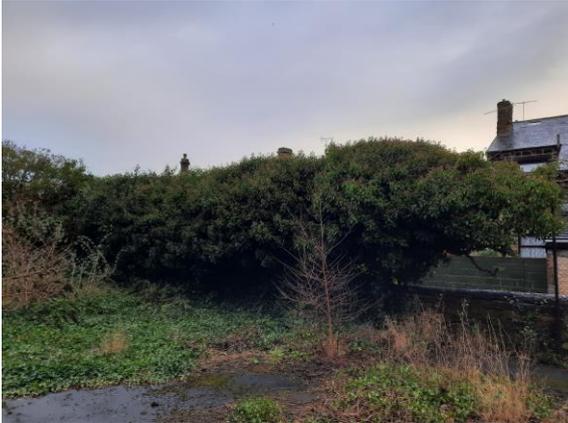
**Plate 1:** H002 from the west

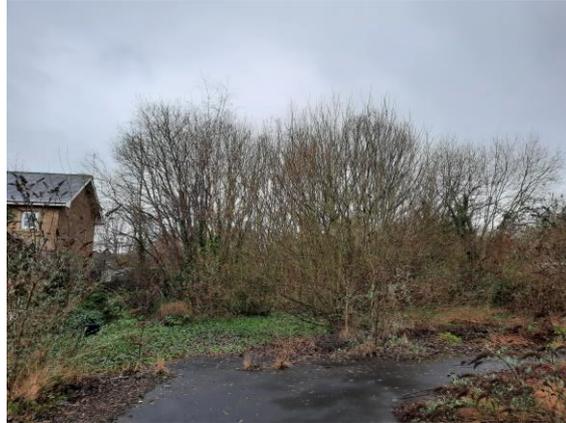
| Tree No. | Species | Height (m) | No. of Stems | Stem Dia. @ 1.5m (mm) | Crown Spreads (m) | | | | Height of Crown Clearance (m) | Age Class | SLE | Overall Condition | Comments | Management | Category | RPA Radius (m) | RPA Area (m <sup>2</sup> ) |
|---|---|---|---|---|---|---|---|---|---|---|---|---|--|---|---|---|---|
| T004 # | Willow ( <i>Salix caprea</i> ) | 8 | >10 | 120 avg | 3 | 3.5 | 3 | 3 | 0.5 | Semi Mature | 10+ Years | Good | Dense ivy at base but potentially growing through surrounding tarmac, multi-stemmed at base, no obvious defects | <b>Removal required to facilitate construction of dwellings</b> | C2 | 6.4 | 129 |

**Plate 2:** G003 and T004 from the north east

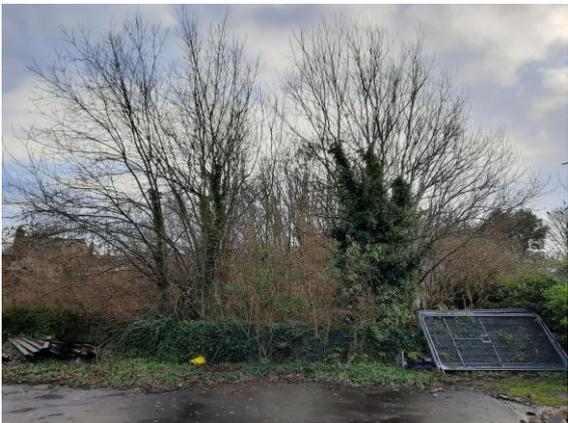
**Plate 3:** G003 from the west

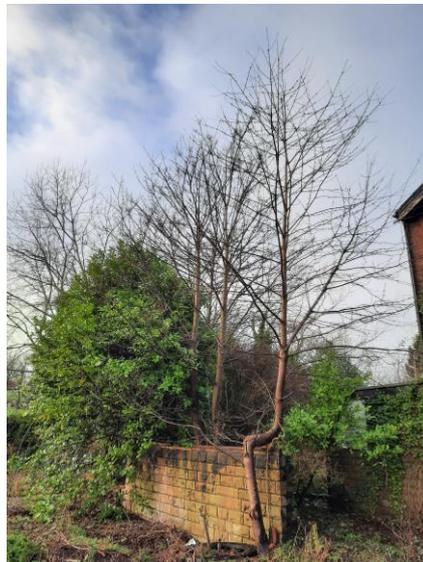
| Tree No. | Species | Height (m) | No. of Stems | Stem Dia. @ 1.5m (mm) | Crown Spreads (m) | | | | Height of Crown Clearance (m) | Age Class | SLE | Overall Condition | Comments | Management | Category | RPA Radius (m) | RPA Area (m <sup>2</sup> ) |
|---|--|---|---|---|---|---|---|---|---|---|---|---|---|--|---|---|---|
| T005 # | Cherry ( <i>Prunus avium</i> ) | 10 | 1 | 200 | 3 | 3 | 2 | 2.5 | 2 | Semi Mature | 10+ Years | Fair | Growing on corner between stone wall & concrete foundations, various historical wounds low on stem, stem has 90 degree kink at approx 1.7m then curves back to near vertical, western branches touching building | Removal required to facilitate construction of dwellings | C1 | 2.4 | 18 |
| G007 | Cherry ( <i>Prunus avium</i> )<br>Cherry Laurel ( <i>Prunus laurocerasus</i> ) | 8 | >10 | 100 avg | See Plan | | | | 0.5 | Semi Mature | 20+ Years | Fair | Linear group growing close to concrete foundations, surrounded by various woody shrubs, generally multi-stemmed at base, evidence of extensive historical pruning potentially managing the group as a hedgerow | Removal required to facilitate construction of dwellings, vehicle parking and access | C2 | - | - |

**Plate 4:** T005, T006 and G007 from the east

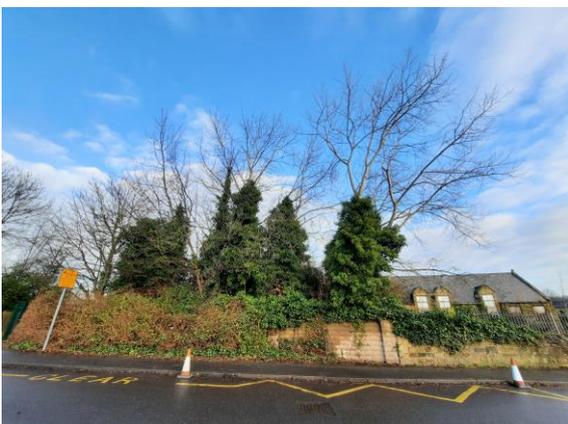
- 3.2.3 The most significant trees were located to the west of the site and include G008 and T009. These moderate value poplar, sycamore and laburnum trees appeared to have good future prospects and were located in a prominent roadside position.
- 3.2.4 The moderate value sycamore, T006, provided some moderate short term value, however its prospects were significantly limited due to its poor rooting area, against a stone wall and close to a concrete foundation.
- 3.2.5 The remaining trees and hedgerows were of particularly low individual value and retention category C. They should not pose a significant constraint to the development potential of the site.

**Plate 5:** G008 and T009 from the south

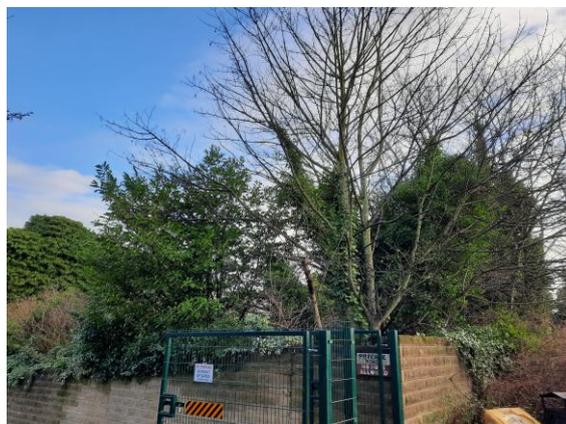
| Tree No. | Species | Height (m) | No. of Stems | Stem Dia. @ 1.5m (mm) | Crown Spreads (m) | | | | Height of Crown Clearance (m) | Age Class | SLE | Overall Condition | Comments | Management | Category | RPA Radius (m) | RPA Area (m <sup>2</sup> ) |
|---|--|---|---|---|---|---|---|---|---|---|---|---|---|--|---|---|---|
| T010 # | Cherry Laurel ( <i>Prunus laurocerasus</i> ) | 7.5 | >10 | 60 avg | 2.5 | 2 | 1.5 | 1 | 1.5 | Semi Mature | 40+ Years | Good | Growing close to western boundary wall, multi-stemmed at base, dense ivy low on stems | | C1 | 3.2 | 32 |

**Plate 6:** T009 and T010 from the west
