Contaminated Land Phase One Desk
Study and Coal Risk Assessment for
proposed residential development
at
Land Adjacent
52 Ingham Road,
Thornhill Lees,
Dewsbury,
Kirklees,
WF12 0AQ.

September 2023

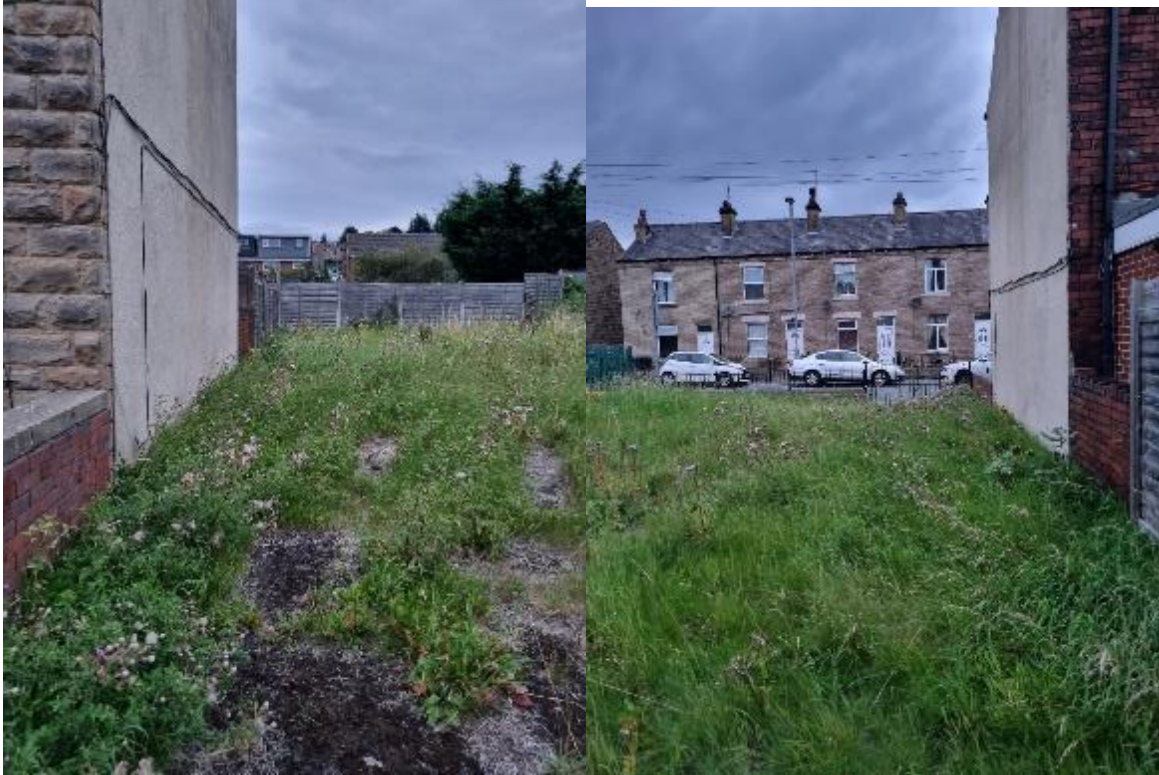
Northern boundary with 52 looking east then west.

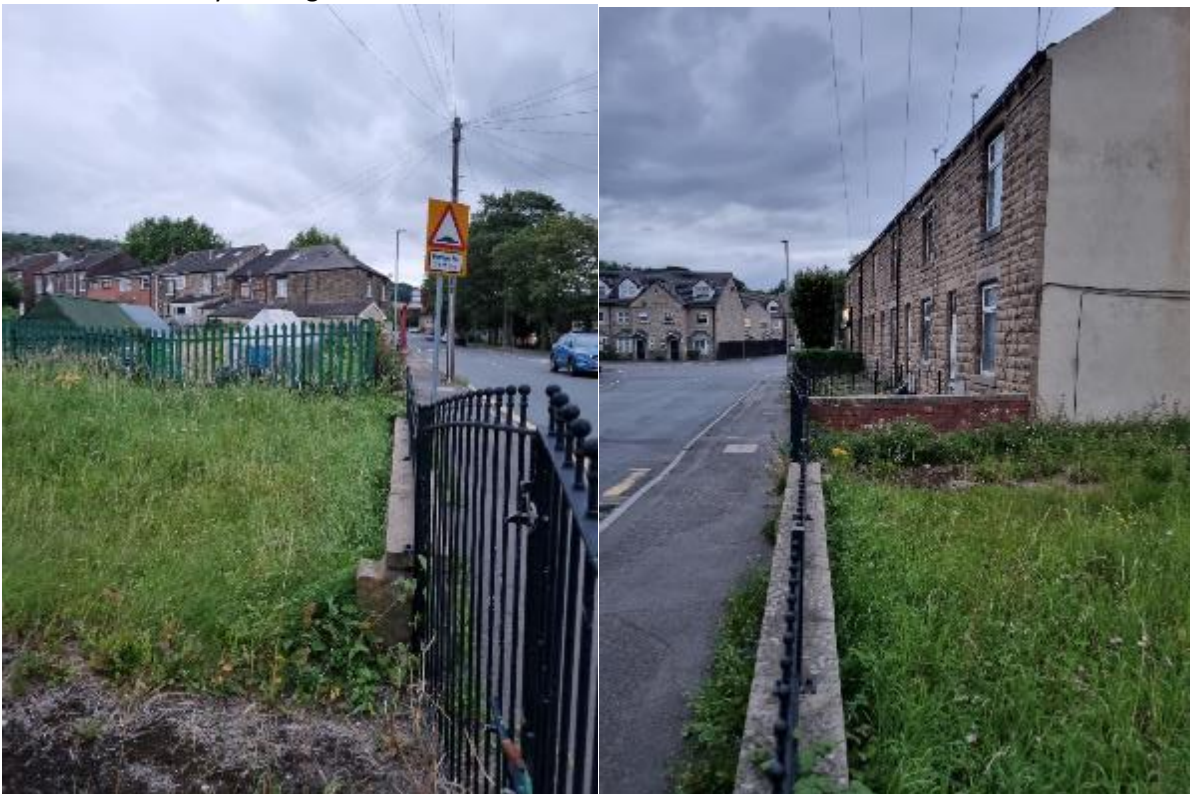
Western boundary looking south and north

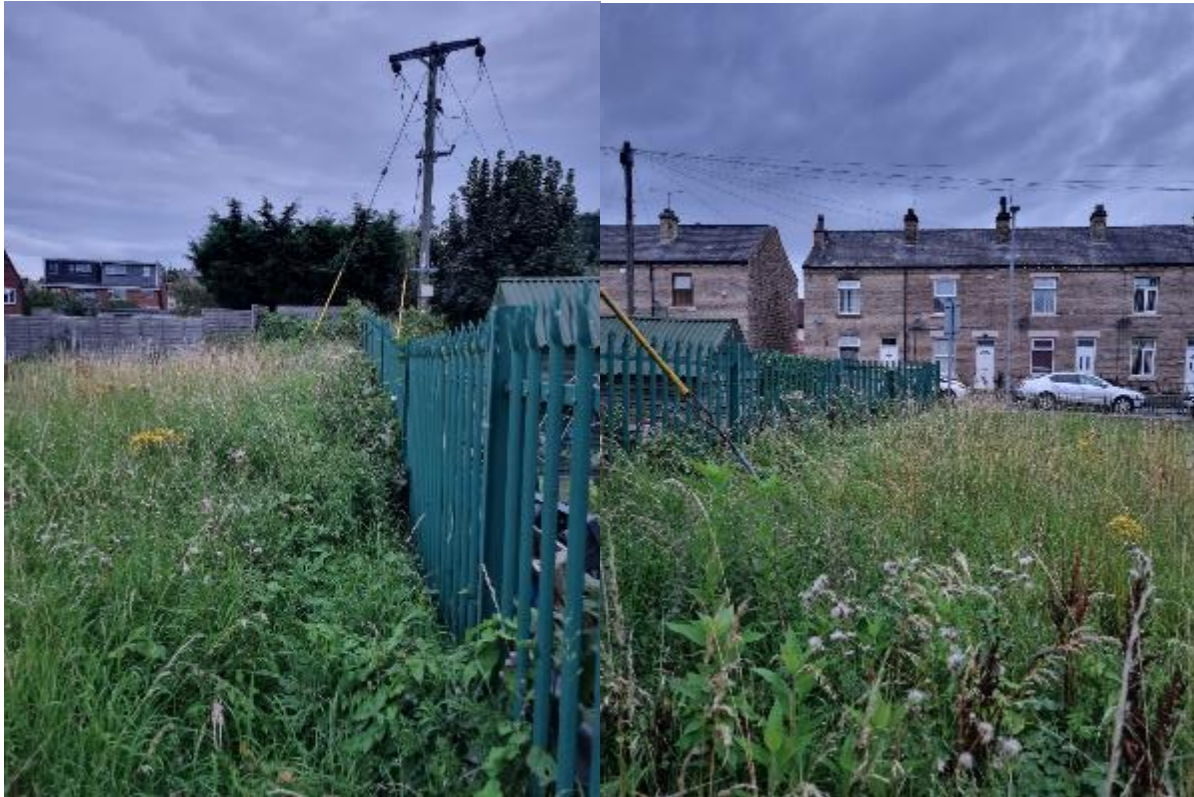
Southern boundary looking east then west

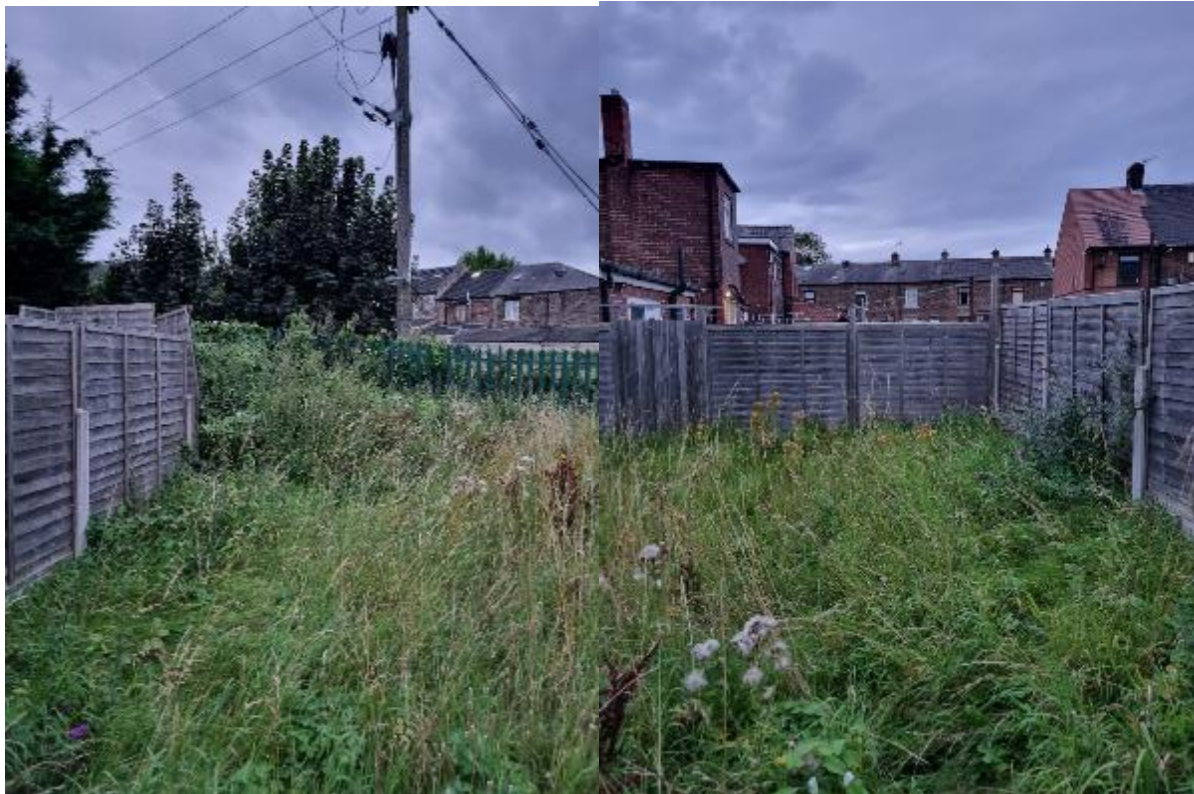
eastern boundary looking south then north

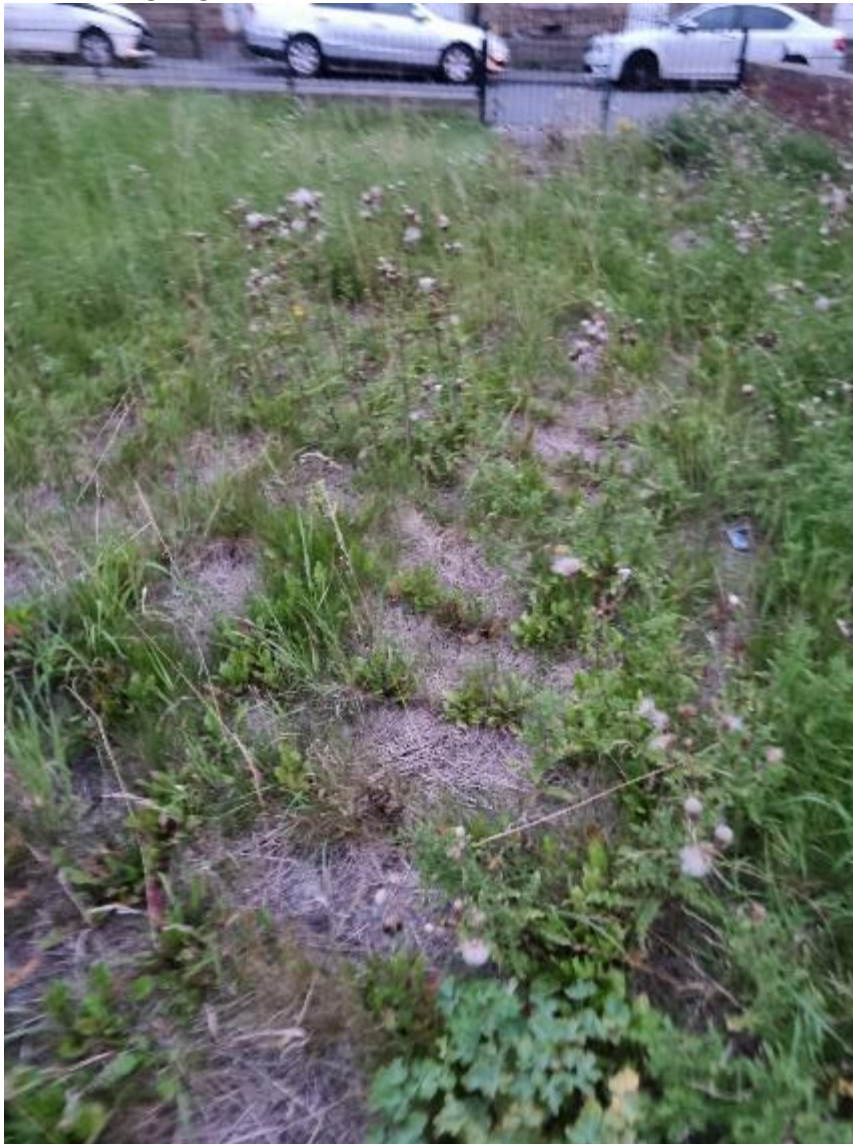
The former garage/drive

Evidence of the identified drive was present in the form of hard standing from the entrance gates.

As a result of the investigation into the historical use of the site no sources of contamination likely to affect the site have been identified off-site. However the previous use of the site with the presence of a former residential garage has the potential to result in contamination from leaks or asbestos within the structure of the building. Further information/ evidence is required to clarify this risk, if no further evidence is available then a preliminary intrusive investigation of the area around the former garage is recommended to identify the presence of hydrocarbon contamination from leaks and asbestos from the garage structure.

Following the site walkover and review of the available information it has been concluded that there are no contaminants off-site which pose a significant risk of significant harm to the identified receptors. On site, the former domestic garage has the potential, subject to further information being obtained, to present a slight risk from oil/flue leaks and asbestos within the structure to the receptors. As such additional information or a further intrusive investigation is recommended around this former structure.
