Location:
**Cliffe Lane,
Gomersal**

Report Type:
Arboricultural Impact Assessment

Ref:
ARB/CP/3075

Date:
May 2024

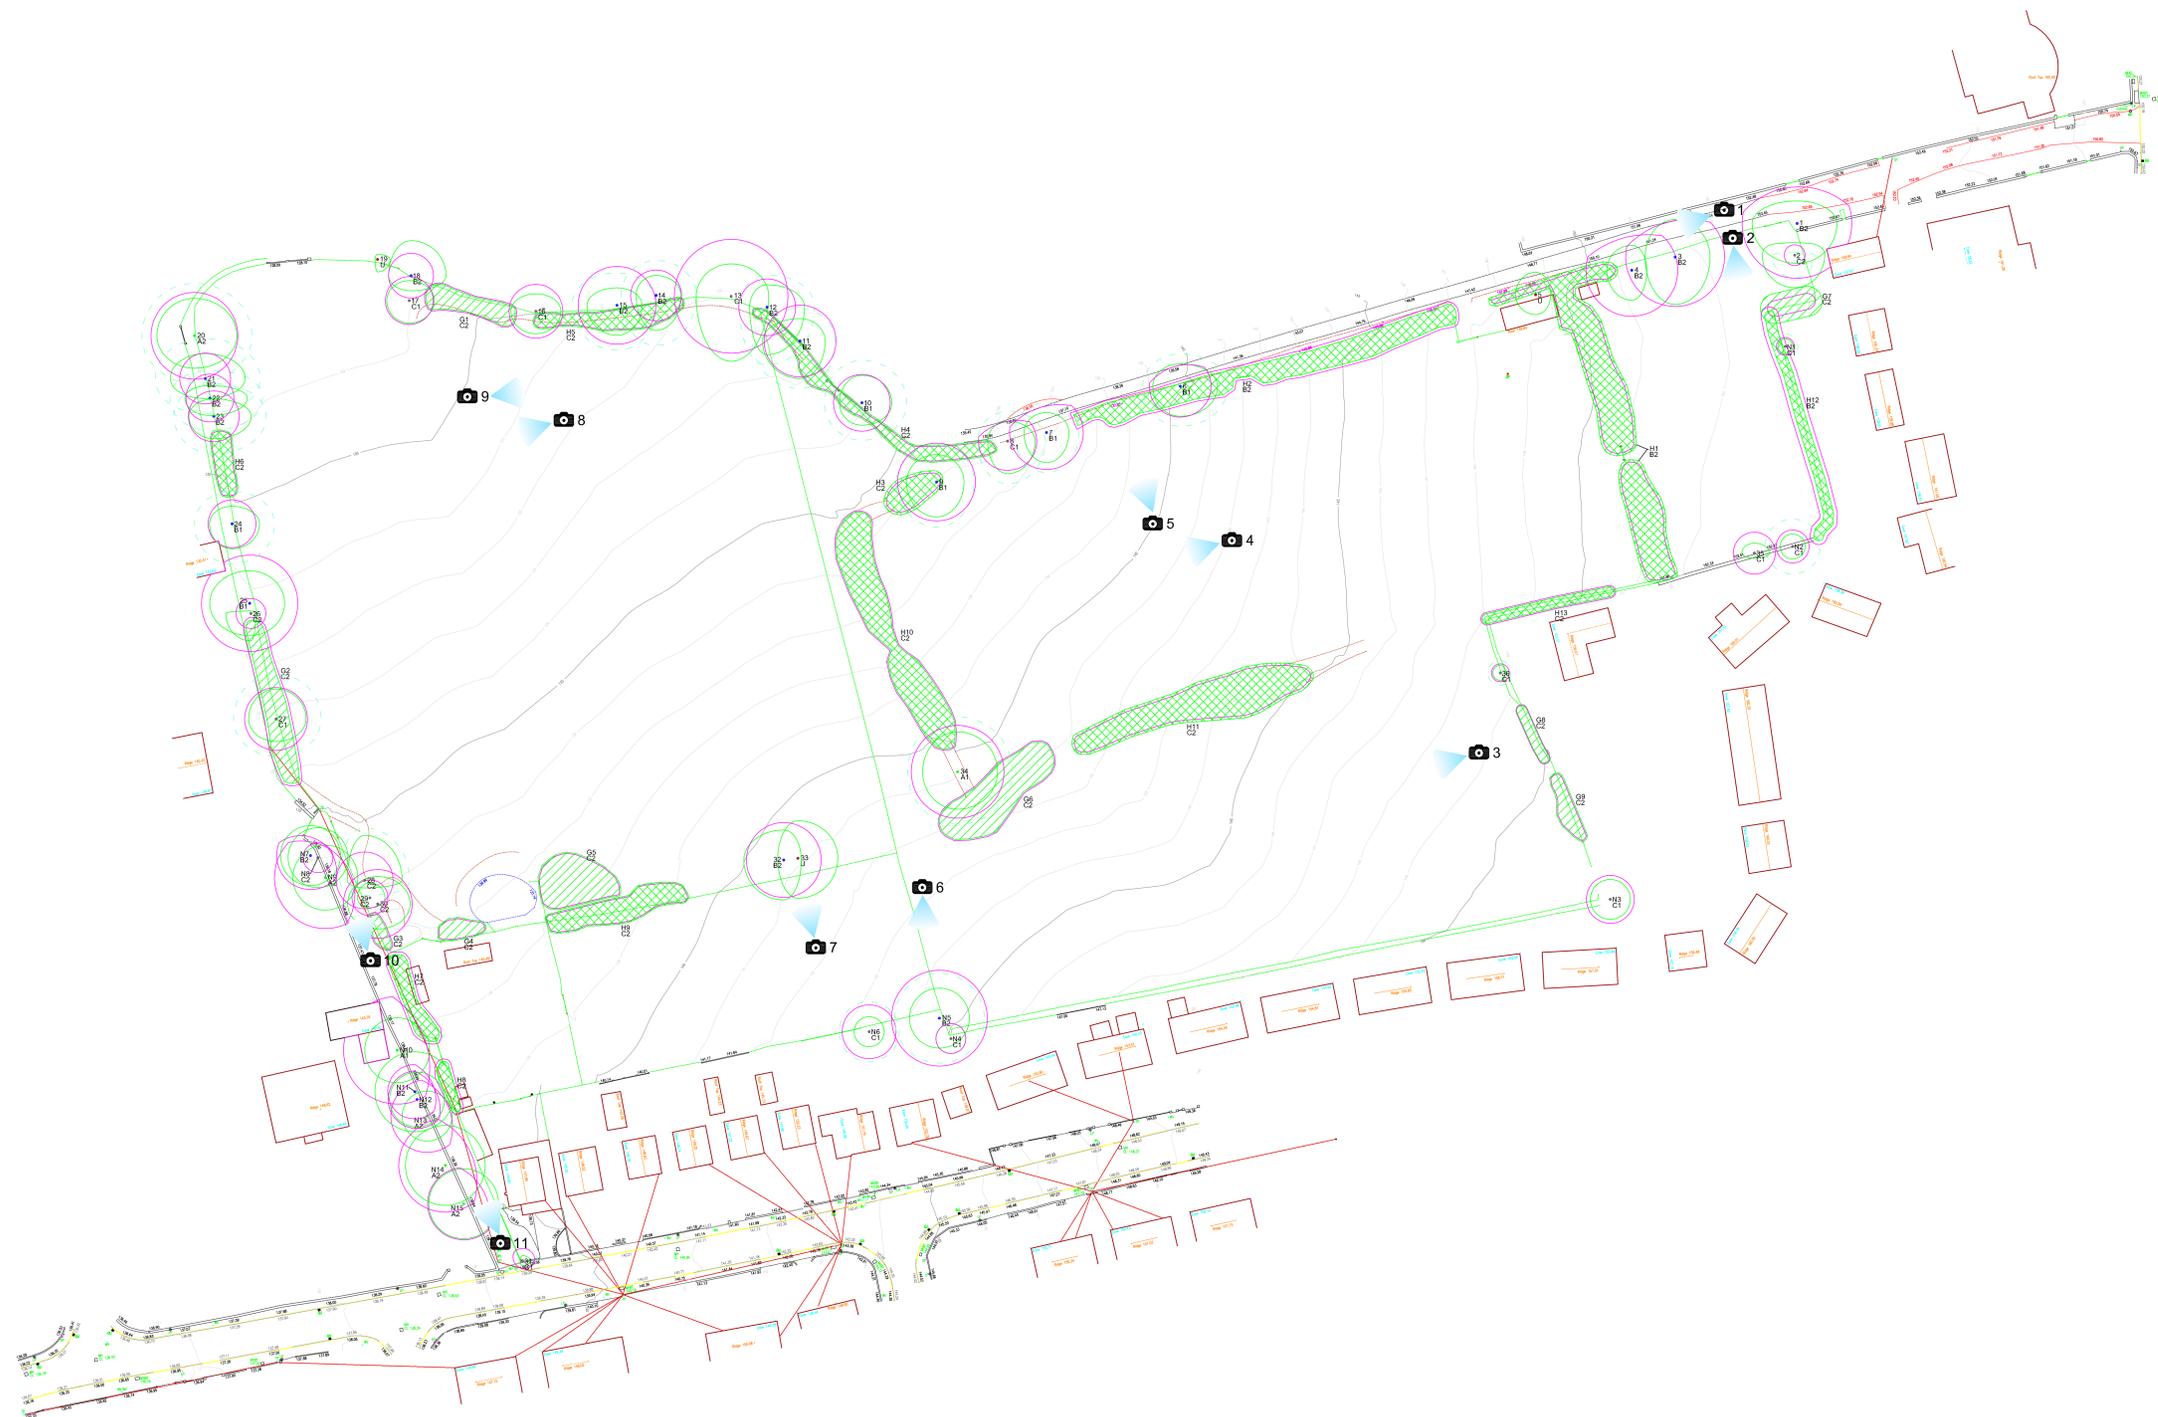
Drawing Title: Tree Constraints Plan
 Project: Cliffe Lane, Gomersal
 Drawing Number: ARB/CP/3075/TCP
 Date: March 2023
 Scale: 1:500 @ A0

- 2.3 The trees are predominantly located within field boundary hedgerows that surround and crisscross the area. A small number of trees located within adjacent properties were recorded where they could have an influence within the site. Their details are annotated upon the Tree Constraints Plan, Appendix 2.

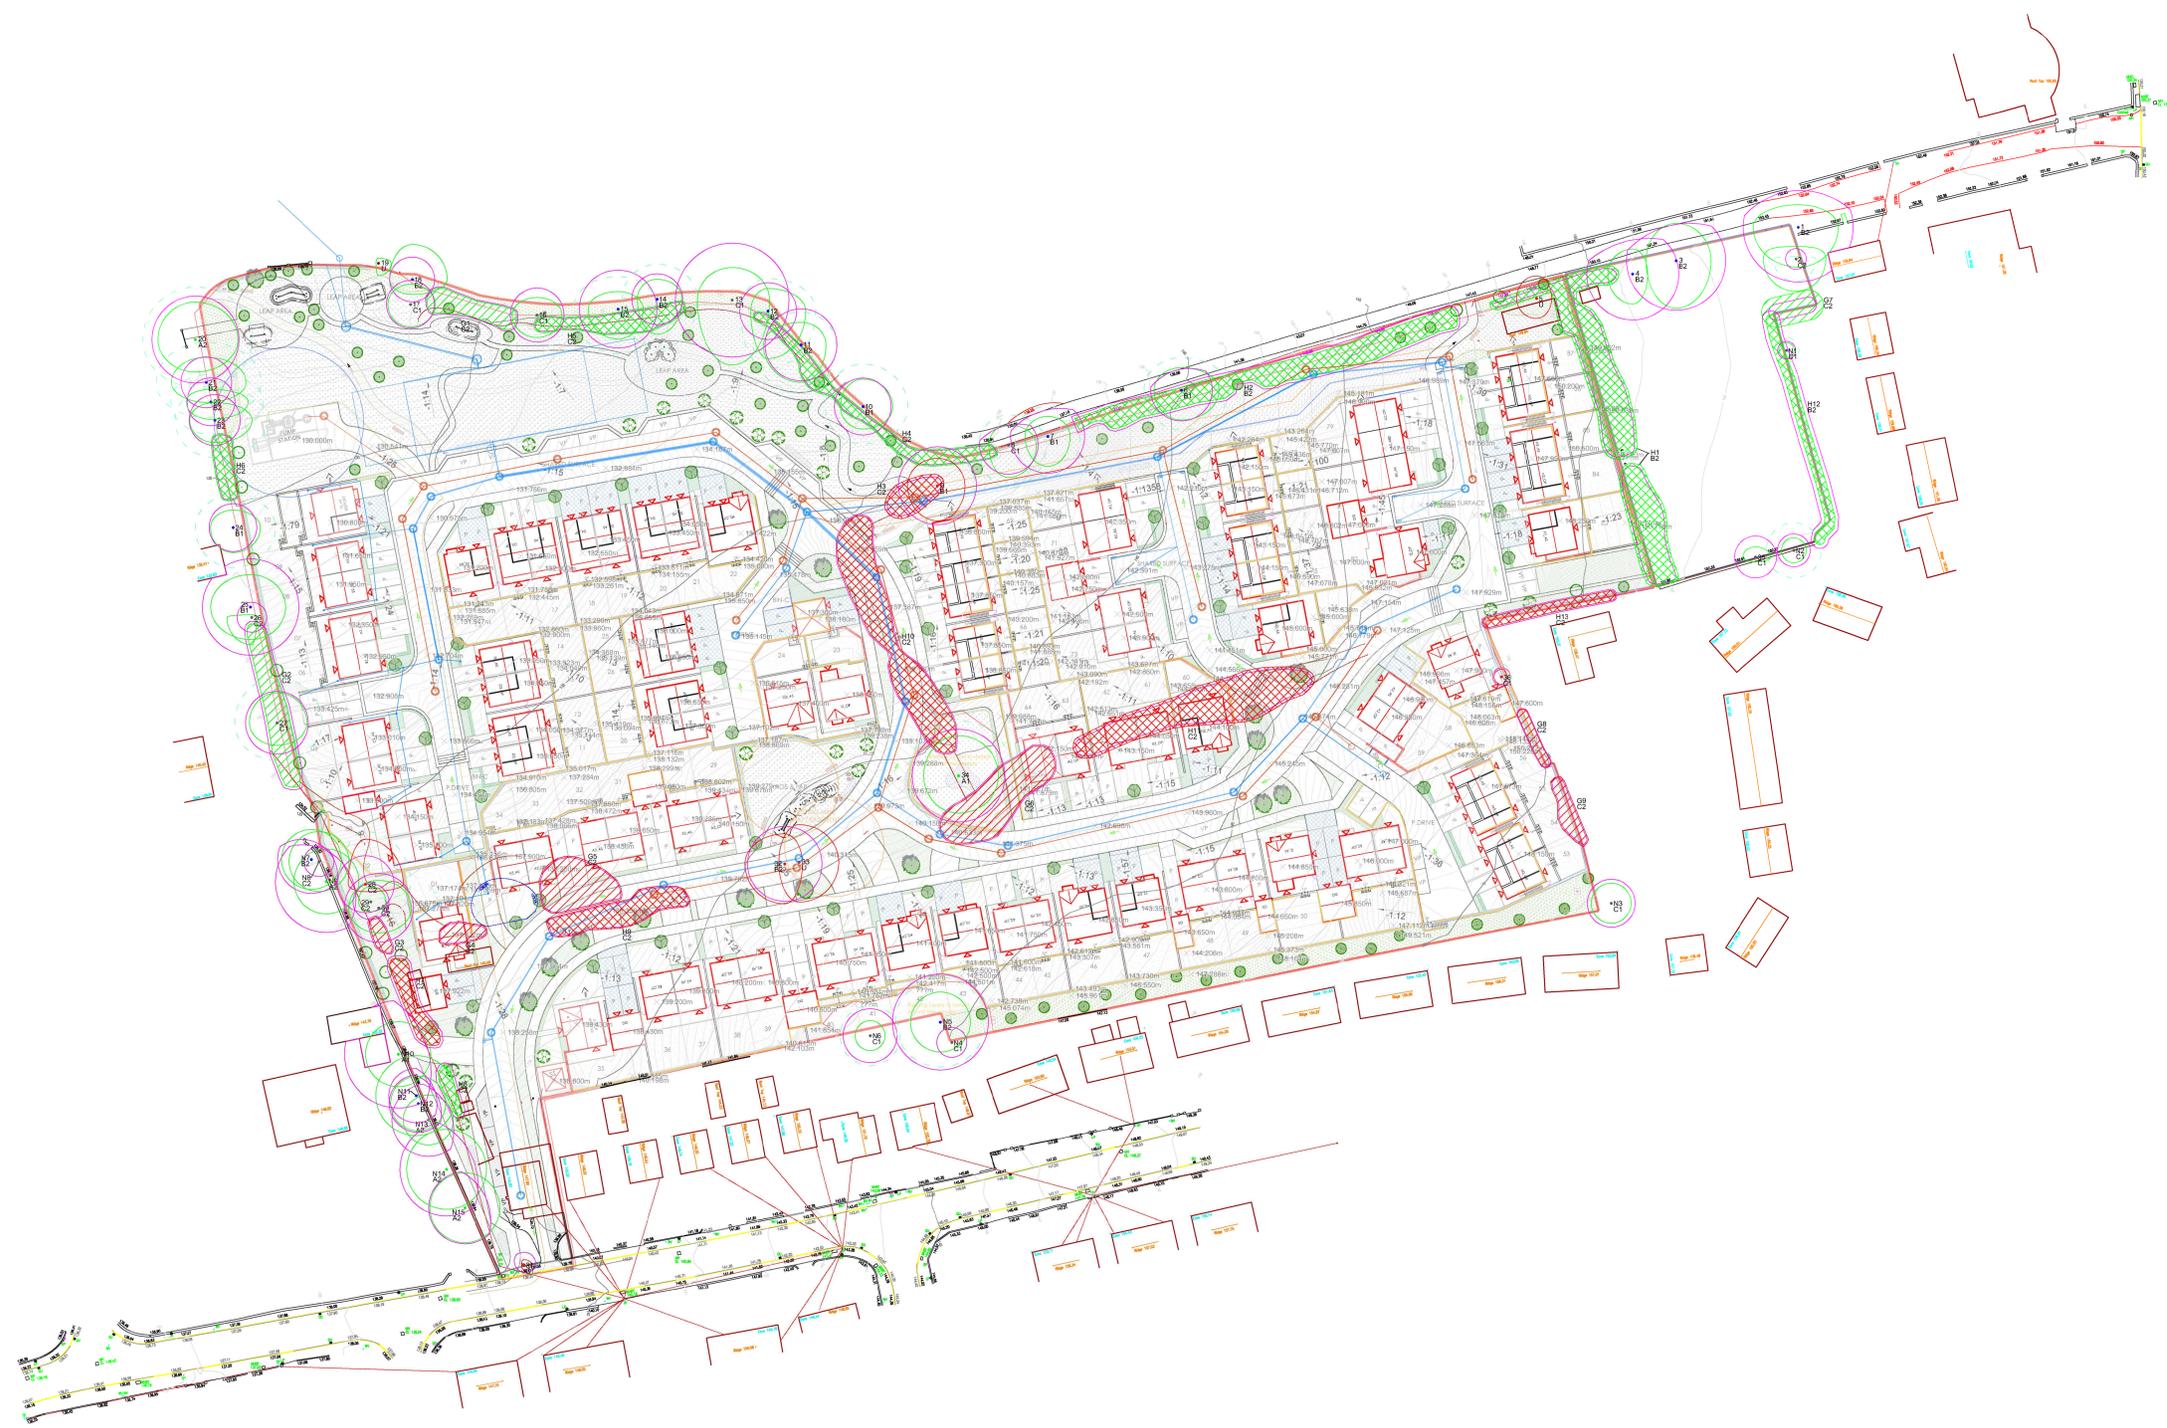
The proposed layout will necessitate the removal of six individually surveyed trees, six groups of trees and six hedgerows.

There are some encroachments from proposed structures within root protection areas of trees.

There is a minor encroachment for Tree 27 from a proposed parking bay, which should not negatively impact the condition of the tree.

A proposed retaining wall enters into the northern section of the root protection area of tree N5, a Willow located within an adjacent property. The rear gardens of the plots in this area have been terraced to ensure that the existing ground levels can be retained as far as possible but the retaining wall encroachment in this area is unavoidable. The encroachment would be minor and should not impact the tree.

Mitigation / Countermeasure: Two of the individually surveyed trees requiring removal (9 & 32) were classified as Category B. Three individual trees (28, 31 & 36), six groups of trees (3-6, 8 & 9), and six hedgerows (3, 7, 9-11 & 13) that would need to be removed were classified as Category C. The remaining one tree that would need to be removed (33) was classified as Category U. In addition, we would also recommend the removal of Tree 5 due to poor condition and unsuitability to be incorporated within a residential development. The tree and hedge removals will be necessary to enable construction of the proposed houses, internal road and path network and other supporting infrastructure. A great deal of effort has been made by architects and engineers to minimise losses of the larger individual trees, with numerous changes made to ensure that proposed structures, drainage infrastructure and ground level changes have as little negative impact as possible. Whilst the loss of the internal hedgerows and groups has been unavoidable, they are all of low quality, Category C, along with three individual trees. The retention of two moderate quality, Category B trees has not been possible. Tree 9 is an early-mature Oak with a basal cavity, whose loss is necessary to ensure that Tree 34, a Category A Oak, is afforded adequate space. Tree 32 is a mature Ash which would need to be removed due to the mine shaft easements dictating the road position. From an arboricultural perspective the magnitude of impact from the tree and hedgerow losses that would be necessary is deemed to be low/moderate. Post-development tree, hedge and shrub planting will assist with mitigating the impact.

Mitigation / Countermeasure: The site topography is such that ground level alterations need to be made across the site to deal with the sloping nature. Ensuring that the level changes can be achieved whilst avoiding root protection areas has been a challenge for the design team, but they have produced a scheme that largely meets the brief. There are some encroachments of ground level changes within the root protection areas of Trees 6, 7, 13, 15, 16 and 20. Where the site needs to be built up the higher ground will be graded down to meet the existing levels. Impacts of grading down to and in some cases into the root protection areas will be minor and will not negatively impact the trees.
