**Moss View, Holmfirth**  
**Bat Survey Report, including nocturnal survey**  
**23<sup>rd</sup> May 2024**

| Document ref: MBE/BAT/2023/110/02 | | | | |

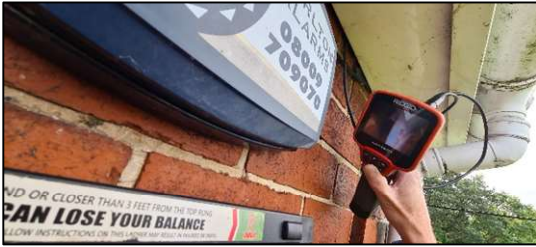
| PRF | Photo | Description |
|---|---|---|
| A | | Gap at the back of the soffit box on the western elevation. All other soffits and fascias were well sealed. |

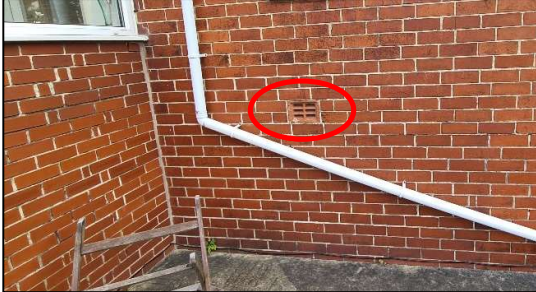
| PRF | Photo | Description |
|---|---|---|
| B | | Ventilation grills leading to the wall cavity. |

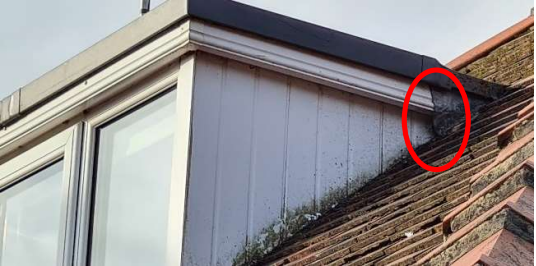
| PRF | Photo | Description |
|---|---|---|
| C | | Gap behind lead flashing next to dormer window. |

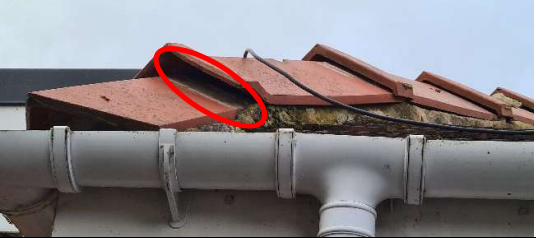
| PRF | Photo | Description |
|---|---|---|
| D | | Gaps under ridge tiles on the hips |

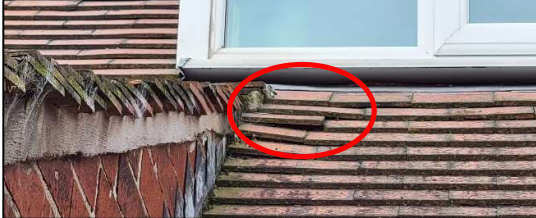
| PRF | Photo | Description |
|---|---|---|
| E | | Slightly raised tiles near the catslide roof and the base of the dormer window. |

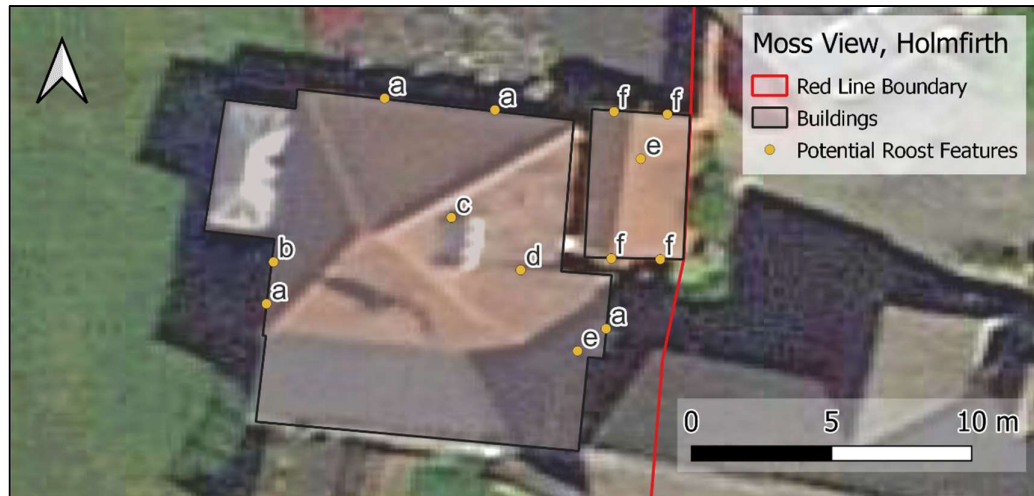
**Figure 3. PRF Locations**

- 5.2.5 Gaps with potential to be used by roosting bats comprised a gap into the soffit box, a gap behind lead flashing on the dormer window, gaps beneath ridge tiles, ventilation grills leading to the wall cavity, and gaps beneath raised tiles. The PRFs are shown in Table 3 and Figure 3 below.

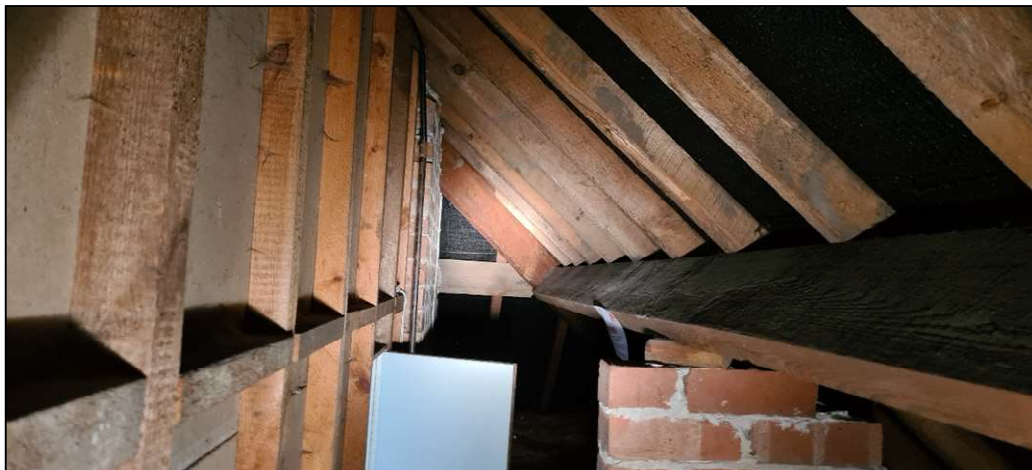
- 5.2.6 The roof voids within the property were limited to the underdrawn eaves and a very small loft above the bedroom. The eaves were triangular in cross section and approximately 2 m high (Plate 3).

**Plate 3. Underdrawn eaves**

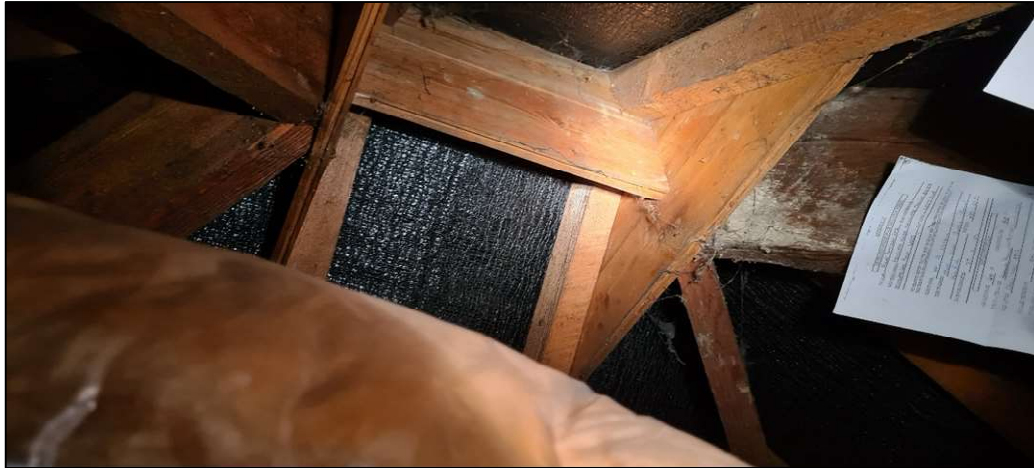
- 5.2.7 The roof was supported by purlins resting on brick pillars / internal walls. The tiles were backed by Type 1F bitumen coated roofing felt and insulation was present between, and on top of, the joists. No signs of bats were present within the eaves space.
- 5.2.8 The small loft above the upstairs bedroom was approximately 0.6 m high (Plate 4). Additional insulation was present on top of the ceiling. No bats or signs of bats were present.

**Plate 4. Small roof space over the upstairs bedroom**

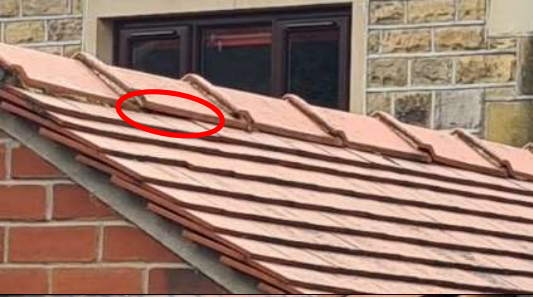
| PRF | Photo | Description |
|---|---|---|
| D | | Gap under ridge tiles |

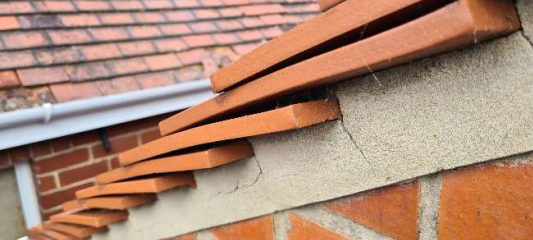
- 5.2.10 Gaps with potential to be used by roosting bats comprised a gap under a ridge tile, and gaps under tiles at the verges. The PRFs are shown in Table 4 and on Figure 3 below.

| PRF | Photo | Description |
|---|---|---|
| F | | Gaps under tiles at the north and south verges |

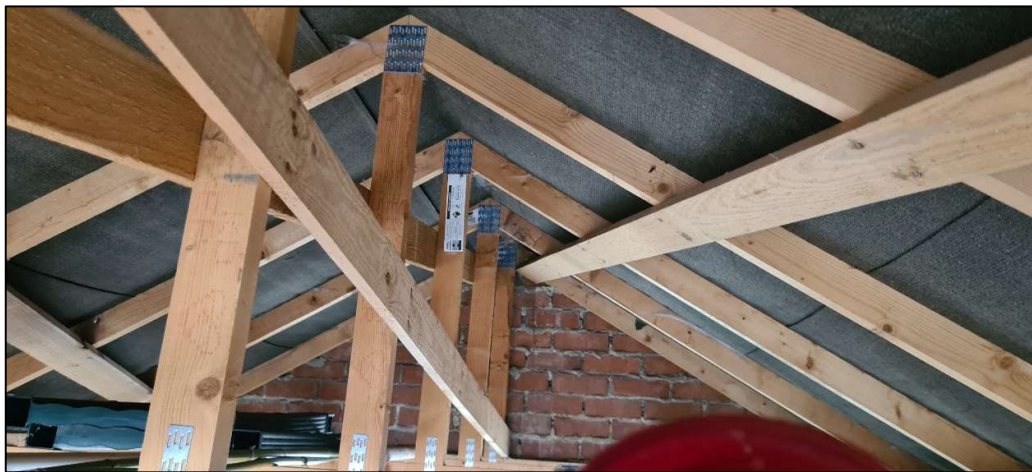
5.2.11 Inside the garage the roof was open to the pitch (i.e. there was no roof void). Type 1F bitumen coated underfelt was present beneath the roof tiles. The roof was supported with modern prefabricated trusses (Plate 6). No bats or signs of bats were present.

**Plate 6 the inside of the garage roof**

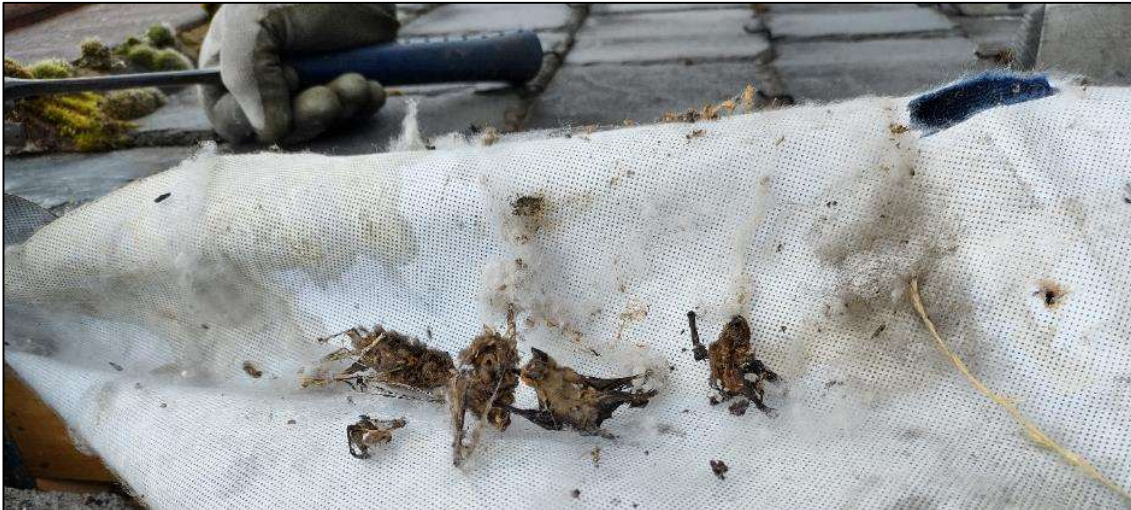
Non-bitumen coated membranes used below roof slates and tiles present a significant problem for bats. Over time, strands are pulled away from the surface of these materials as bats crawl over them. These fuzzy strands are very strong and can tangle and trap bats, sometimes causing the death of bats over multiple years<sup>2</sup>.

One example we have encountered comprised a pipistrelle roost which formed in a building extension constructed in 2009. Over the course of just 13 years the roofing felt degraded to the extent that it trapped and killed more than 10 bats. Fortunately, the problem in this roost was identified and remedial work was undertaken to replace the roofing membrane in 2022.

#### Plate A2.1. Four dead pipistrelles tangled in breathable roofing membrane

The best roofing membrane option for areas where bat roosts are expected is traditional Type 1F bitumen coated hessian backed roofing felt. Bitumen coated roofing felts have been widely and safely used as a secondary weather barrier since approximately the 1950s/1960s. Wooden sarking has also been used for many decades and if appropriately treated, is safe for

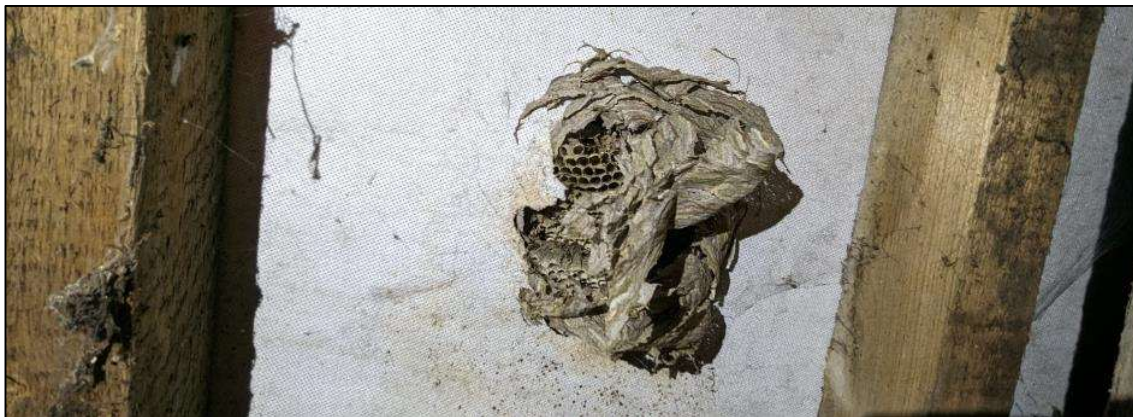
In recent years a fairly substantial proportion of the lofts we have surveyed which had existing breathable felt, were found to have been damaged by wasps (Plate A2.2). In these situations, the wasps appear to have chewed holes in the felt and formed nests in the holes. This doesn't appear to be a problem associated with the traditional bitumen coated roofing felt. Obviously, any holes within roofing felt would be likely to significantly reduce its functionality as a secondary weather barrier. Where bats or birds do come into contact with breathable roofing membranes, they can damage the membrane causing it to leak and they can also significantly reduce the breathability of the felt in that location.

**Plate A2.2. Damage to a breathable roofing membrane adjacent to a wasp nest**
