# Arboricultural Impact Assessment

## WC-181.1a

Land off Round Ings Road, Outlane,  
Huddersfield HD3 3FQ

<b>Report type:</b>	Arboricultural Impact Assessment
<b>Report reference:</b>	WC-181.1
<b>Revision:</b>	a
<b>Client:</b>	Robert Halstead Chartered Surveyors & Town Planners
<b>Site address</b>	Land off Round Ings Road, Outlane, Huddersfield HD3 3FQ
<b>Grid reference:</b>	SE 08118 17034
<b>Report prepared by:</b>	Jack Delaney MICFor MArborA
<b>Date:</b>	3 <sup>rd</sup> January 2024

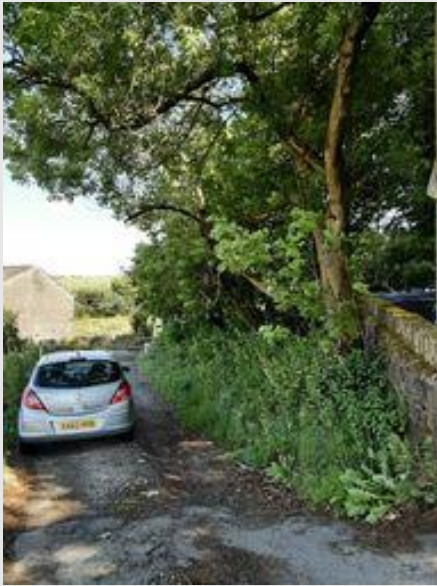
**Plate 1:** T001 (right) & T002 (left)

Tree Ref:	Species	Age	SULE	Ht.	DBH	CS				CC	Comments	PC	BS 5837:2012 Category	Recommendations
						N	E	S	W					
T001	Common Ash ( <i>Fraxinus excelsior</i> )	SM	20-40	11	410	7.5	5.5	2	4	4	Asymmetrical crown spread p due to proximity with adjacent trees. Minor deadwood < 100 mm in diameter scattered throughout crown. Multiple pruning stubs on west aspect of main stem from historic crown lifting.	F	B1	No works recommended
T002	Common Ash ( <i>Fraxinus excelsior</i> )	EM	20-40	16	530	6	6.5	4	3.5	3	Minor deadwood < 100 mm in diameter scattered throughout crown.	F	B1	No works recommended

- All excavations into the soil within the RPAs of T001 and T002 are to be carried out using a compressed air soil displacement method. Compressed air soil displacement is an efficient method of soil removal within RPAs which - when compared to traditional mechanical methods - significantly reduces the damage incurred to tree roots.
- If major roots that are greater than 25 mm are encountered, these should not be severed without first consulting with the Project Arboriculturalist. If roots under this diameter are present, these will be pruned using an appropriate sharp pruning tool, such as pruning saw or secateurs. Any temporarily exposed roots will be covered with sharp sand to prevent desiccation.

**4.2.7.** The strip excavations required for the installation of kerbs can inflict serious damage upon tree roots. Within the RPAs of T001, T002, T005, T006, and T010 this should be avoided by using alternative methods of edge support; for example, Tanalised® board edging positioned directly on top of existing grade levels, and secured with track or road pins, as is detailed in **Section 8** of the **Outline AMS** in **Appendix 3**.

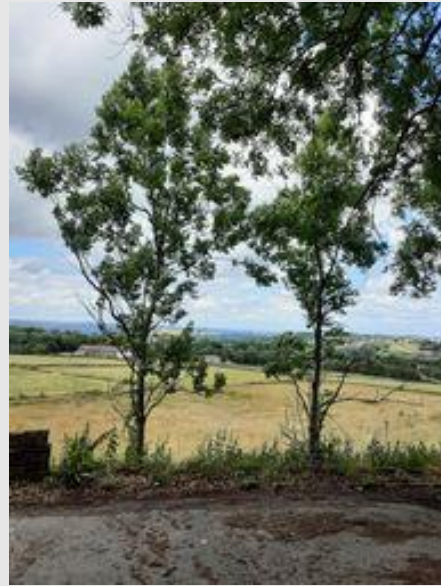
**Plate 2:** T003 (left) & T004 (right)

Tree Ref:	Species	Age	SULE	Ht.	DBH	CS				CC	Comments	PC	BS 5837:2012 Category	Recommendations
						N	E	S	W					
T003	Common Ash ( <i>Fraxinus excelsior</i> )	Y	40-80	8	160	2	2	2	2	2	No obvious significant defects, though lacks qualities for higher BS 5837 categorisation.	F	C1	Remove tree
T004	Common Ash ( <i>Fraxinus excelsior</i> )	Y	40-80	8	160	2	2	2	1	2	No obvious significant defects, though lacks qualities for higher BS 5837 categorisation.	F	C1	Remove tree
T005	Elder ( <i>Sambucus nigra</i> )	SM	10-20	5	230 100 90	3	3.5	1.5	1.5	2	No obvious significant defects, though lacks qualities for higher BS 5837 categorisation. Tertiary branches to south-east encroach upon power cables.	F	C1	No works recommended
T006	Sycamore ( <i>Acer pseudoplatanus</i> )	SM	40-80	16	410	3	4	5	4	1	No obvious significant defects, though lacks qualities for higher BS 5837 categorisation. Tertiary branches to east encroach upon power cables.	G	B1	No works recommended

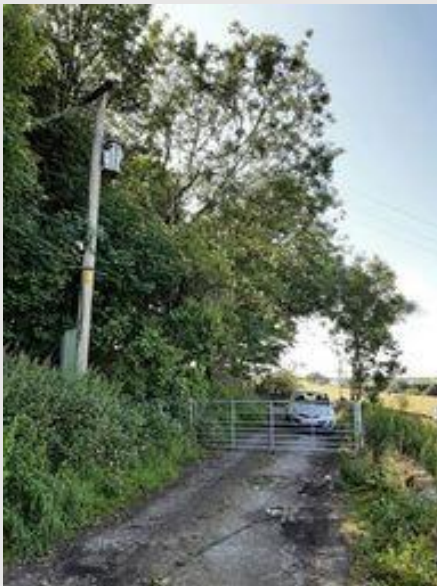
**Plate 3:** Group containing T005, T006, and T007

T007	Sycamore ( <i>Acer pseudoplatanus</i> )	SM	10-20	7	210	1	2.5	3.5	2.5	1	Asymmetrical crown spread due to proximity with adjacent trees. Historically topped at circa 5 m.	F	C1	No works recommended
T008	Common Ash ( <i>Fraxinus excelsior</i> )	SM	10-20	17	290	3.5	3	2	3.5	6	Minor crown tip dieback, possibly indicating Chalara ash dieback ( <i>Hymenoscyphus fraxineus</i> ).	P	C1	No works recommended

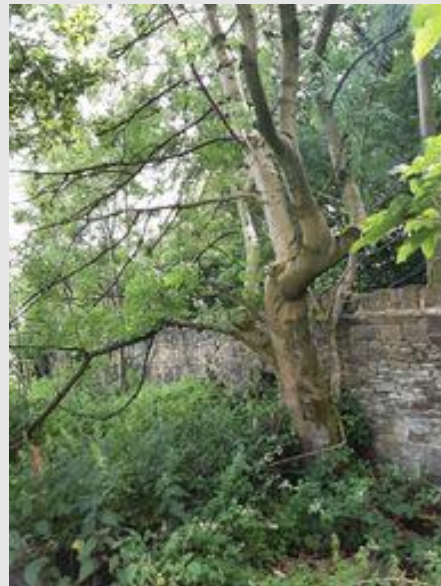
**Plate 4:** T009

Tree Ref:	Species	Age	SULE	Ht.	DBH	CS				CC	Comments	PC	BS 5837:2012 Category	Recommendations
						N	E	S	W					
T009	Common Ash ( <i>Fraxinus excelsior</i> )	EM	40-80	16	490	4.5	4	4.5	4	0	Minor deadwood < 100 mm in diameter scattered throughout crown	F	B1	No works recommended
T010	Sycamore ( <i>Acer pseudoplatanus</i> )	EM	40-80	14	420 430	6	5.5	6	3	2	Bifurcates at ground level into two co-dominant primary stems; union is acute and possibly included.	G	B1	No works recommended
T011	Common Hawthorn ( <i>Crataegus monogyna</i> )	M	20-40	7	560	4.5	4.5	4	3	0	Bifurcates at 0.3 m into two co-dominant primary stems; union is acute and possibly included. Minor deadwood < 100 mm in diameter scattered throughout crown	F	B1	No works recommended
T012	Common Ash ( <i>Fraxinus excelsior</i> )	Y	5-10	6	110 90 100	2	2	2	1.5	3	Multiple stemmed, self-seeded tree. Minor crown tip dieback, possibly indicating Chalara ash dieback ( <i>Hymenoscyphus fraxineus</i> ).	P	C1	No works recommended

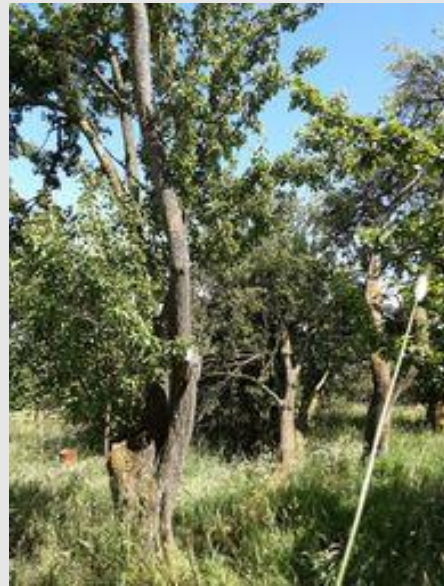
***Plate 8: T013, T014, & T015 (left to right)***

T013	Common Pear ( <i>Pyrus communis</i> )	EM	40-80	10	470	4	5	2	2	3	Bifurcates at 1 m into two co-dominant primary stems; union is acute and possibly included. Asymmetrical crown spread to the north-east.	F	B1	No works recommended
T014	Common Pear ( <i>Pyrus communis</i> )	EM	10-20	6	360	0	8	6	2	0	Historically failed at root plate, though appears to have now rerooted and stabilised.	F	C1	No works recommended

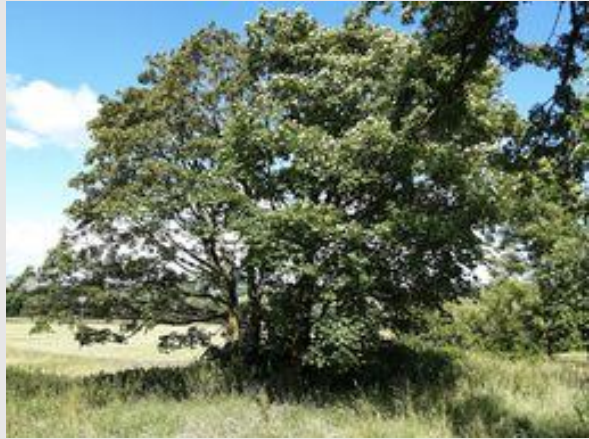
**Plate 10:** T020 (right) and T021 (left)

T020	Sycamore ( <i>Acer pseudoplatanus</i> )	EM	40-80	15	590 380	3	7	7	6.5	1	Asymmetrical crown spread to south due to proximity with adjacent tree.	F	B1	No works recommended

Tree Ref:	Species	Age	SULE	Ht.	DBH	CS				CC	Comments	PC	BS 5837:2012 Category	Recommendations
						N	E	S	W					
T021	Sycamore ( <i>Acer pseudoplatanus</i> )	EM	20-40	15	410 380	7	5	2	6	1	Asymmetrical crown spread to north due to proximity with adjacent tree. Bifurcates at ground level into two co-dominant primary stems; both stems have historically been ring-barked, with some crown tip dieback as a result.	F	B1	No works recommended
T022	Wild Cherry ( <i>Prunus avium</i> )	EM	20-40	6	410	5	6	6	4	1	No obvious significant defects.	F	B1	No works recommended
T023	Cultivar Apple ( <i>Malus domestica</i> )	SM	20-40	6	210	3.5	2	2	3.5	1	Main stem leans slightly to the north-west, though with no indication of root plate movement. Partially failed secondary branch within north aspect of crown at approx. 2.5 m.	F	C1	No works recommended.
T024	Wild Cherry ( <i>Prunus avium</i> )	EM	20-40	7	360	3	2.5	5.5	5.5	1	Asymmetrical crown spread to south-west.	F	B1	No works recommended

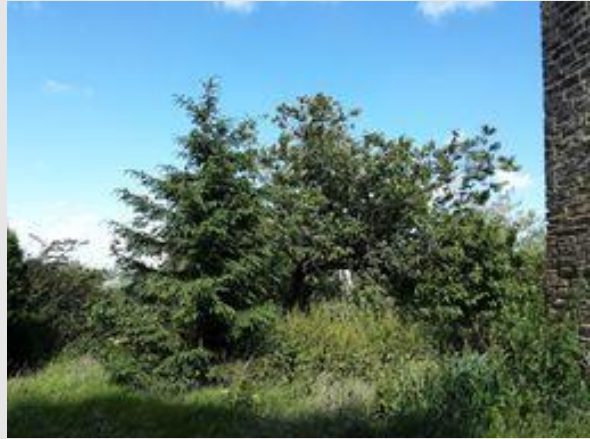
***Plate 14: T025***

T025	Norway Spruce ( <i>Picea abies</i> )	Y	40-80	5	160	1.5	1.5	1.5	1.5	0	No obvious significant defects, though lacks qualities for higher BS 5837 categorisation.	G	C1	No works recommended
T026	Elder ( <i>Sambucus nigra</i> )	SM	10-20	5	150 100 90 90 110 210	1	3	3.5	3	0	Multiple-stemmed self-seeded tree, growing from base of gable end of barn. Asymmetrical crown spread to the south.	F	C1	Remove tree

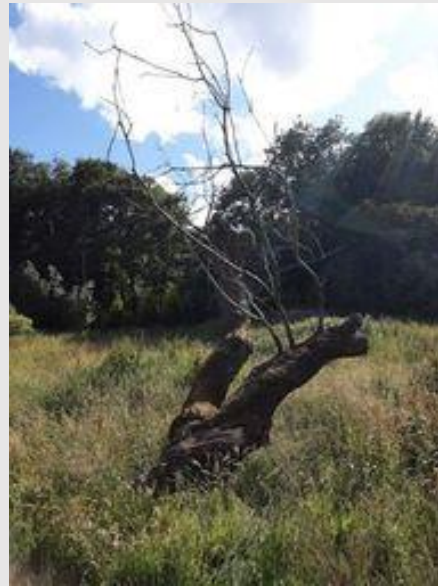
***Plate 16: T027***

Tree Ref:	Species	Age	SULE	Ht.	DBH	CS				CC	Comments	PC	BS 5837:2012 Category	Recommendations
						N	E	S	W					
T027	Sessile Oak ( <i>Quercus petraea</i> )	M	Dead	4	710	1	2	2	1	1	Moribund tree	D	U	No works recommended

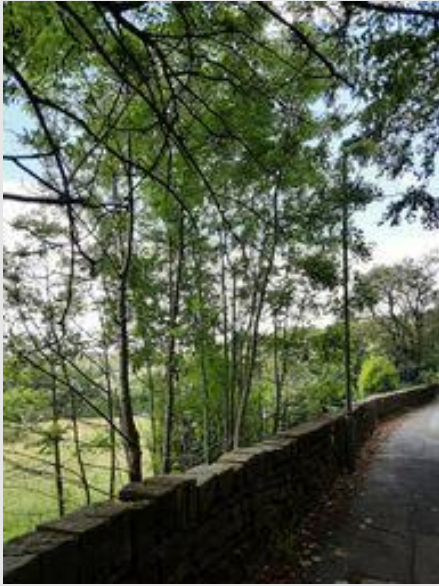
*Plate 17: G001*

Group Ref:	Species Composition	Age	SULE	Av. Ht.	Av. DBH	Approx. No. of Stems	CC	Comments	PC	BS 5837 :2012 Category	Recommendations
G001	Common Ash ( <i>Fraxinus excelsior</i> )	Y	20-40	8	100	20	1	Group containing self-seeded sapling ash. No obvious significant defects, though of limited arboricultural merit, and lacking qualities for higher BS 5837 categorisation. Tertiary branches to west encroach upon adjacent streetlamp.	F	C1	No works recommended
G002	Sour Cherry ( <i>Prunus cerasus</i> ) Wild Cherry ( <i>Prunus avium</i> ) Cultivar Apple ( <i>Malus domestica</i> )	Y SM	20-40	6	200	15	0	Group of fruit orchard trees. No obvious significant defects, though of limited arboricultural merit, and lacking qualities for higher BS 5837 categorisation.	F	C1	No works recommended
G003	Common Ash ( <i>Fraxinus excelsior</i> ) White Willow ( <i>Salix alba</i> ) Silver Birch ( <i>Betula pendula</i> ) Common Holly ( <i>Ilex aquifolium</i> ) Leyland Cypress ( <i>Cupressus x leylandii</i> )	Y	20-40	7	150	30	0	Linear group predominantly consisting of Leyland cypress. No obvious significant defects, though of limited arboricultural merit and lacking qualities for higher BS 5837 categorisation.	G	C1	No works recommended

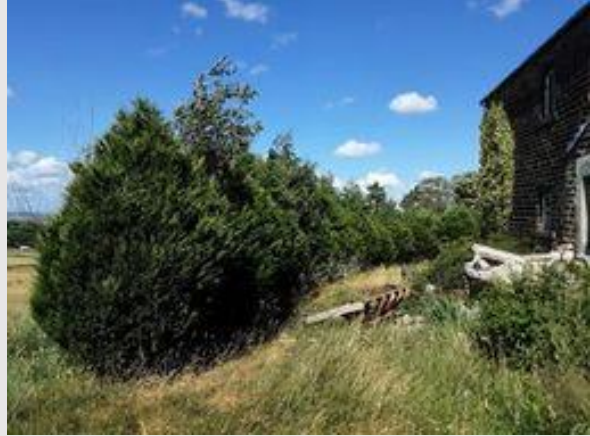
*Plate 18: G004*

Group Ref:	Species Composition	Age	SULE	Av. Ht.	Av. DBH	Approx. No. of Stems	CC	Comments	PC	BS 5837 :2012 Category	Recommendations
G004	Goat Willow ( <i>Salix caprea</i> ) Laurel Cherry ( <i>Prunus laurocerasus</i> ) Leyland Cypress ( <i>Cupressus x leylandii</i> ) Summer Lilac ( <i>Buddleia davidii</i> )	Y	20-40	6	160	20	0	Linear group predominantly consisting of Leyland cypress. No obvious significant defects, though of limited arboricultural merit and lacking qualities for higher BS 5837 categorisation.	G	C1	No works recommended
