82 Manchester Road, Slaithwaite

Bat Survey Report

7th May 2024

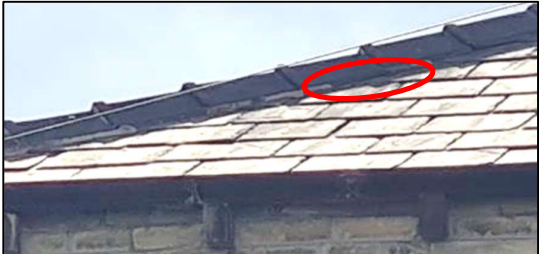
PRF	Photo	Description
A

Section of missing mortar.

- 5.2.5 The potential roost features identified outside the building had marginal suitability to be used by roosting bats. The missing mortar on the hip was located on the north side of the building, the gaps between angle cap ridge tiles were considered likely to be shallow and the raised slate was unlikely to be suitable unless there was a membrane beneath.
- 5.2.6 The rest of the building was well maintained and no other suitable gaps were present. Outside lights were present on the eastern and southern aspects of the building (Plate 3).

- 6.2.1 No further bat or bird survey is required. Although the features present are considered to have negligible suitability for use by roosting bats, a single bat can occasionally roost almost anywhere and vigilance should be taken when removing the ridge tiles on the hips of the roof. If bats are recorded at any time during the renovation, work in that area should cease and advice sought from Middleton Bell Ecology.

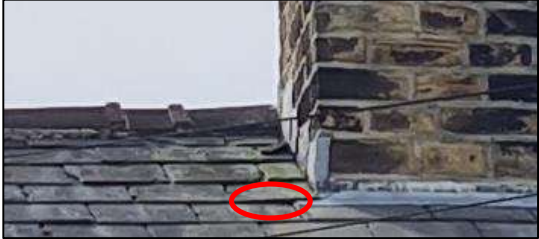
Very slightly raised slate.
C

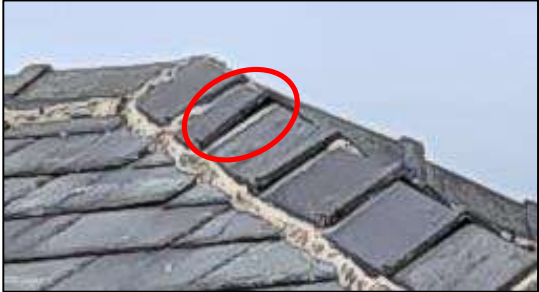
Small gaps below the angle cap section of the hip ridge tiles.

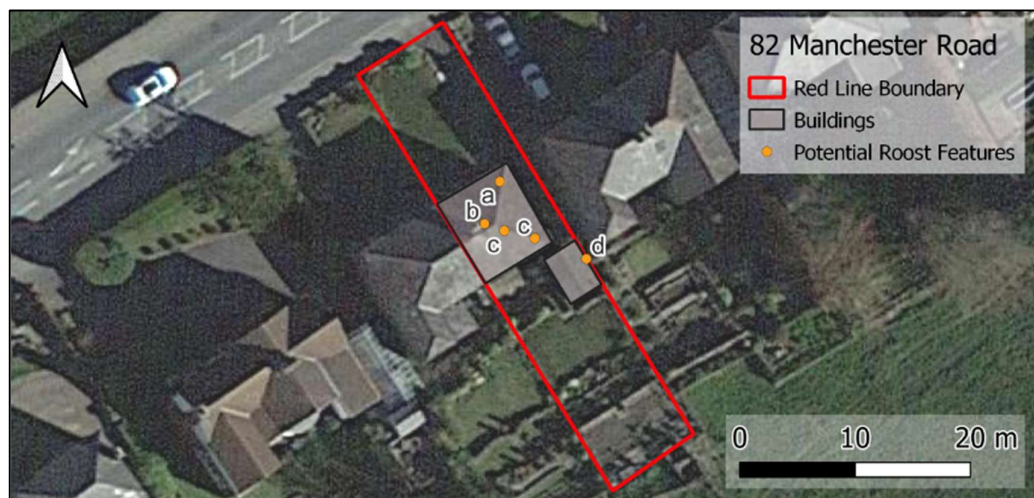
Figure 2. PRF Locations

5.2.4 The only potential bat roost feature present comprised gaps below or between ridge tiles and one gap beneath a raised slate, shown in Table 2 and Figure 2 below.

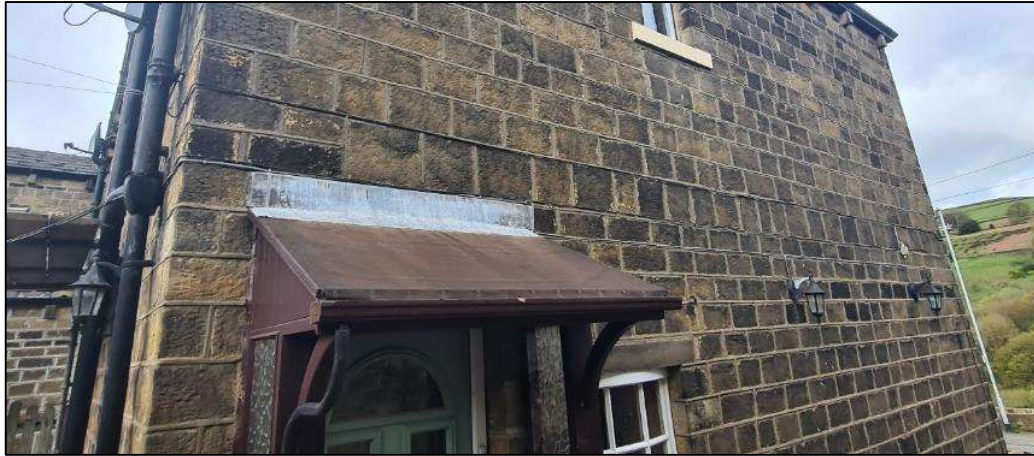
Plate 3. The eastern aspect of the building showing the building-mounted lamps

- 6.2.3 Existing light levels around the exterior of the building were considered likely to be relatively high. In line with guidance from the Bat Conservation Trust and the Institute of Lighting Professionals, outdoor lighting should be kept to a minimum with passive infrared sensors and/or timers used to ensure lights are only on when they're needed. Where new outside lighting is required, it should be low level, downwards facing, relatively dim, and a warm white colour (ILP, 2023).

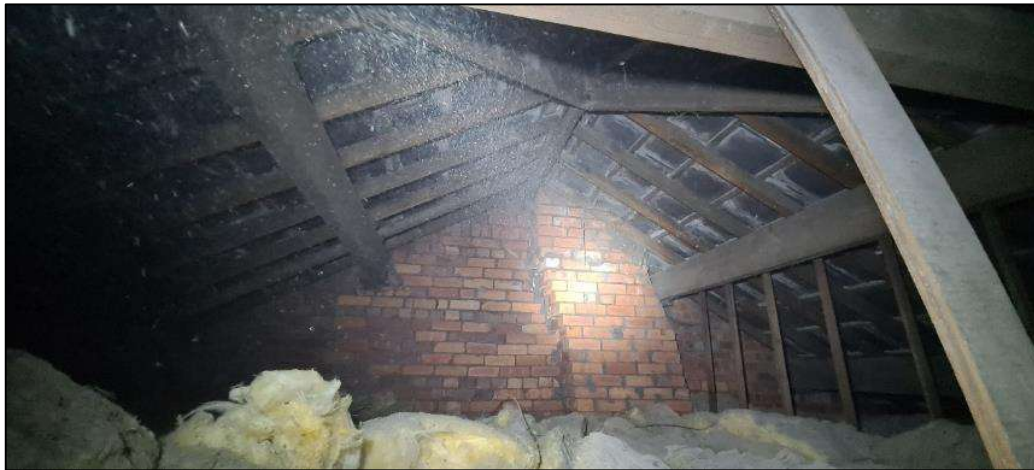
- 5.2.8 The roof was supported by timber purlins, rafters and a ridge beam. No roof lining was present allowing the underside of the slates to be inspected from the void. The roof was supported by timber purlins, rafters and a timber ridge beam, with the purlins resting on the internal brick wall and the rafters supported by the external walls (Plate 4).

Plate 4. The roof structure

- 5.2.9 There was approximately 1500 mm of insulation present and a large amount of dust was visible above the insulation. This was considered likely to be a result of degraded torching on the back of the slates.
- 5.2.10 No bats or signs of bats were present within the roof void. Given the lack of bat signs internally, and the lack of a roofing membrane it was concluded that the potential bat roost features recorded on the exterior of the building were of negligible bat roost suitability.

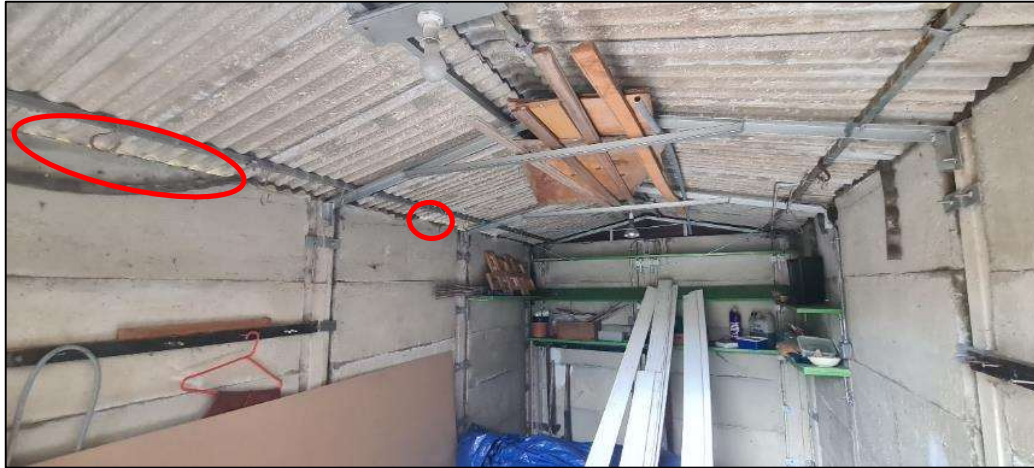
5.2.12 No suitable potential bat roost features were identified on the garage. Some gaps were present beneath the corrugated board at the wall top on the eastern side of the building (Plate 7) (PRF D, Figure 2). These allowed access into the interior of the garage but were not considered sufficient to be used as a potential roost location in their own right as the wall was relatively thin.

Plate 7. The interior of the garage including the spaces beneath the corrugated boards at the top of the wall (circled red)

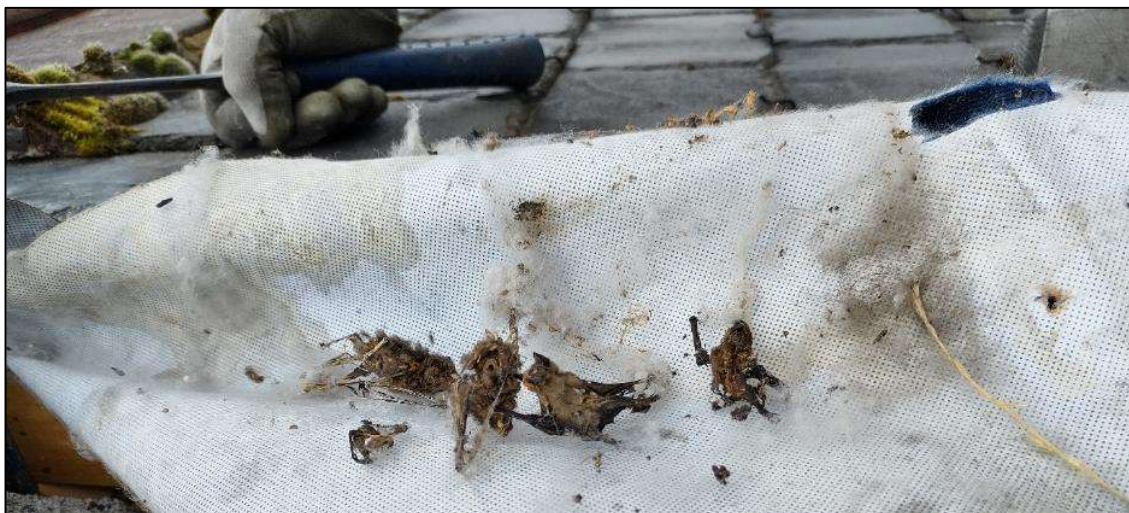
One example we have encountered comprised a pipistrelle roost which formed in a building extension constructed in 2009. Over the course of just 13 years the roofing felt degraded to the extent that it trapped and killed more than 10 bats. Fortunately, the problem in this roost was identified and remedial work was undertaken to replace the roofing membrane in 2022.

Plate A2.1. Four dead pipistrelles tangled in breathable roofing membrane

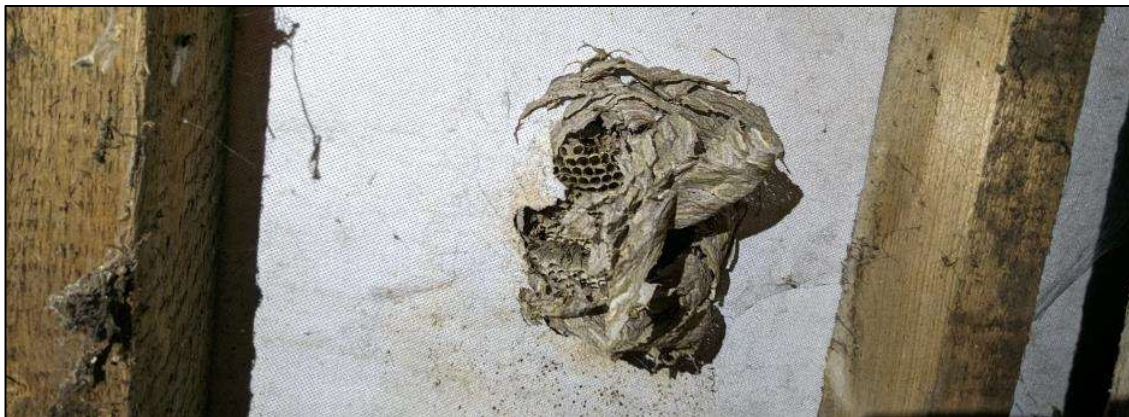
In recent years a fairly substantial proportion of the lofts we have surveyed which had existing breathable felt, were found to have been damaged by wasps (Plate A2.2). In these situations, the wasps appear to have chewed holes in the felt and formed nests in the holes. This doesn't appear to be a problem associated with the traditional bitumen coated roofing felt. Obviously, any holes within roofing felt would be likely to significantly reduce its functionality as a secondary weather barrier. Where bats or birds do come into contact with breathable roofing membranes, they can damage the membrane causing it to leak and they can also significantly reduce the breathability of the felt in that location.

Plate A2.2. Damage to a breathable roofing membrane adjacent to a wasp nest
