# Buildings at The Barn, Paddock Farm, Marsden

## Bat Survey Report

6<sup>th</sup> June 2024

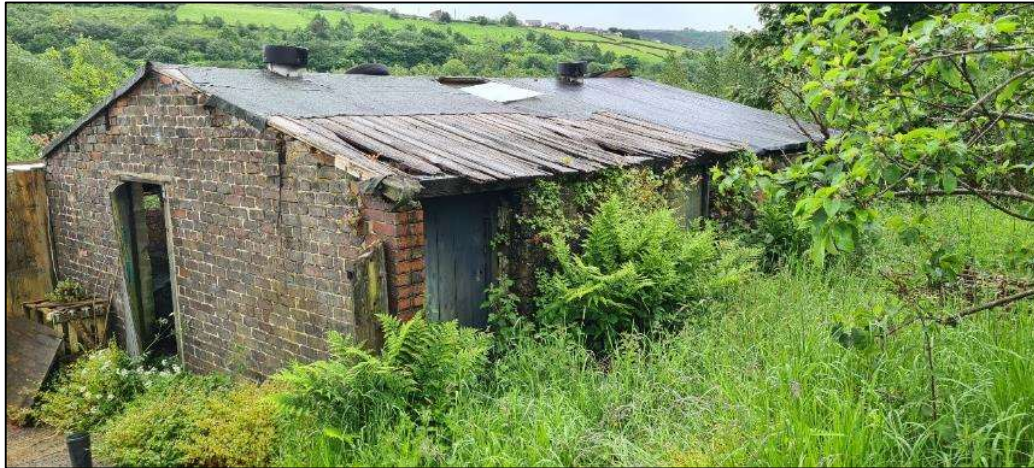
**Plate 1. The original brick and stone barn viewed from the north**

- 5.2.2 The large storage barn comprised a brick and stone built original barn with a more recent extension to the southeast (Plate 1). The original section of the building had a two-pitched roof partially covered with bituminous felt. The wooden sarking on the uncovered areas was exposed to the elements.
- 5.2.3 The extension to the southeast was constructed from hollow concrete blocks with a

metal and timber frame. The extension was open fronted (to the southeast). The extension had a shallow, single-pitched roof, covered with plastic sheeting. The extension had itself been extended by the addition of a wood store to the northeast. The woodstore had an open wooden frame and a lean-to roof which stepped up in the middle. The roof was covered with sedum and colonising grasses and herbs.

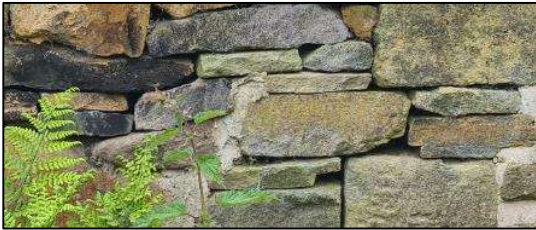
| PRF | Photo | Description |
|---|---|---|
| A | | Gaps between stonework. |

- 5.2.5 No bats or signs of bats were recorded within B1. The gaps in the stonework, and the five access points leading into the hollow concrete blocks (PRFs a and d) could be relatively well inspected. All of the entrance could be seen as well as what was considered to be the majority or all of the internal cavity. Many of the cavities had cobwebs inside the cavities that held small amounts of debris, indicating that the web had been present for at least a little while. No bat droppings were present inside these cavities despite a relatively thorough search and dry internal conditions.

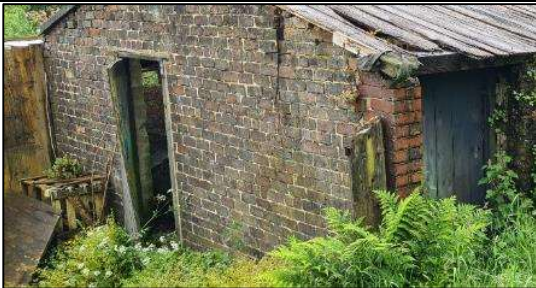
| PRF | Photo | Description |
|---|---|---|
| B | | Gaps between wooden door and frame. |

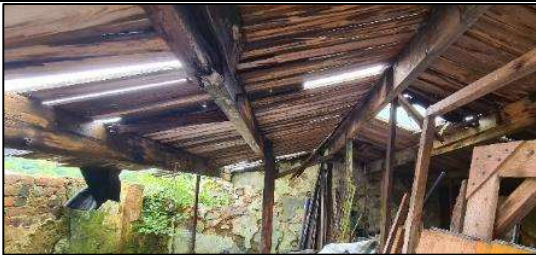
| PRF | Photo | Description |
|---|---|---|
| C | | Holes in the roof. |

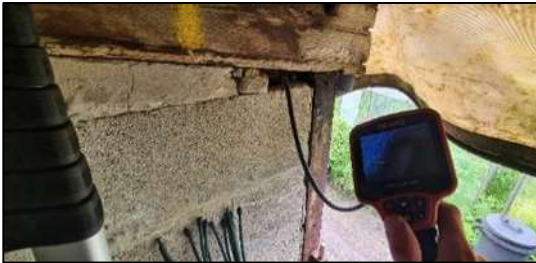
| PRF | Photo | Description |
|---|---|---|
| D | | Holes allowing bats access into hollow concrete blocks. |

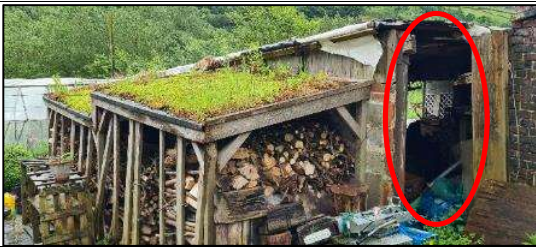
| PRF | Photo | Description |
|---|---|---|
| E | | Open sides to the building. |

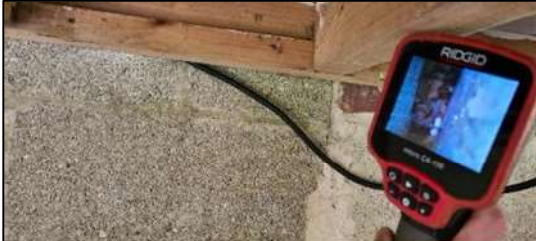
| PRF | Photo | Description |
|---|---|---|
| F | | Gap between timber structure and the blockwork wall behind. |

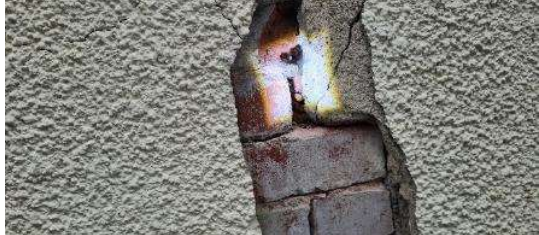
| PRF | Photo | Description |
|---|---|---|
| G | | A shallow / open crack in the brickwork. |

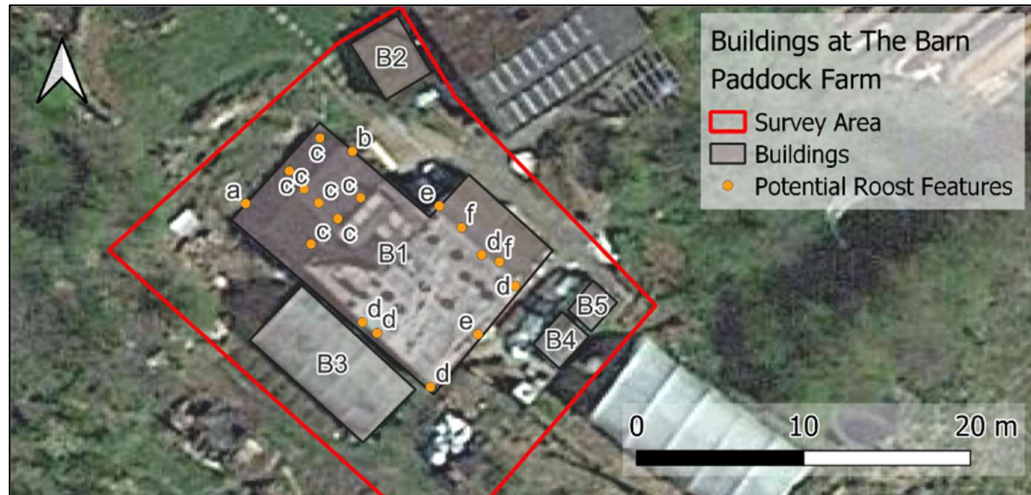
**Figure 2. PRF Locations**

- 5.2.4 Potential bat roost features present comprised only gaps between stonework on the northwestern elevation, gaps providing access into hollow concrete blocks, and a gap between the timber frame of the woodstore and the blockwork wall behind. Bats could also enter the structure via the open front of the extension and the woodstore, gaps around a wooden door in the original section of the building, and via holes in the roof (including around a glass skylight). The potential roost features and access points (PRFs) are shown in Table 2 and Figure 2 below.

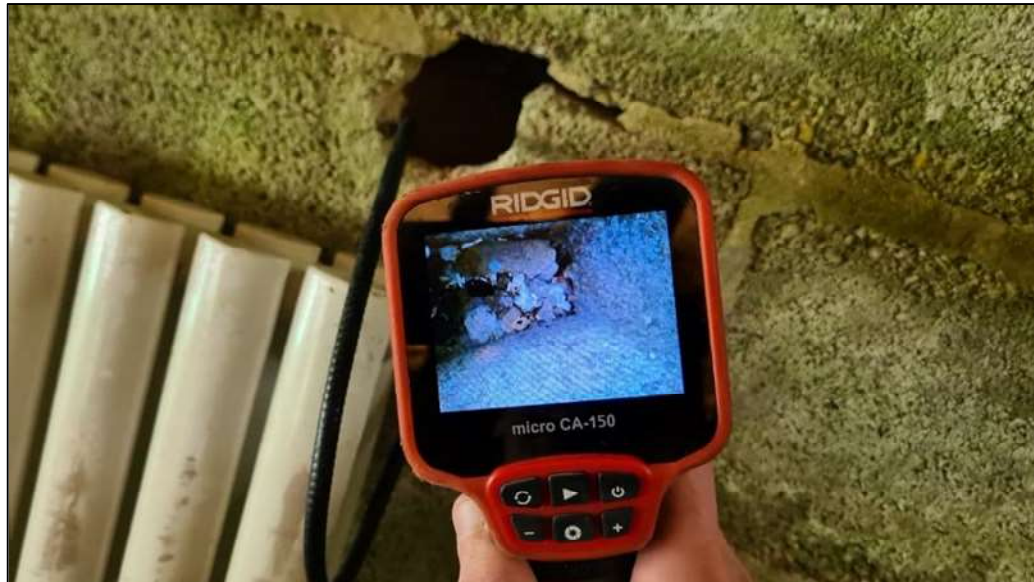
**Plate 3. The hole in the hollow concrete blockwork wall being inspected**

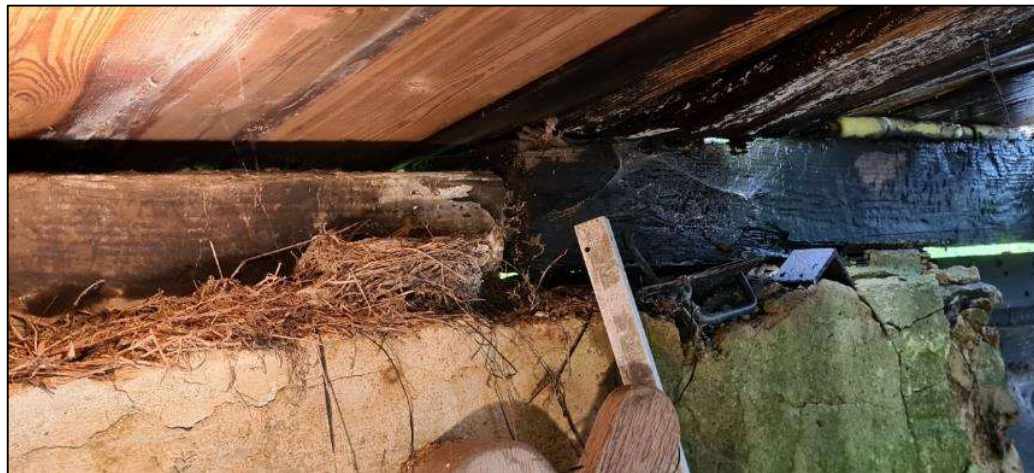
- 5.2.6 Two bird's nests were recorded within the original section of B1. One was located on the wall top (Plate 4) and a second was located within an old swallow nest cup (Plate 5). The client confirmed that wrens *Troglodytes troglodytes* and robins *Erithacus rubecula* were known to nest within the building and that swallows had nested in the past but now rarely did.

**Plate 4. Bird's nest on the wall top at the northwestern end of B1**

- 6.2.3 Nesting birds were identified within Building 1, the client confirmed that robins, wrens, and swallows have been known to nest there. It is therefore recommended that the demolition either avoids the nesting bird season (March to September), or a check for active nests is undertaken prior to the start of demolition. If an active nest is present, it must be retained in-situ until the young have fledged.

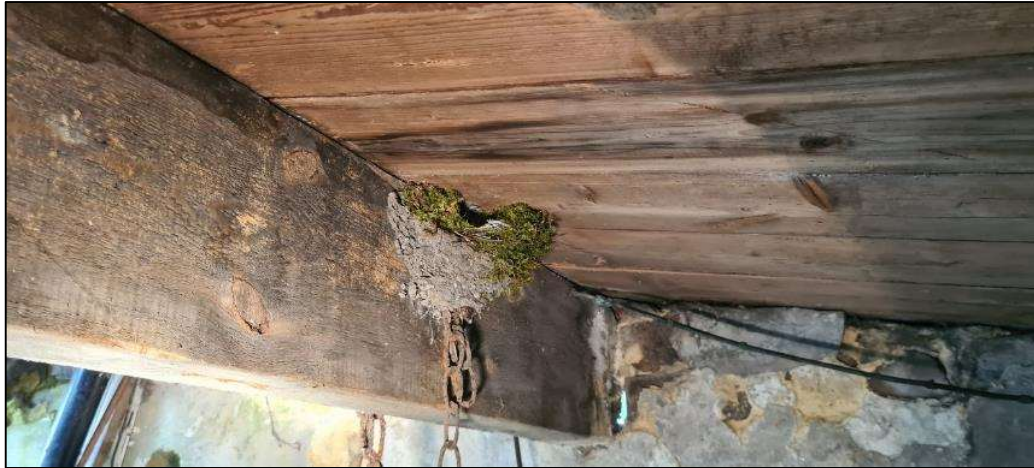
**Plate 5. Bird's nest in an old swallow nest cup inside the northwestern end of B1**

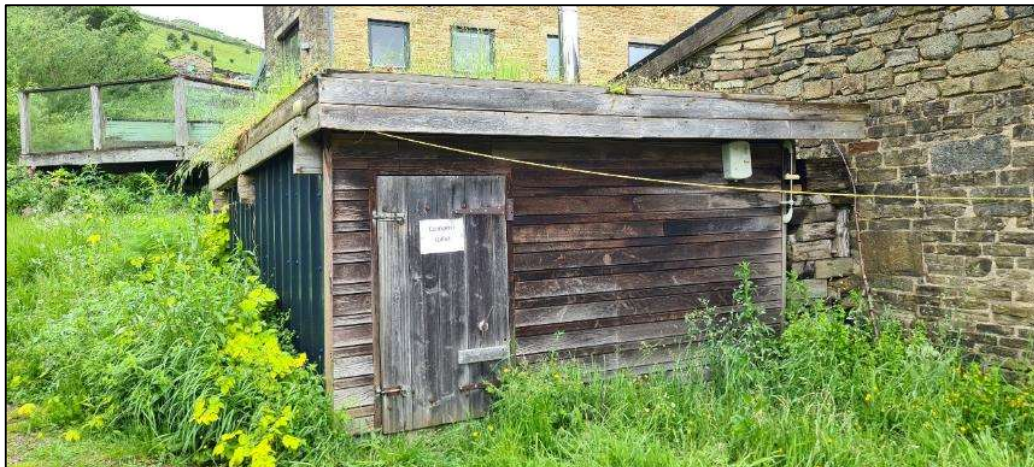
- 5.2.7 B2 was a composting toilet. The building comprised a wooden frame constructed over an old coal bunker which had been constructed from concrete blocks (Plate 6). The building had a shallow-pitched green roof (Plate 7).
- 5.2.8 The walls were clad in timber and profiled metal sheets. The eaves were exposed and the building was set into the sloping hillside.

**Plate 6. The composting toilet (B2) viewed from the south**

- 5.2.9 The building was not considered to have any obviously suitable potential bat roost features on the exterior, or access points which would allow roosting bats to reach the interior.

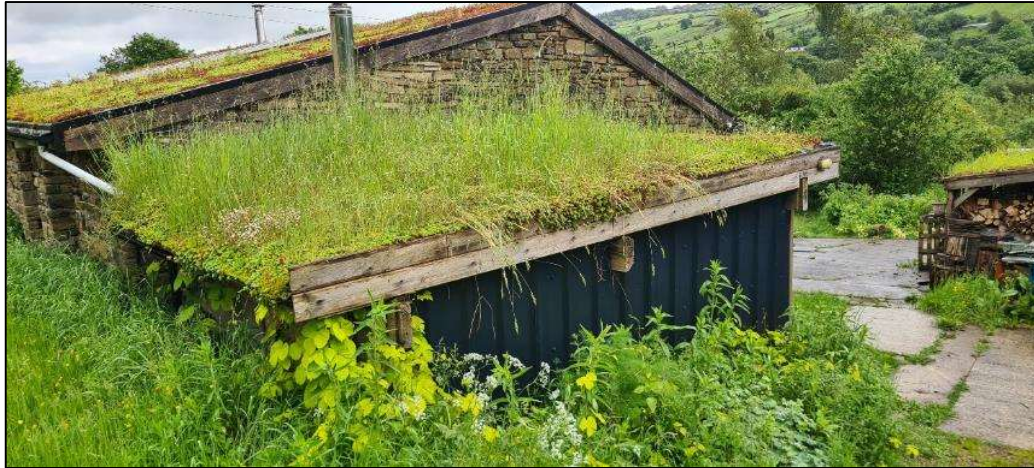
**Plate 7. The composting toilet (B2) viewed from the west**

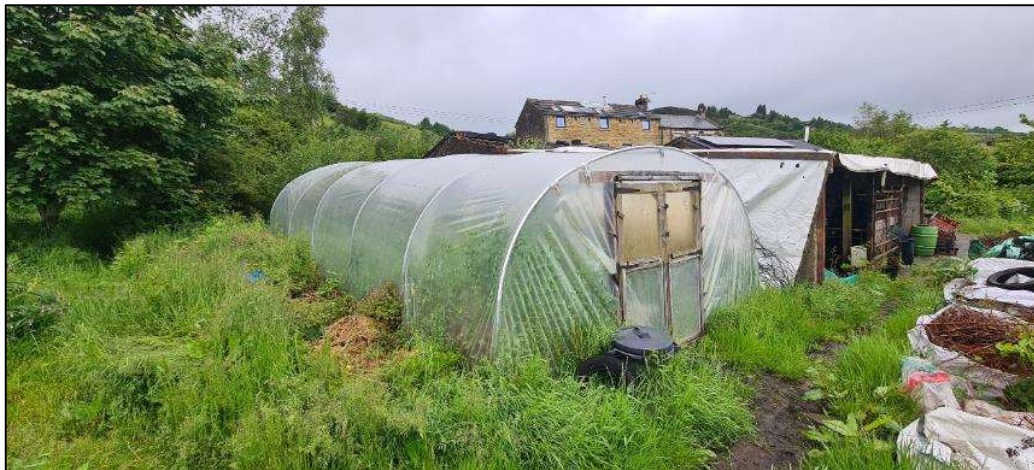
- 5.2.10 B3 was a poly tunnel measuring approximately 9 m by 4 m (Plate 8). No potential bat roost features were present on this building.

**Plate 8. The polytunnel viewed from the south**

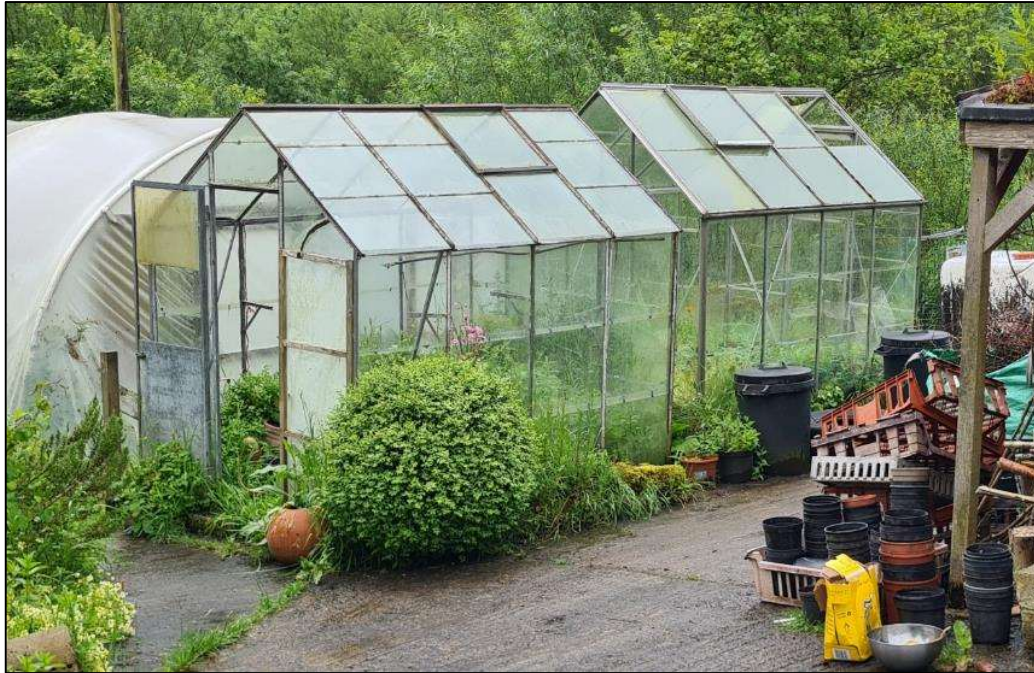
- 5.2.11 B4 and B5 were adjacent greenhouses (Plate 9). No potential bat roost features were present on these buildings.

**Plate 9. The two greenhouses viewed from the north**
