Ref: 547/01(02)  
February 2024  
Rev: #

Kirkby Grange Hall, Flockton, Wakefield, WF4 4AQ

## Heritage, Design & Access Statement

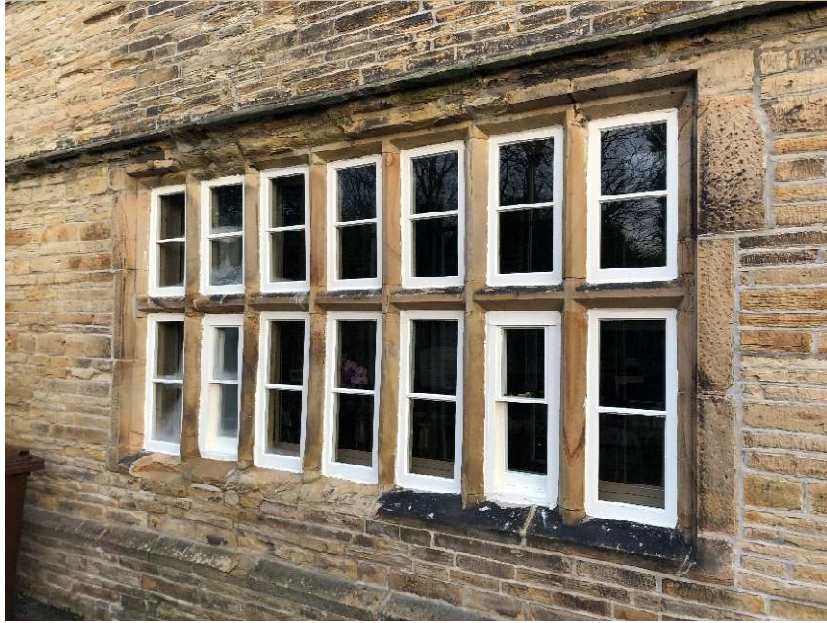
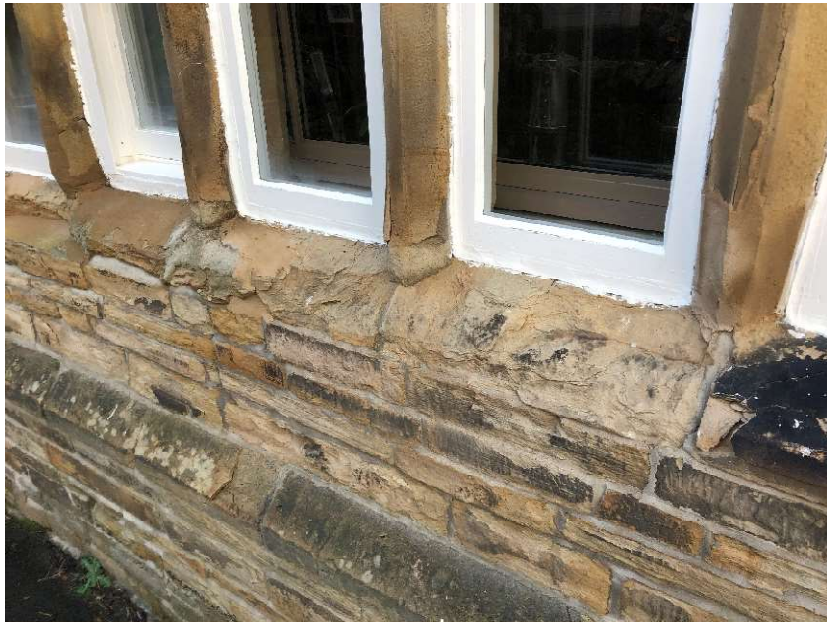
External view: Significant stone decay to the window surrounds on the south elevation (GF.04)

- Structural engineer to be consulted prior to any intervention.
- All works to be completed by hand.
- Defrass stonework
- Carefully remove existing glazing units.
- Apply biocide where necessary.
- Carefully remove stonework.
- Reuse suitable removed stonework where possible.
- Suitably qualified stonemason to install replacement cut-faced stone, where necessary – style and colour to match existing.
- Repoint stonework where necessary with a lime mortar mix
- new glazing and timber Accoya slimline double-glazed units (painted) carefully installed as per the necessary consents/conditions

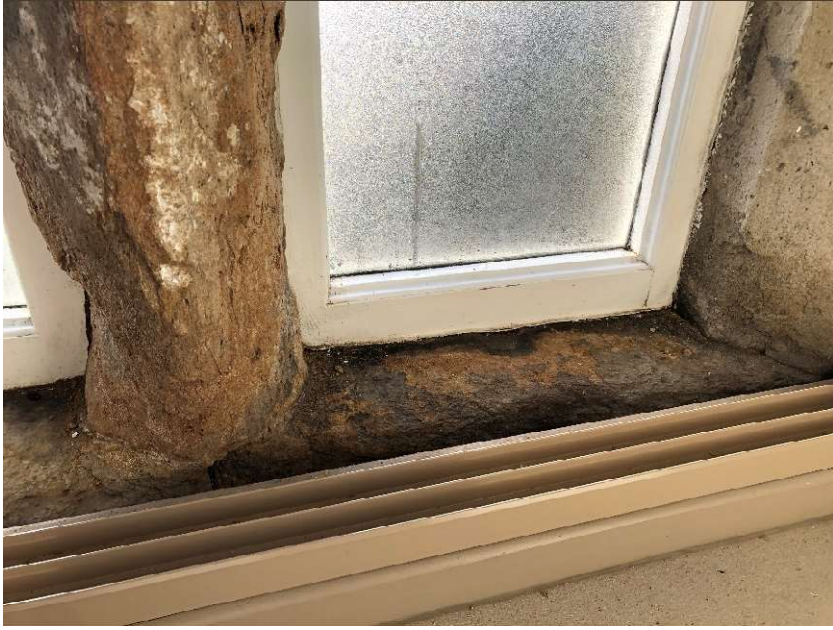
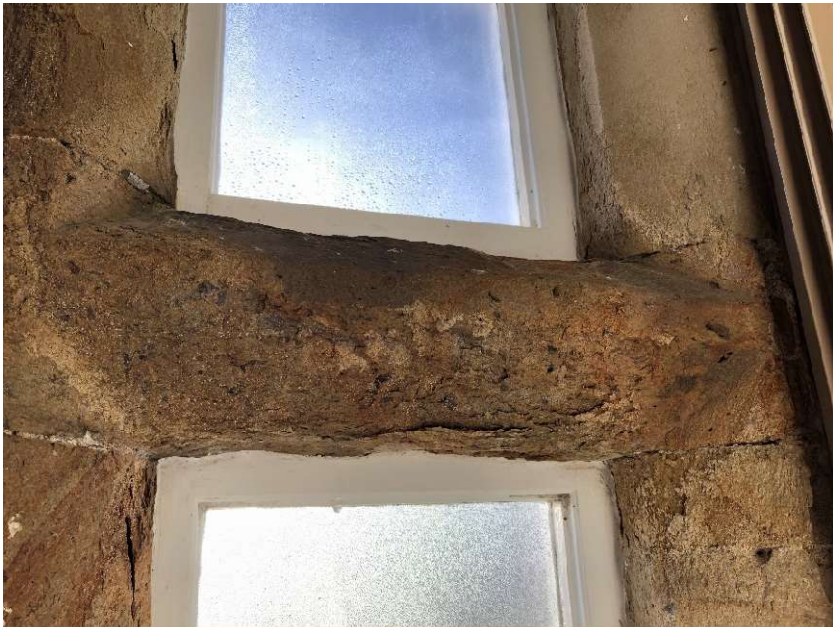
Internal view: Significant stone decay to the window surrounds on the south elevation (FF.03)

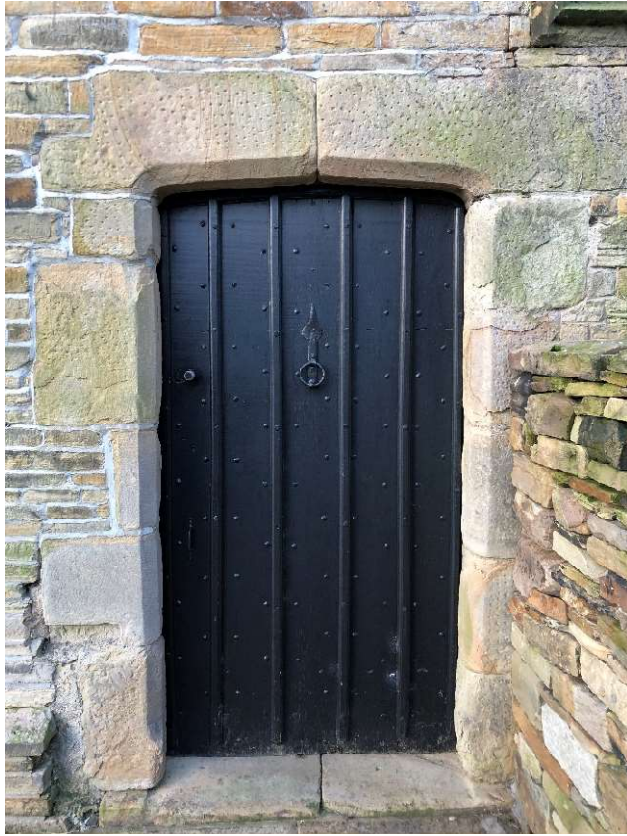
External view: The existing front door (GF.01)

The existing door is not original and no longer fit for purpose. Inadequacies include poor standard of fabric resulting in very poor thermal performance, very poor airtightness, very poor waterproofing and inadequate security. The replacement is to be a sympathetic hand-crafted period style door befitting of the property built to a high specification to remedy the inadequacies noted above. The replacement is to have aesthetics that complement the listed building.

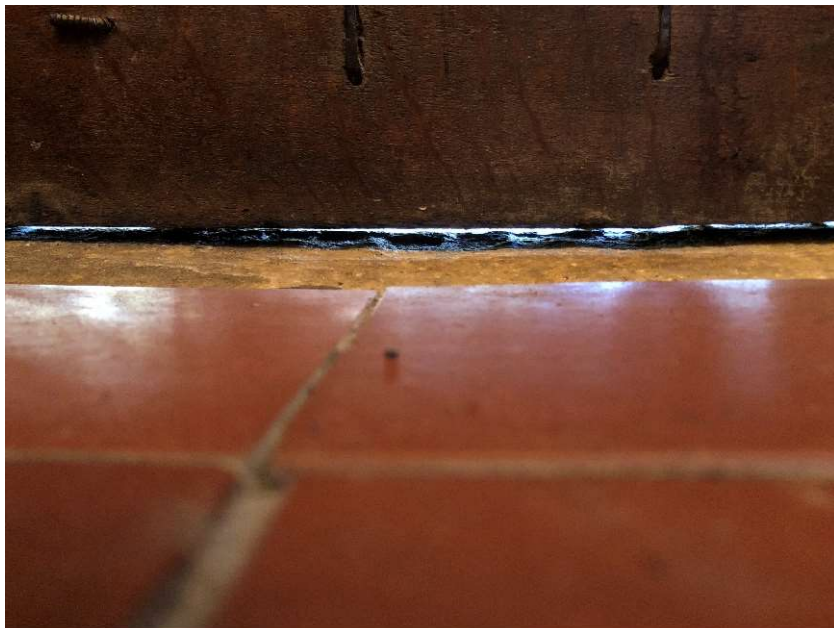
Internal view: The existing front door (GF.01)
