# Appendix H - Existing Informal Passing Places and Proposed Improvement Locations

Reference plan showing existing & improved passing place locations

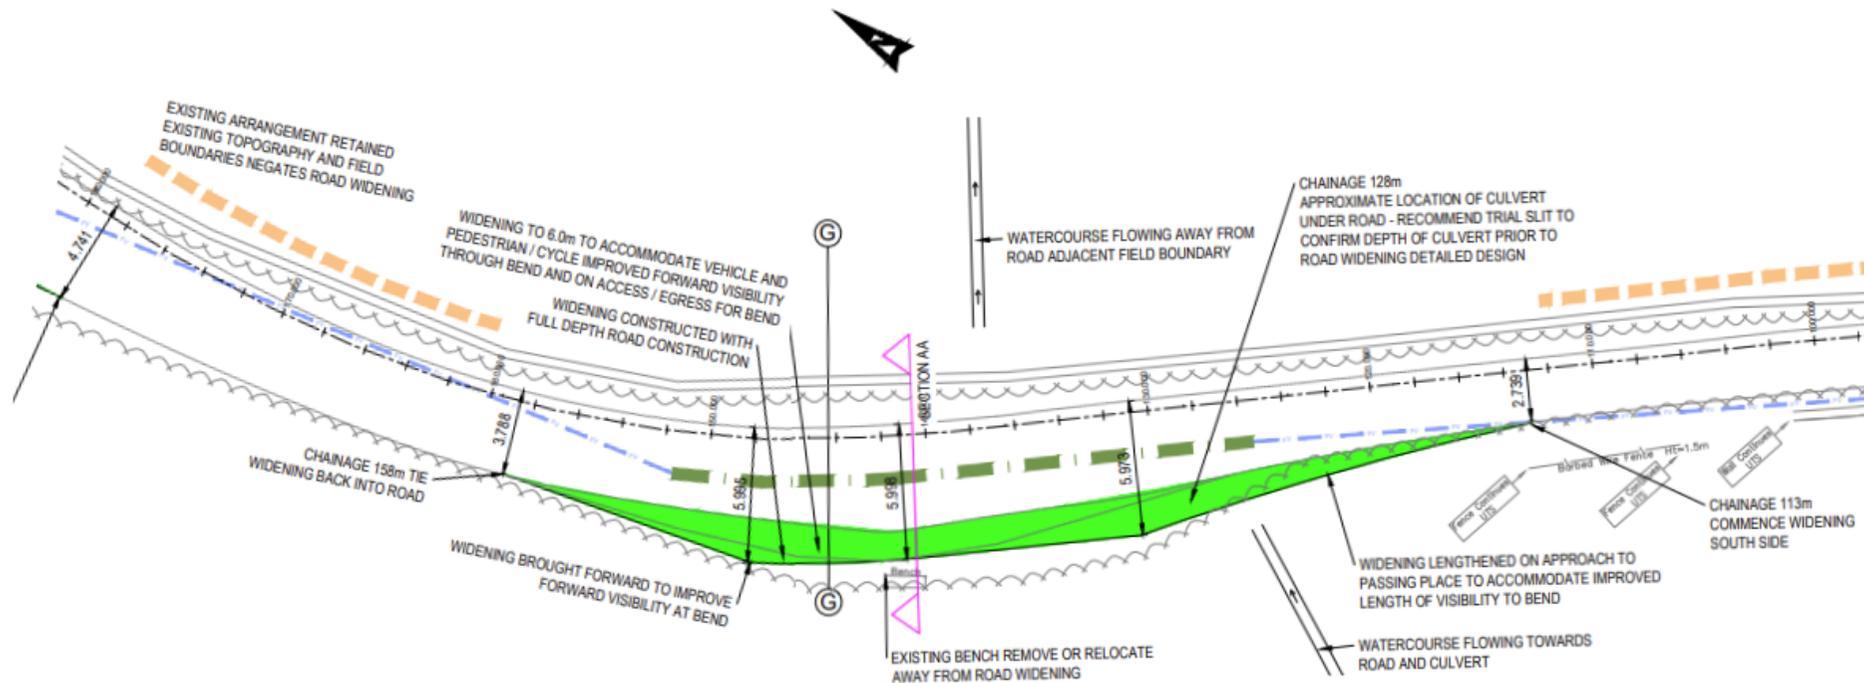
## Passing Place A (PP - A) shown on TPS Drawing 0110 P3 (Approx. Ch.140)

- There is already a passing place in this location, which is circa 10m long by 5.5m+ wide and can accommodate multiple cars. Therefore, the proposal effectively resurfaces the carriageway that already exists (or existed as it is currently eroded to sub-base level within the existing widening). As such, these works have only margin benefit by improving the existing carriageway surface.
- The improved carriageway surface may assist motor vehicle traffic, and potentially cyclists when passing. However, it may also increase traffic speeds, to the detriment of active travel users.
- The improvement to visibility noted on the plans is marginal (and has not been quantified).
- The suggestion to remove the bench is unacceptable.

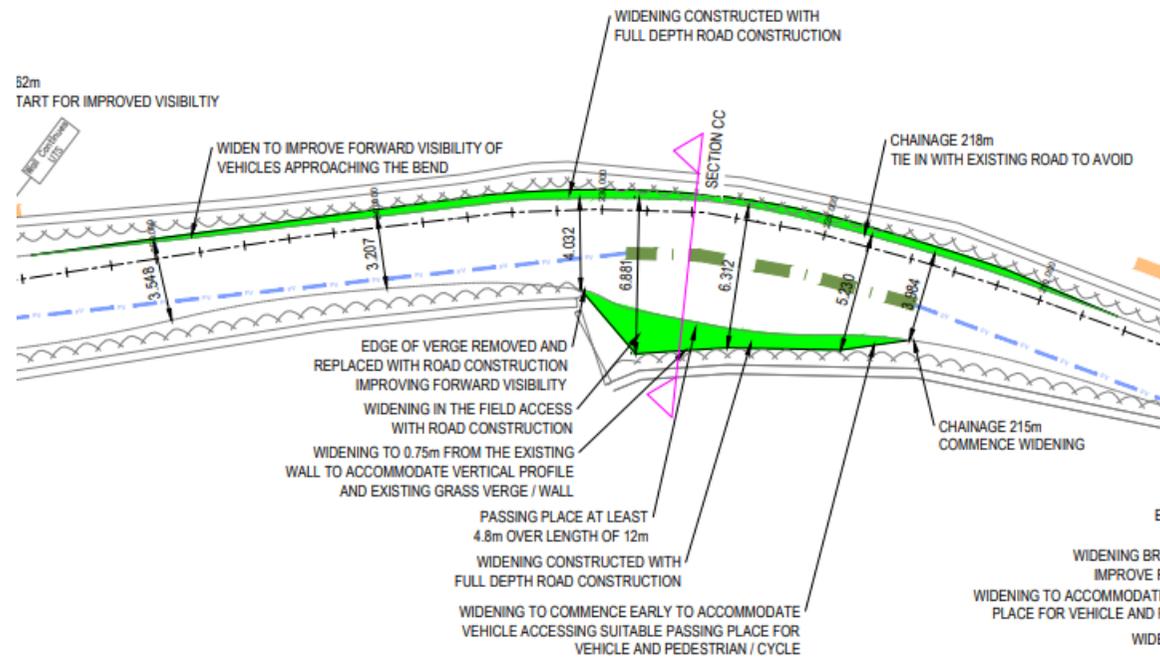
## Passing Place C (PP - C) shown on TPS Drawing 0110 P3 (Approx. Ch. 230)

- There is already a passing place in this location. Whilst the proposal increases the width of the passing place slightly, this additional width may have limited benefit. This is due to there being sub-standard forward visibility from this passing place (looking northwest), so drivers are unlikely to utilise the extra width, as this will result in their visibility being further restricted.
- The new passing place design includes an abrupt exit taper (1:1). Therefore, it is unclear whether a vehicle could effectively exit the passing place, and utilise the extra space provided.
- No swept path analysis has been provided, to confirm whether the passing place is functional.
- The passing place does include some additional width, which could increase capacity (if the spaces is usable, which has not been demonstrated) for circa two cars to pass, so may have some minor benefit.

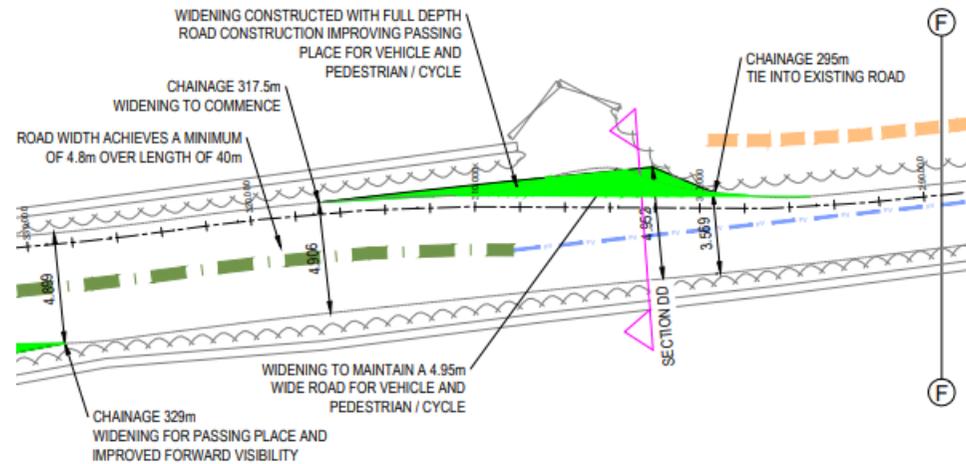
## Passing Place D (PP - D) shown on TPS Drawing 0110 P3 (Approx. Ch. 300)

- There is already a passing place in this location. Whilst the proposal increases the width of the passing place slightly, this additional width is minimal and would have limited benefit. There is also sub-standard forward visibility from this passing place (looking southeast), so drivers are unlikely to utilise the extra width, as pulling further to the left will result in their visibility being further restricted.
- No swept path analysis has been provided, to confirm whether the passing place is functional. However, the exit taper at this passing place is better than some of the other proposed designs, so may function adequately (but this has not been demonstrated).
- The passing place includes only minimal (if any) additional width, and the carriageway is already a reasonable width in this location (e.g. 4.8m+). Therefore, any benefit from these works is minimal.

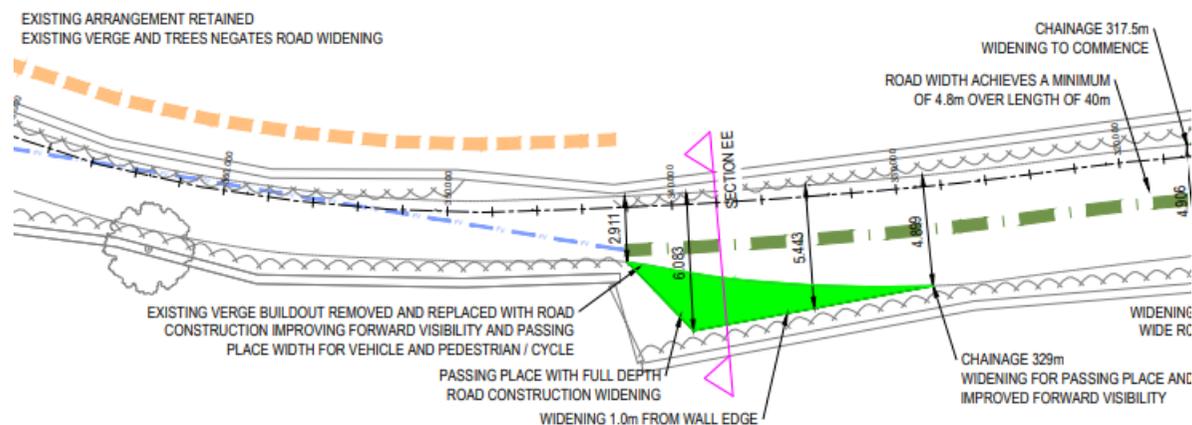
## Passing Place E (PP - E) shown on TPS Drawing 0110 P3 (Approx. Ch. 340)

- There is already an informal passing place adjacent to the field gate in this location. Whilst the proposal increases the width of the passing place slightly, and provides a hard paved surface that would be of benefit to motor vehicles and cyclists, no additional highway width is created. Therefore, there will be no material improvement in capacity of the existing informal passing place.

- The new passing place design includes an abrupt exit taper (1:1). Therefore, it is unclear whether a vehicle could effectively exit the passing place, and utilise the extra space provided. This is unlikely, given the narrow carriageway (2.9m) immediately northwest of the passing place.

- No swept path analysis has been provided, to confirm whether the passing place is functional.
- The extended passing place is unlikely to be deliverable as shown, as the exit taper impacts on a boundary wall (that has been damaged by existing vehicle overrun, but not shown on the plans) adjacent to the field entrance. It is noted that boundary walls do not typically form part of the highway, so it is unlikely that the wall could be removed and the additional land dedicated as highway to provide the extended passing place (even if it were demonstrated to be functional, which does not appear to be the case).

- There is severely restricted forward visibility looking northwest from this passing place, which is not improved in any way by these proposals. The visibility is restricted due to vegetation on the inside of the right hand bend to the northeast, which cannot be significantly improved, as there are trees that block visibility that are generally beyond or straddle the highway boundary. This includes a large oak tree (not shown on the Appellants drawings, as is the case for many trees that are missing from the drawings), which would need to be removed to increase visibility to acceptable levels. However, the removal of the oak tree is unlikely to be acceptable (and has not been identified or assessed).

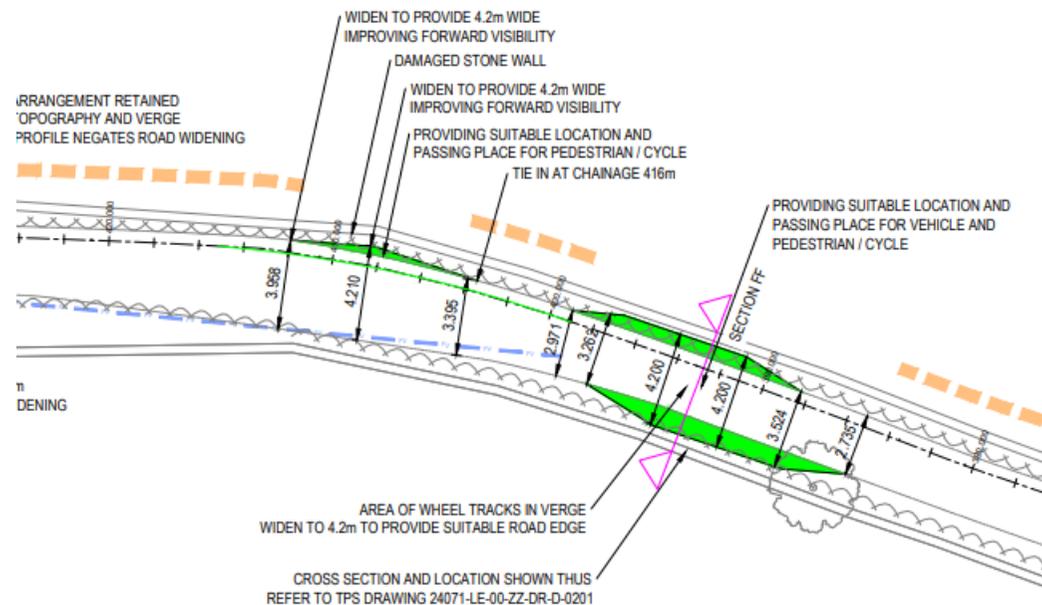
## Passing Place F (PP - F) shown on TPS Drawing 0110 P3 (Approx. Ch. 390)

- Small vehicles already pass in this informal passing place, by overrunning the adjacent highway verges. However, the width of the highway in this area is inadequate to allow two cars to safely pass (e.g.  $4.8\text{m} + 2 \times 0.5\text{m}$  offsets from walls =  $5.8\text{m}$  total highway width required). Therefore, the  $4.2\text{m}$  wide formalised passing place that is proposed would be ineffective, and provide little if any improvement over the current situation, with this passing place being well below standard.

- The proposed carriageway widening is also staggered due to existing trees growing within the adjacent verges and walls (that are not shown on the plans). This results in the effective length of the passing place being circa  $3\text{m}$ , which could not accommodate a vehicle.

- No swept path analysis has been provided, to confirm whether the passing place is functional, although it is quite clear that this would demonstrate that it is not.

- The passing place is shown built up to boundary walls, which will not provide safe clearance for drivers. However, this is more of concern for cyclists, who require a minimum of  $0.5\text{m}$  clearance to avoid clashes with their pedals and handlebars. Therefore, this formalised passing place would not benefit cyclists.

- It is unclear how this widening would be undertaken. However, it appears that it would require upgrade of the boundary walls, which has not been identified on the plans. This is likely to require works that are beyond the highway boundary, so it is unclear whether the proposal is deliverable.

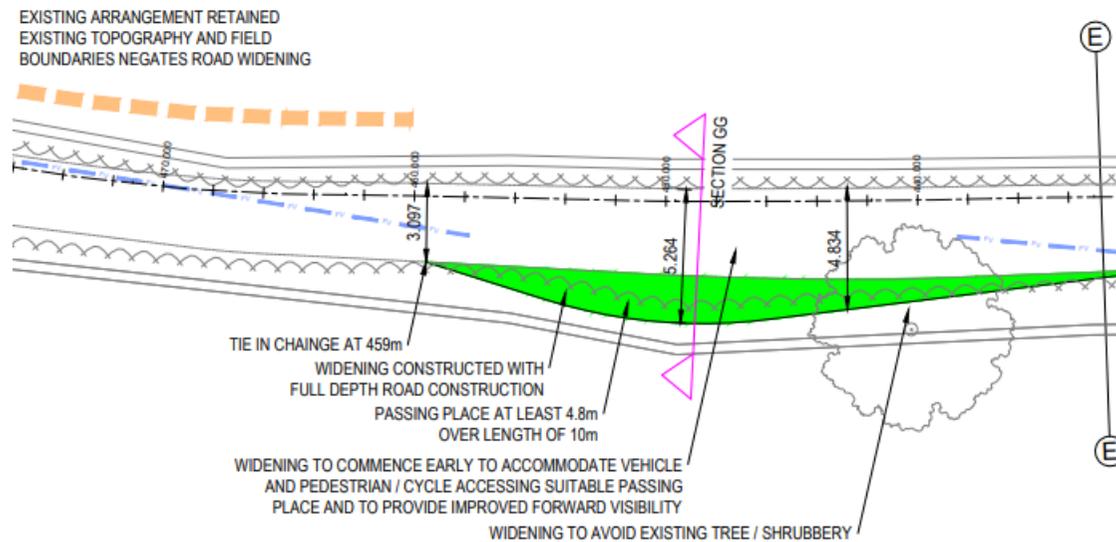
## Passing Place G (PP - G) shown on TPS Drawing 0111 P3 (Approx. Ch. 450)

- This location is already used as an informal passing place. Therefore, the proposal provides only marginal benefit, by hard paving the informal passing place that already exists (and is currently longer than is shown for the improved passing place).
- The carriageway widening that has been shown, is likely to impact the existing vegetation along the west side, which includes trees (most of which are not shown on the plans) along the highway boundary. The base of these trees are higher than the existing carriageway level. Therefore, cutting into the base of the trees and verge in this location, is likely to damage them and result in their loss. Therefore, it is unlikely that widening will be possible to the extent shown.

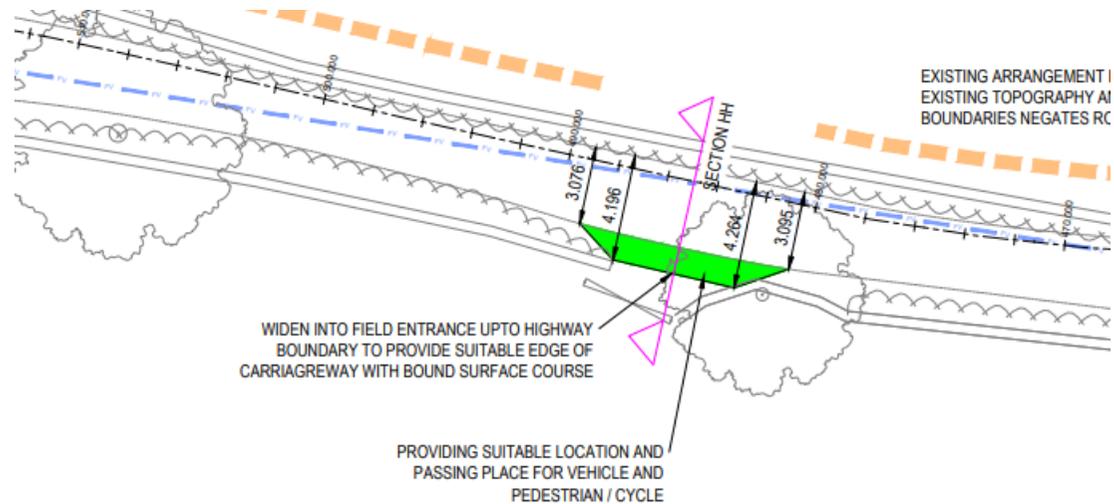
## Passing Place H (PP - H) shown on TPS Drawing 0111 P3 (Approx. Ch. 490)

- Small vehicles already pass in this location, by overrunning the adjacent highway verges. However, the width of the highway in this area is inadequate to allow two cars to safely pass (e.g.  $4.8\text{m} + 2 \times 0.5\text{m}$  offsets from walls =  $5.8\text{m}$  highway width required). Therefore, the  $4.2\text{m}$  wide formalised passing place proposed would be ineffective, and provides little if any improvement over the current situation, with this passing place being well below standard.

- No swept path analysis has been provided, to confirm whether the passing place is functional. However, the short tapers, short length of the passing place ( $5\text{m}$ ) and narrow width, will not allow it to operate safely (e.g. it doesn't work adequately now, and the improvements suggested offer little, if any, benefit).

- The passing place is shown built up to the boundary wall, which will not provide safe clearance for drivers and cyclists.

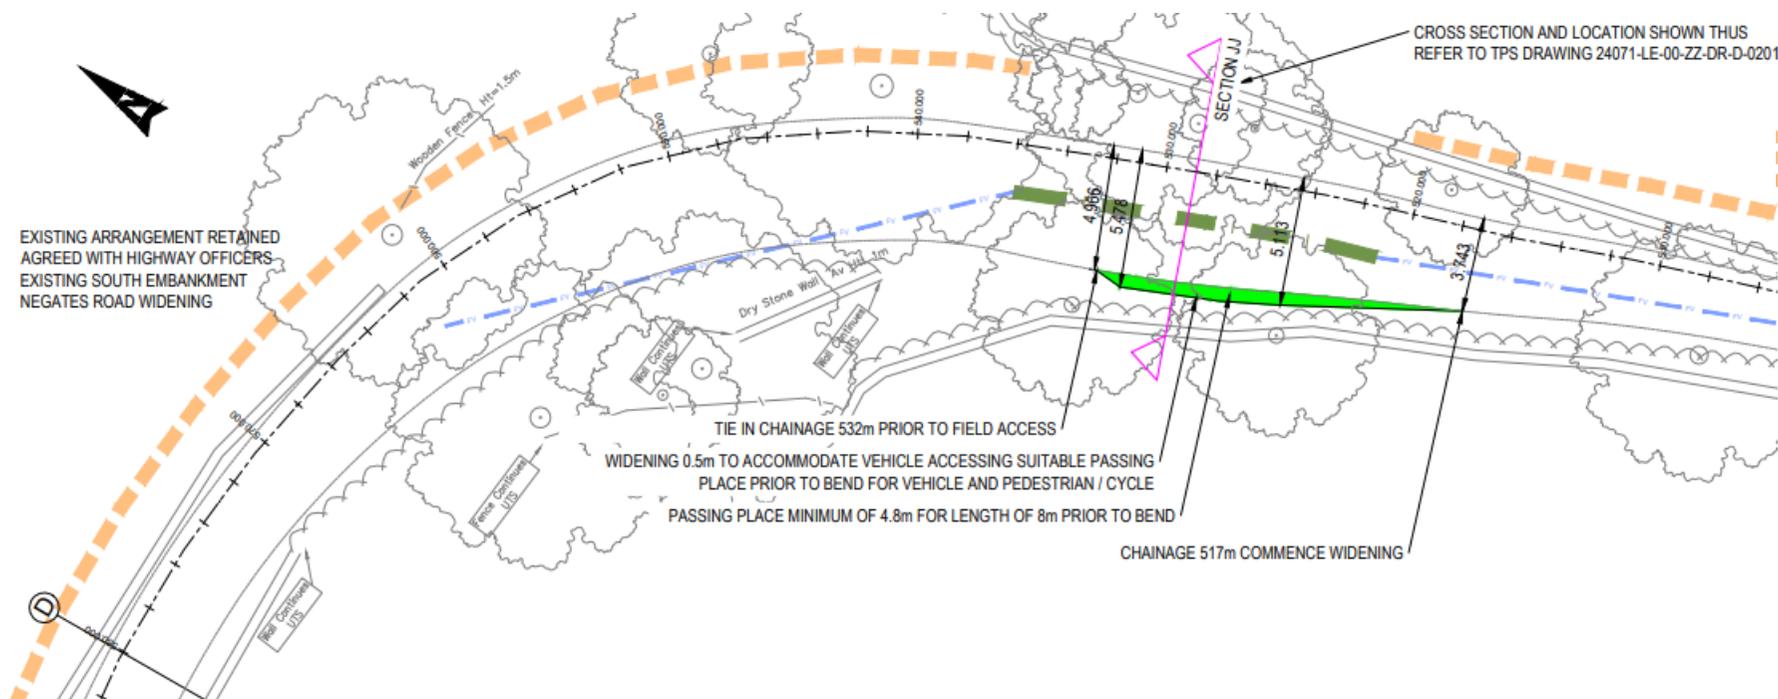
## Passing Place I (PP - I) shown on TPS Drawing 0111 P3 (Approx. Ch. 530 - Near bend approx. Ch.560)

- The existing carriageway within the vicinity of this passing place improvement is already around 4.8-5.0m wide. Therefore, increasing the width to between 5.1-5.7m would have limited benefit.

- The proposal do nothing to address the sub-standard visibility at the bend that heads downhill through Stone Wood, along the single track section, which is one of the key highway safety problems in this location.

- It is also unclear whether any widening is possible in this locations, as it would impact on the adjacent banking. The submitted drawings suggest that other cross-section drawings have been prepared (e.g. drawing 0201 is referenced), but these were not provided with the submission, to confirm whether the proposal is deliverable, and what impact it would have on adjacent features, such as trees.

- The carriageway surfacing proposals have not be confirmed in detail on the submitted plans. However, if this passing place improvement were provided, it would need to include carriageway resurfacing up to (and including) the bend. Otherwise the change in skid resistance between existing and proposed carriageway surfaces, at the relatively steep bend, could result in skidding issues. This would compound the current highway safety issues in this location (e.g.conflict issues at the bend, where it transitions from two-way to single track, and has sub-standard forward visibility).
