Arboricultural Method Statement

WC-266.1a

Spenn Valley High School, Roberttown
Lane, Liversedge WF15 7LX

Woodsage Consulting Ltd

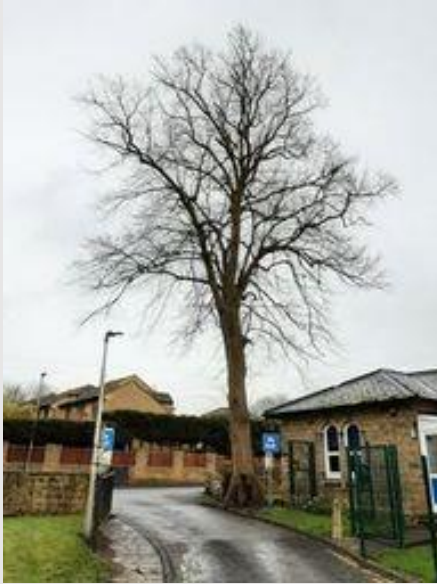
Plate 1: T001

| Tree Ref: | Species | Age | SULE | Ht. | DBH | CS | | | | CC | Comments | PC | BS 5837:2012 Category | Recommendations |
|---|---|---|---|---|---|---|---|---|---|---|---|---|---|---|
| T001 | Common lime (<i>Tilia x europaea</i>) | M | 80+ | 21 | 830 | 7 | 7.5 | 6.5 | 7.5 | 3.5 | No obvious significant defects. Growing in proximity to boundary wall. Epicormic shoots on main stem to 7 m, encroach upon roof of existing lodge house building. | G | G | A1 |

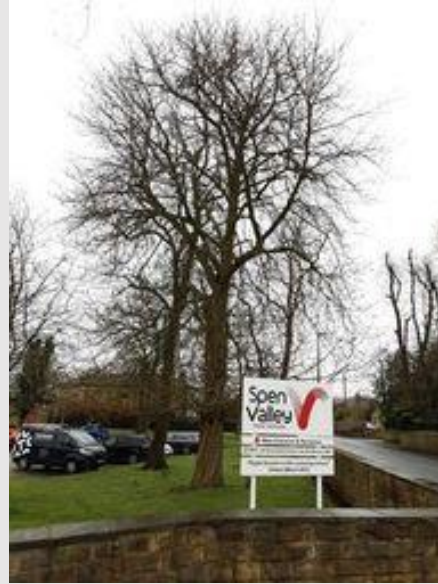
Plate 2: T002

| Tree Ref: | Species | Age | SULE | Ht. | DBH | CS | | | | CC | Comments | PC | BS 5837:2012 Category | Recommendations |
|---|---|---|---|---|---|---|---|---|---|---|---|---|---|---|
| T002 | Horse chestnut (<i>Aesculus hippocastanum</i>) | M | 40-80 | 20 | 870 | 7 | 6 | 7.5 | 7 | 2 | No obvious significant defects. Epicormic on main stem to 5 m. | G | G | A1 |

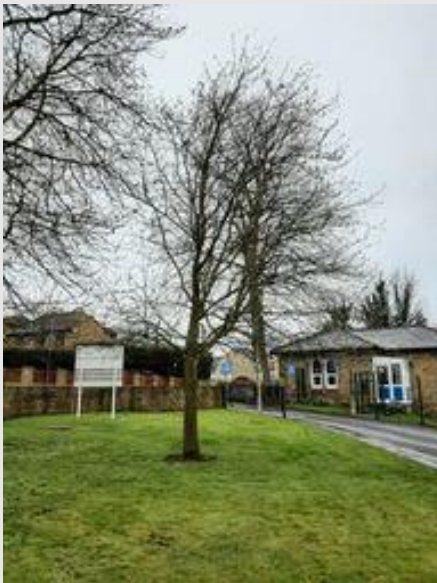
Plate 3: T003

| Tree Ref: | Species | Age | SULE | Ht. | DBH | CS | | | | CC | Comments | PC | BS 5837:2012 Category | Recommendations |
|---|---|---|---|---|---|---|---|---|---|---|--|---|---|---|
| T003 | Whitebeam (<i>Sorbus aria</i>) | SM | 20-40 | 9 | 280 | 4 | 2.5 | 4 | 5 | 2 | Suppressed by adjacent trees with asymmetrical crown spread in result. | G | F | B1 |

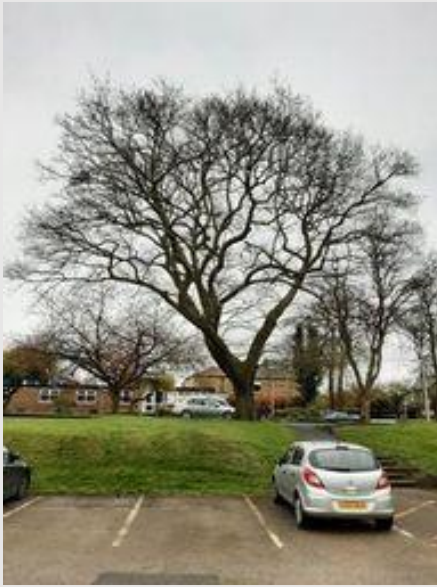
Plate 5: T005

| Tree Ref: | Species | Age | SULE | Ht. | DBH | CS | | | | CC | Comments | PC | BS 5837:2012 Category | Recommendations |
|---|---|---|---|---|---|---|---|---|---|---|--|---|---|---|
| T005 | Turkey oak (<i>Quercus cerris</i>) | M | 80+ | 19 | 1020 | 11 | 10 | 8.5 | 12 | 4 | Bifurcates at 2-3 m into multiple co-dominant stems; unions appear structurally optimised. Branch cavity at 6 m in south aspect of crown. | G | G | A1 |

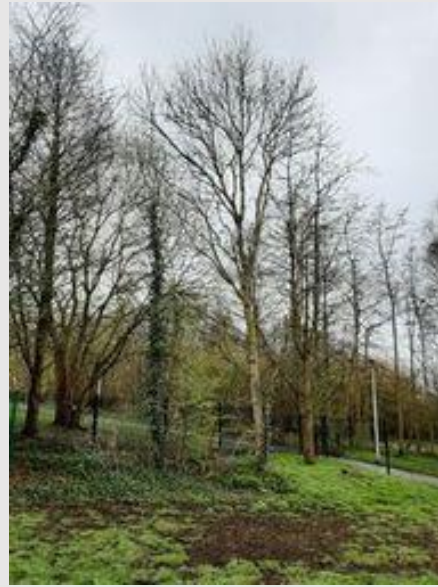
Plate 6: T006, T007, & T008 (right to left)

| Tree Ref: | Species | Age | SULE | Ht. | DBH | CS | | | | CC | Comments | PC | BS 5837:2012 Category | Recommendations |
|---|---|---|---|---|---|---|---|---|---|---|--|---|---|---|
| T006 | Wild cherry (<i>Prunus avium</i>) | SM | 20-40 | 15 | 310 | 4 | 2.5 | 1.5 | 6 | 3.5 | Asymmetrical crown spread due to proximity with adjacent trees. Minor deadwood < 100 mm in diameter scattered throughout crown | F | F | B1 |
| T007 | Common ash (<i>Fraxinus excelsior</i>) | SM | 40-80 | 15 | 360 | 4.5 | 2.5 | 5 | 6 | 2.5 | Asymmetrical crown spread due to proximity with adjacent trees. Minor deadwood < 100 mm in diameter scattered throughout crown. Ivy on main stem to 3 m. | F | F | B1 |
| T008 | Horse chestnut (<i>Aesculus hippocastanum</i>) | Y | 20-40 | 11 | 200 | 2 | 2 | 2 | 3 | 2 | Dense ivy established on main stem and structural branches, obscuring tree features and potential defects. Limited arboricultural merit and lacking qualities for higher BS 5837 categorisation. | F | F | C1 |

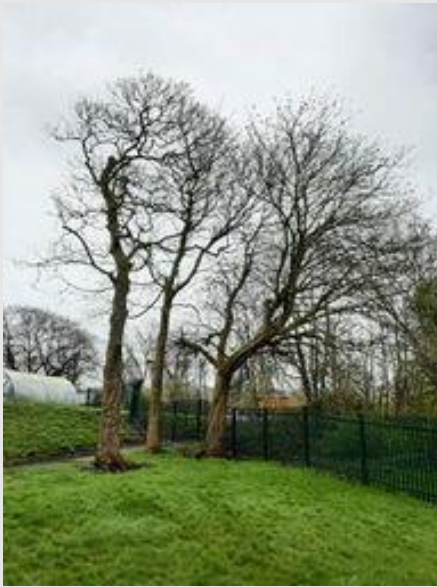
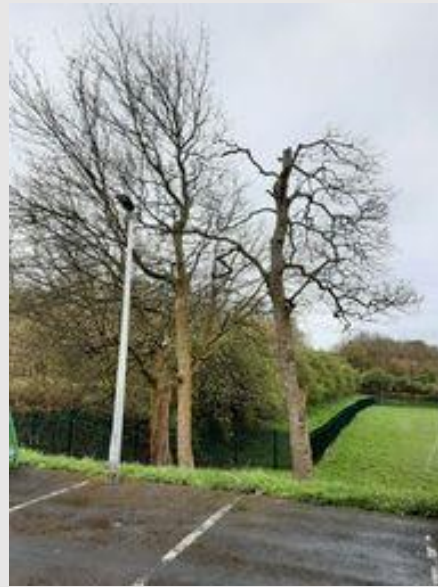
Plate 7: T009, T010, & T011 (right to left)

| Tree Ref: | Species | Age | SULE | Ht. | DBH | CS | | | | CC | Comments | PC | BS 5837:2012 Category | Recommendations |
|---|---|---|---|---|---|---|---|---|---|---|--|---|---|---|
| T009 | Horse chestnut (<i>Aesculus hippocastanum</i>) | M | 20-40 | 16 | 780 | 4 | 6 | 8 | 8 | 4 | Several oozing lesions on main stem, and longitudinal splits in cambium, possibly indicating bleeding canker (<i>Pseudomonas syringae</i> pv. <i>aesculi</i>) infection, though vitality remains fair. Asymmetrical crown spread due to proximity with adjacent trees. Approx. 3 m below levels of proposed structure. | F | F | B1 |
| T010 | Sycamore (<i>Acer pseudoplatanus</i>) | EM | 40-80 | 18 | 460 | 3 | 7 | 7 | 4 | 4.5 | Asymmetrical crown spread due to proximity with adjacent trees. Approx. 3 m below levels of proposed structure. | G | F | B1 |
| T011 | Sycamore (<i>Acer pseudoplatanus</i>) | M | 20-40 | 15 | 670 | 4 | 6 | 5 | 5.5 | 7.5 | Historically reduced at circa 13 m. Approx. 3 m below levels of proposed structure. | F | F | B1 |

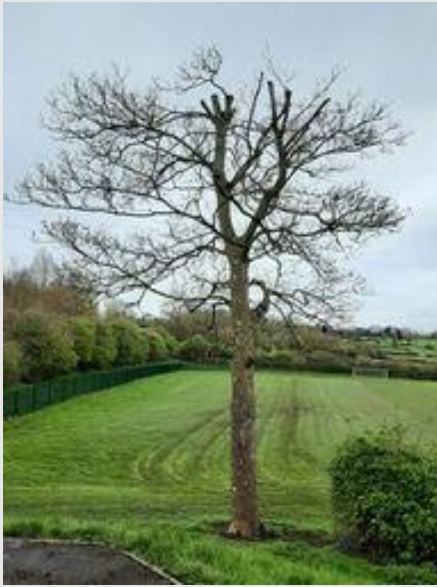
Plate 9: T012

| Tree Ref: | Species | Age | SULE | Ht. | DBH | CS | | | | CC | Comments | PC | BS 5837:2012 Category | Recommendations |
|---|---|---|---|---|---|---|---|---|---|---|--|---|---|---|
| T012 | Sycamore (<i>Acer pseudoplatanus</i>) | M | 20-40 | 14 | 700 | 4.5 | 5.5 | 5 | 6.5 | 6.5 | Historically topped at circa 13 m. Approx. 3 m below levels of proposed structure. | F | F | B1 |

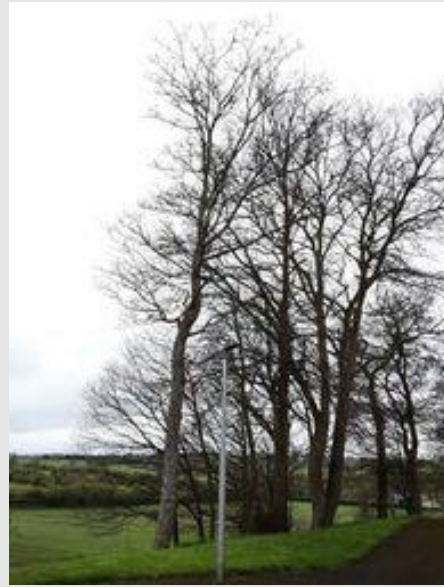
Plate 10: T013 (foreground, left) & T014 (foreground, right)

| Tree Ref: | Species | Age | SULE | Ht. | DBH | CS | | | | CC | Comments | PC | BS 5837:2012 Category | Recommendations |
|---|---|---|---|---|---|---|---|---|---|---|--|---|---|---|
| T013 | Sycamore (<i>Acer pseudoplatanus</i>) | EM | 80+ | 17 | 440 | 4 | 6.5 | 3.5 | 4.5 | 6 | No obvious significant defects. | G | G | B1 |
| T014 | Common lime (<i>Tilia x europaea</i>) | EM | 80+ | 18 | 520 | 5 | 5 | 5.5 | 4.5 | 2 | Dense epicormic around base of main stem, obscuring tree features and potential defects, though upper portion of crown appears of good vitality and vigour. | G | G | B1 |

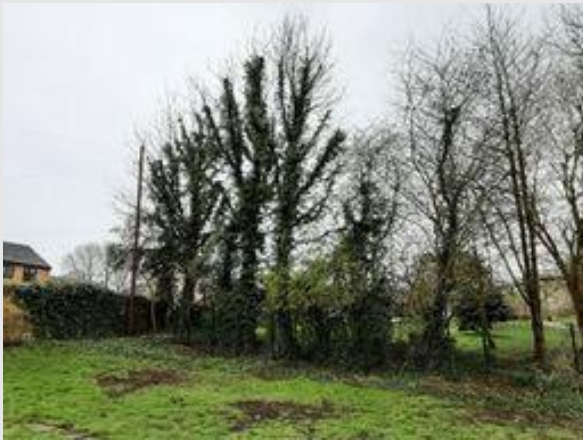
Plate 11: G001

| Group Ref: | Species Composition | Age | SULE | Av. Ht. | Av. DBH | Approx. No. of Stems | CC | Comments | PC | BS 5837 :2012 Category | Recommendations |
|---|--|---|---|---|---|---|---|---|---|---|---|
| G001 | Goat willow (<i>Salix caprea</i>) Sycamore (<i>Acer pseudoplatanus</i>) Wild cherry (<i>Prunus avium</i>) Whitebeam (<i>Sorbus aria</i>) Elder (<i>Sambucus nigra</i>) Common hawthorn (<i>Crataegus monogyna</i>) | SM EM | 40-80 | 16 | 440 | 12 | 2 | Linear group of trees situated on adjacent property. Dense ivy established throughout group, obscuring tree features and potential defects. | F | F | B1 |

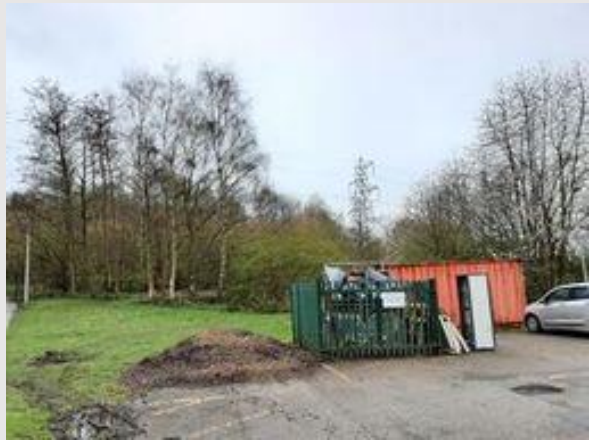
Plate 12: G002

| Group Ref: | Species Composition | Age | SULE | Av. Ht. | Av. DBH | Approx. No. of Stems | CC | Comments | PC | BS 5837 :2012 Category | Recommendations |
|---|--|---|---|---|---|---|---|---|---|---|---|
| G002 | Silver birch (<i>Betula pendula</i>) Common dogwood (<i>Cornus sanguinea</i>) Hazel (<i>Corylus avellana</i>) Wild cherry (<i>Prunus avium</i>) Common ash (<i>Fraxinus excelsior</i>) Horse chestnut (<i>Aesculus hippocastanum</i>) Common alder (<i>Alnus glutinosa</i>) | Y SM | 20-40 | 17 | 460 | 15 | 2 | Woodland plantation. Multiple specimens display features typical of woodland trees, including acute primary and secondary unions, asymmetrical forms, and/or leaning stems. | F | F | C1 |
