# Arboricultural Impact Assessment

**WC-294.1a**

Greenhead College, Huddersfield  
Road, Huddersfield HD1 4ES

**Woodsage Consulting Ltd**

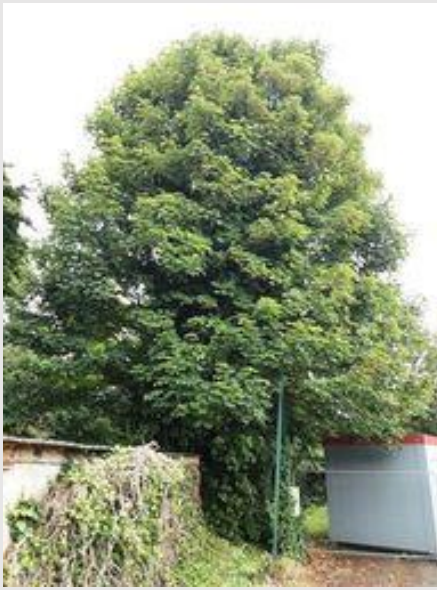
***Plate 1: T001***

| Tree Ref: | Species | Age | SULE | Ht. | DBH | CS | | | | CC | Comments | PC | SC | BS 5837:2012 Category | Recommendations |
|---|---|---|---|---|---|---|---|---|---|---|---|---|---|---|---|
| T001 | Sycamore<br>( <i>Acer pseudoplatanus</i> ) | EM | 40-80 | 16 | 180<br>370<br>380<br>530 | 5.5 | 6.5 | 5.5 | 5 | 5.5 | Bifurcates at ground level into multiple co-dominant primary stems. Dense ivy ( <i>Hedera helix</i> ) established on main stem and primary branches, obscuring tree features and potential defects | F | F | B2 | No works recommended |

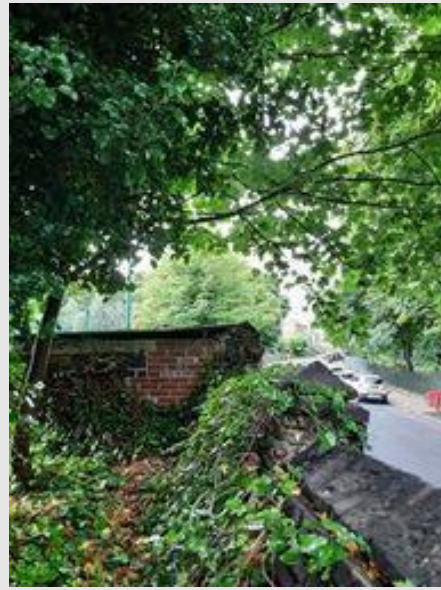
***Plate 2: T002***

- 4.1.1. The development proposals will necessitate the removal of T002, T003, and T005.
- 4.1.2. T002, T003, and T005 are all located within 0.5 m of the existing compromised retaining walls which are to be dismantled and rebuilt. The proposed repairs are likely to require adequate working space behind the wall, which if retained, T002, T003, and T005 would not permit.
- 4.1.3. T002 and T003 are both category C trees of low-quality only; in accordance with *BS 5837: 2012*, these should not be considered a constraint to the development.
- 4.1.4. Although removal of T005 - which is a category B tree of moderate-quality - is unfortunate, on-site mitigation tree planting will be carried out.

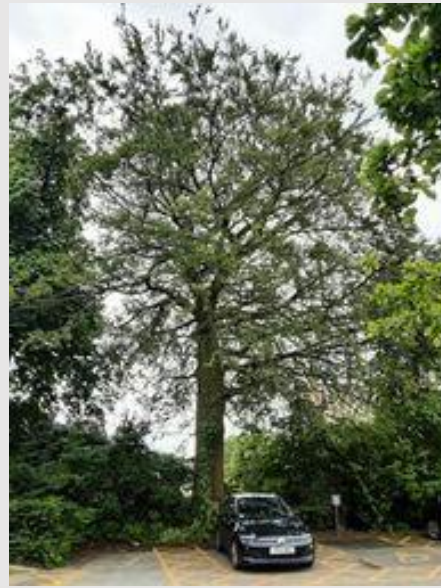
**Plate 6:** T004

| Tree Ref: | Species | Age | SULE | Ht. | DBH | CS | | | | CC | Comments | PC | SC | BS 5837:2012 Category | Recommendations |
|---|---|---|---|---|---|---|---|---|---|---|---|---|---|---|---|
| T004 | Common beech<br>( <i>Fagus sylvatica</i> ) | M | 40-80 | 21 | 1050 | 8.5 | 8 | 12 | 10 | 4 | Somewhat sparse foliage, possibly relating to ground works recently carried out within RPA. Minor deadwood <100 mm in diameter scattered throughout crown | F | F | A2 | No works recommended |
