**Brindle
& Green**

Arboricultural Impact Assessment

Land off Westfield Court, Mirfield

Report Reference: BG24.183

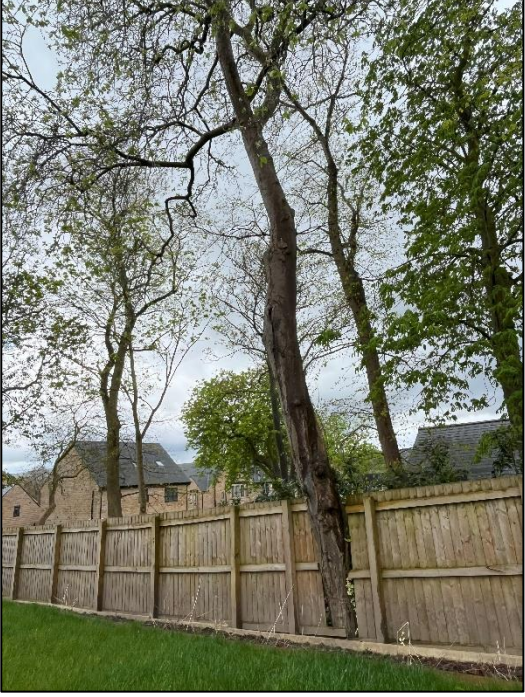
- 4.3.7 A new boundary fence will separate the new dwelling from the adjacent, existing dwelling. This fencing will occur within the notional RPA of T9, a Category B protected whitebeam, though the fencing has been adjusted to the greatest possible extent to minimise disturbance to the RPA. Fencing installation has the potential to damage tree roots, and should be conducted under arboricultural supervision. Roots under 25mm may be cleanly severed during excavation for fence posts, however, a degree of flexibility is required with the fence post locations, should larger roots be encountered. Despite the small level change present across the garden, the architects (Lonie Lozano Architecture Ltd) confirmed that level changes **will not** be proposed within the RPAs of offsite TPO trees. Fencing installation should occur under arboricultural supervision.

| Tree ID | Common Name | Maturity | TPO Ref. | Height and direction of first significant branch (m) | Height (m) | No. of Stems | Calculated Stem Diameter (mm) | Radius of Nominal Circle (m) | RPA ^(m2) | Crown Spread (m) | | | | Crown Height (m) | | | | Crown | Stem | Basal Area | BS 5837 Category | Life Expectancy | Phys Condition | Comment |
|---|---|---|---|--|---|---|---|---|---|---|---|---|---|---|---|---|---|---|---|---|---|---|---|--|
| T9# | Common Whitebeam | Mature | TPO No.23 1992 A3 | SW 8 | 15 | 1 | 550 | 6.6 | 136.8 | 4 | 5.5 | 4 | 4.5 | 5 | 5 | 7.5 | 8.5 | Good | Fair | N/A | B2 | 20 to 40 yrs | Fair | Grows through boundary fence. Significant past pruning of lower limbs, resulting in single stemmed to 8m. Significant mature tree. Decay at former branch attachment to the north east at 4m (wet cavity) and south east at 5.5m. Client voiced concerns of hollowing (squirrel nesting within stem), however sounding mallet test (from ground level) indicates sound wood. |

| Image | Description |
|---|---|
| | <p>Mature, Category B, protected whitebeam T9.</p> |

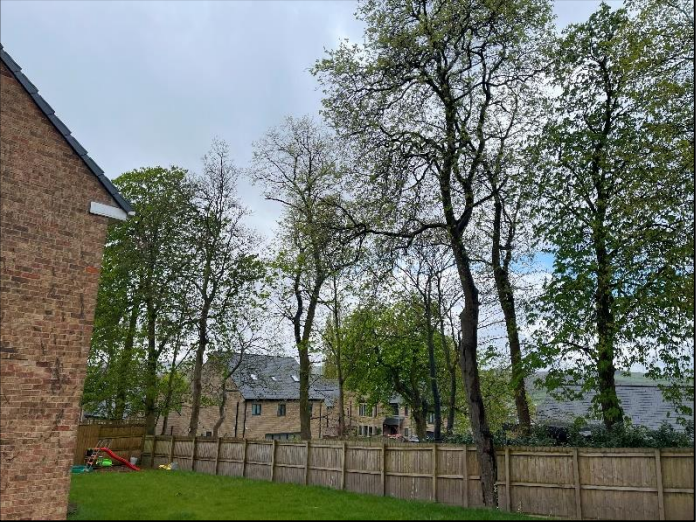
| Image | Description |
|---|---|
| | <p>Photo shows trees beyond the development site, including T12-T13 and G3.</p> |
