Desk study and preliminary risk assessment report

Wood Lane, Mirfield

Client: South Pennine Boat Club

REFERENCE:	SPBC-DS	VERSION:	1	ISSUE DATE:	11 September 2024
-------------------	---------	-----------------	---	--------------------	-------------------

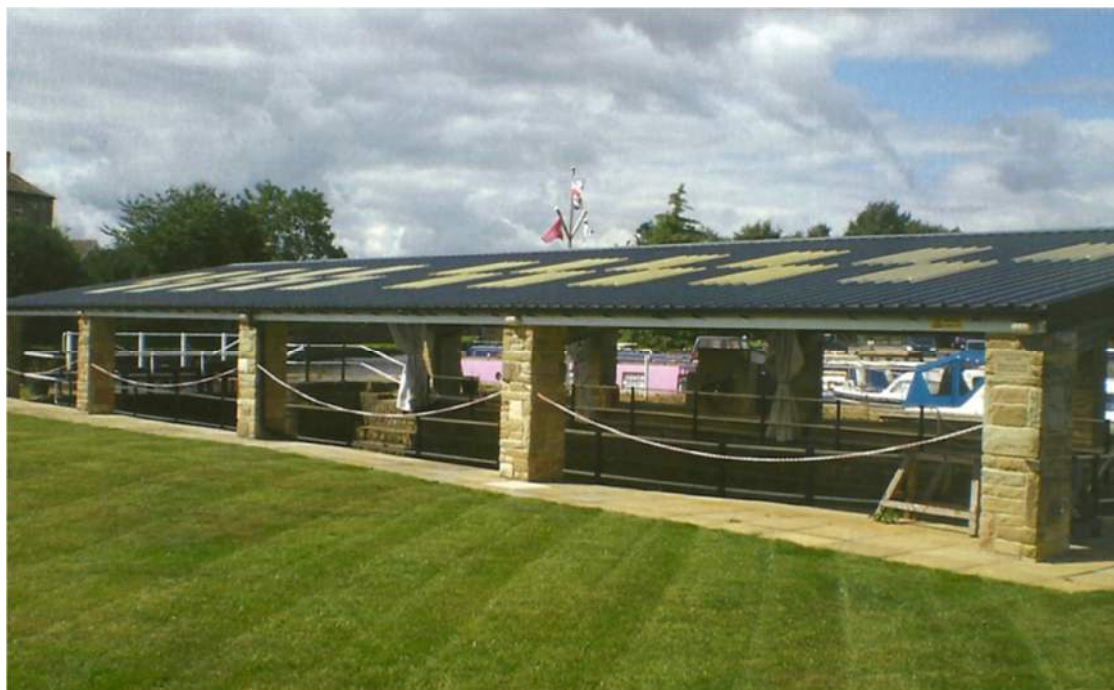
Figure 2: Current structure

Within the site boundary there is currently a dry dock, attached via a lock gate to the Battyeford Cut, and covered by an open sided structure as shown in Figure 2.

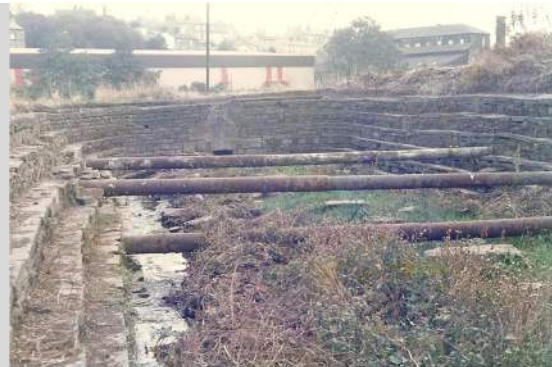
<p>3: Spring 1986, dry dock with steel bars (boat supports) and original stone walls, from southwest. Sluice can be seen to rear, where water was released to drain dock into River Calder via drainage ditch/pond.</p>

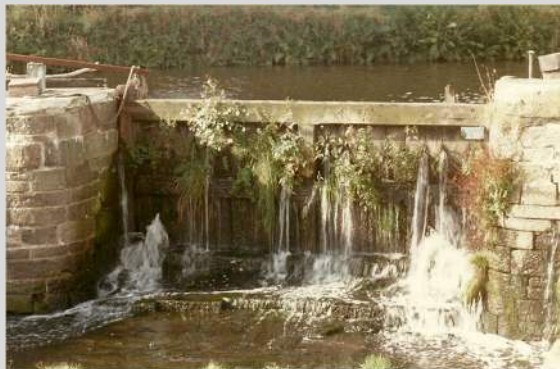
<p>4: Spring 1986, entrance to dry dock from Cut with leaky gate, from northeast.</p>

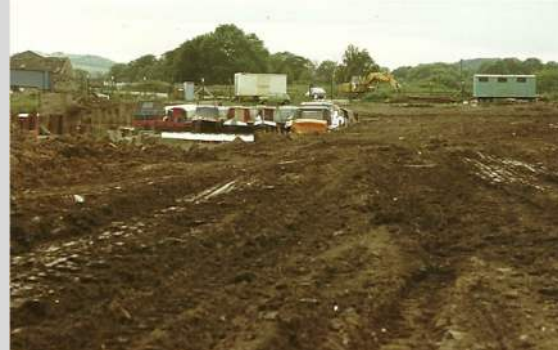
12. Arisings used to infill drainage ditch and lagoon to rear of dry dock, after new culvert installed

The large excavation undertaken to create the mooring basin (photos 7 to 12) reportedly did not encounter any unexpected or unusual ground conditions, and the arisings were used to infill the ditch and lagoon to the rear of the dry dock, after installation of a culvert leading directly from the sluice to the River Calder.

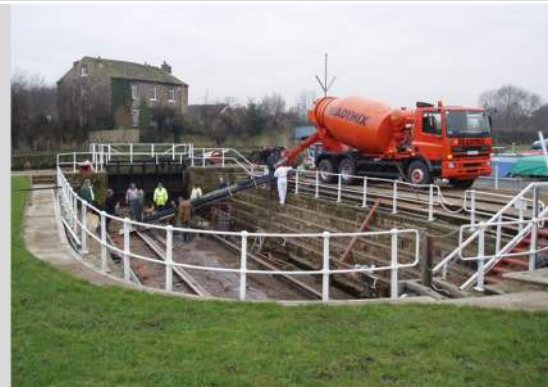
16. Reinforced concrete laid over original stonework at base of dry dock. Railings and paving slabs installed around perimeter.

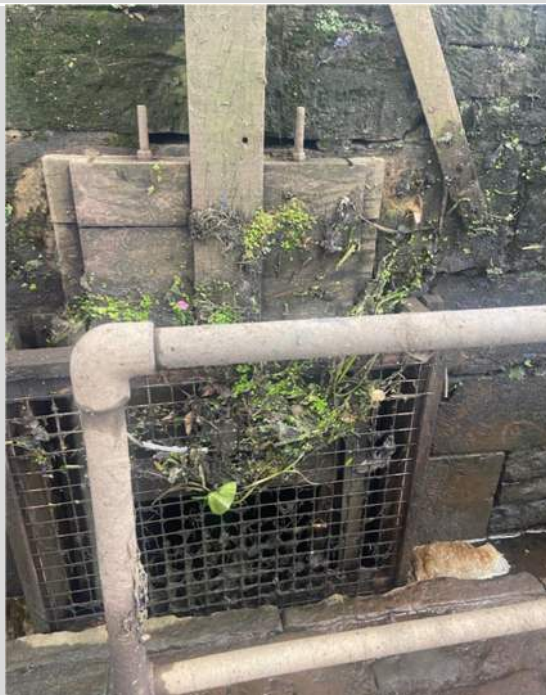
11. Sluice gate at northeast end of dry dock. The drainage ditch and lagoon have been replaced with a culvert that feeds directly into the River Calder.

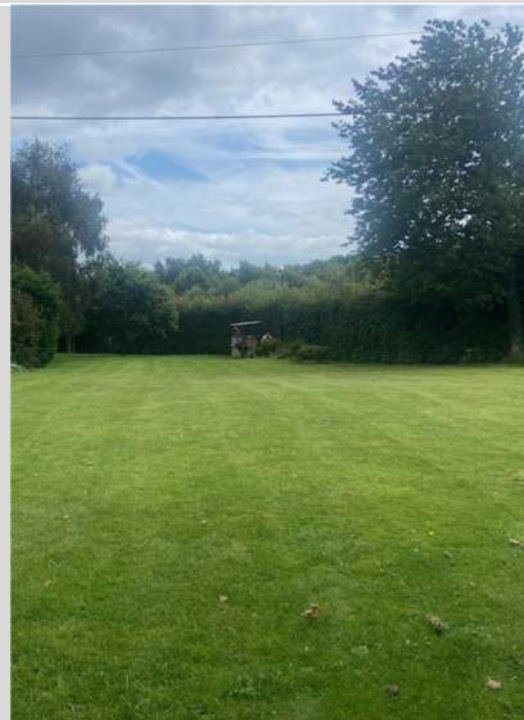
12. Boat club grounds, well maintained, no evidence of grass die-back.

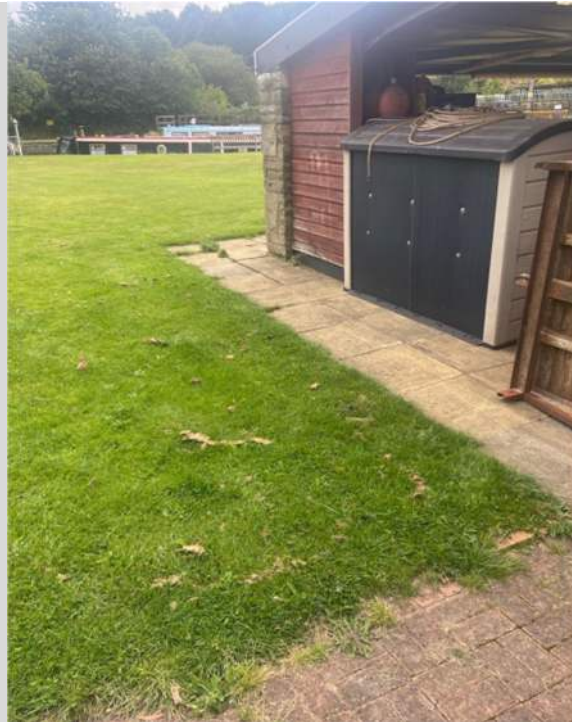
13. Northwest end of enclosure, from north. This is where the proposed workshop as detailed in the planning application will be located.

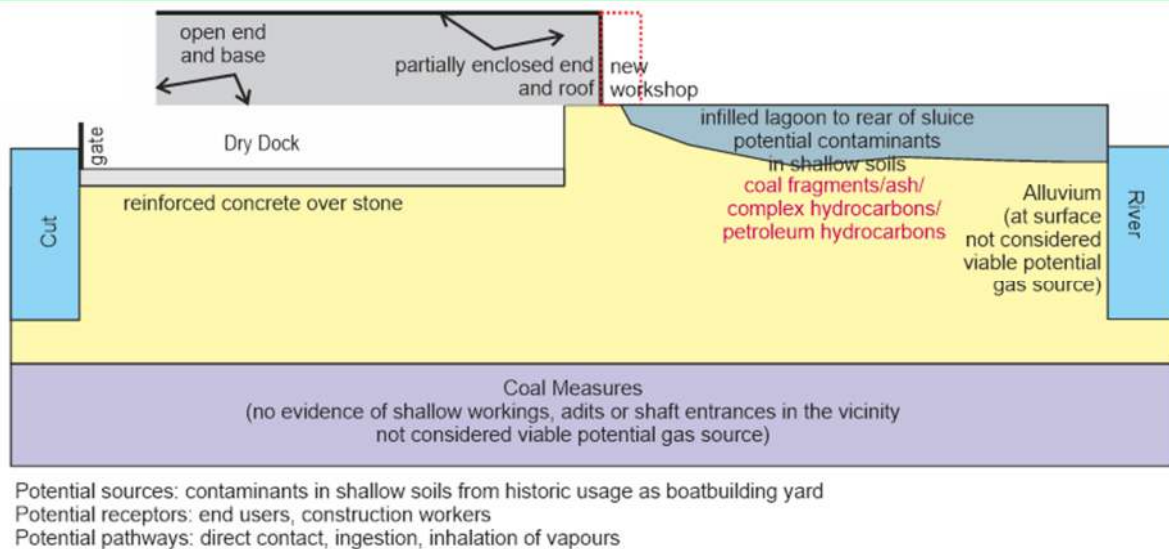
Figure 4: Simplistic ground model

It can be seen from the preliminary risk assessment presented above that there is the potential for residual contaminants to be present within shallow soils across the site from its historic usage as a boatbuilding yard, in particular within the infilled lagoon. It is considered that the shallow strip foundations to be excavated between the existing stone clad pillars on the northwest and southeast of the existing structure will not encounter any contaminated soils, however the new workshop will in part be located over the infilled lagoon.

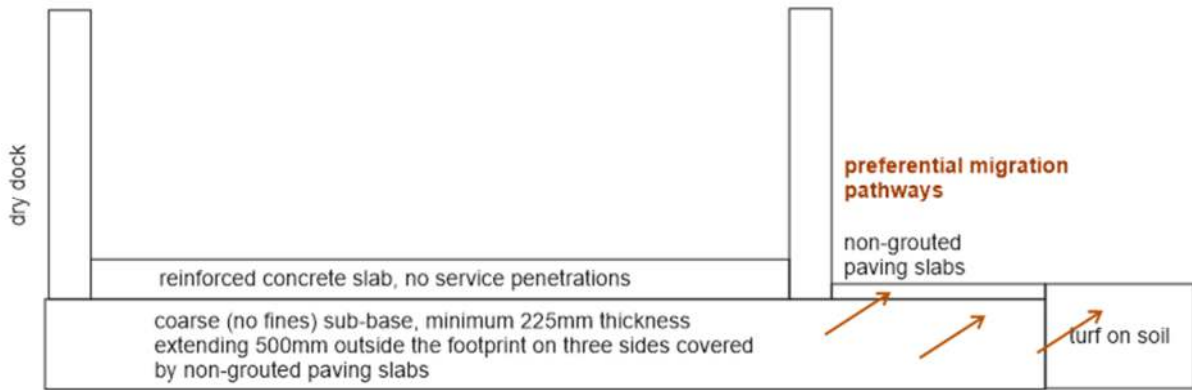
Figure 7: Schematic of passive ventilation layer (NTS)

Any carbon dioxide or hydrocarbon vapours present in the underlying soils will migrate via diffusive mechanisms (driven by concentration rather than pressure) along a concentration gradient. The extended sub-base will represent a preferential diffusive migration pathway to the external area, as opposed to forced migration through the concrete slab.

The accumulation of carbon dioxide within the enclosed space could be identified using an alarm, however this is not ideal and does not make allowance for any hydrocarbon vapours. Although it is considered highly unlikely that any gas or vapour will migrate through the reinforced concrete floor, due to the uncertainties it is considered that a conservative mitigation measure would be the installation of basic protection measures in the form of a passive ventilation layer beneath the floor slab as is shown in Figure 7 below.
