Vistry Yorkshire Ltd, Countryside Properties
(UK) Ltd & Miller Homes Ltd

Blackmoorfoot Road
Huddersfield

Aerial Tree Bat Survey Report

November 2024

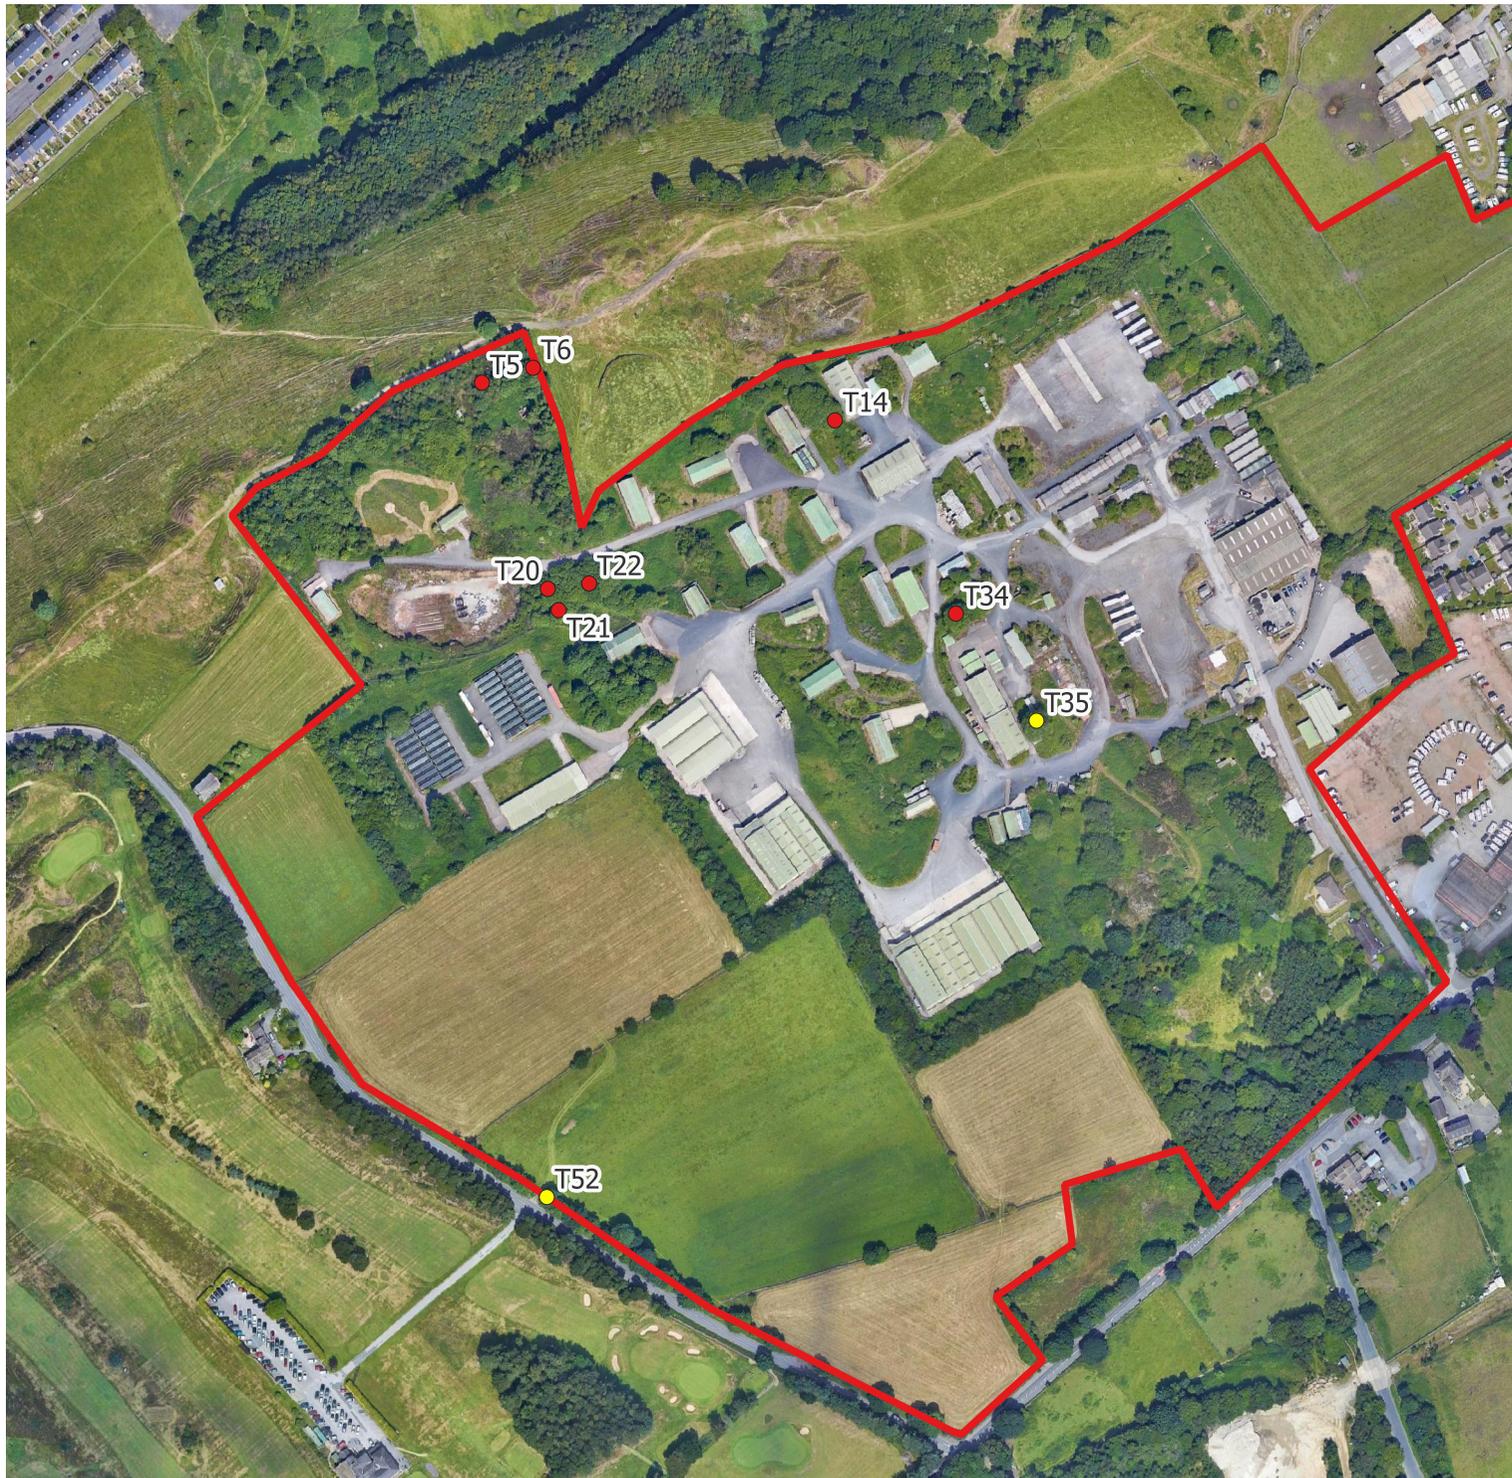
Figure 1
Tree Bat Roost Suitability

- 3.3 A total of 10 trees were considered to contain features up to PRF-M stability in the Ecus report (Ecus, 2024). These trees were all subject to further inspection, with the exception of T25 which was not accessible throughout the survey period. These are described below in Table 1, with an assessment for their suitability to support roosting bats and displayed within Figure 1. No evidence of roosting bats was recorded in any of the trees.

- 3.5 The remaining seven trees all contained at least one feature which was considered to be of suitability or PRF-M following detailed inspection. No evidence of roosting bats were recording during any of the surveys (e.g. live/dead bats, droppings, feeding remains etc)

- 4.6 Seven trees are considered to offer PRF-M suitability for roosting bats, and therefore are suitable for multiple bats and as such may support maternity roosts. It is recommended that Ecological Clerk of Works (ECoW) should perform a final pre-works check of suitable PRF-M features on the day of removal to ensure that there are no bats present within the feature. Following the check, it is considered that Best Practice Measures (BPM) should be utilised when removing these trees. The trees should be felled, taking care not to directly cross-cut through any PRFs which may be supporting roosting bats. The felled tree should be left in-situ overnight to allow any potentially present roosting bats opportunity to vacate the roosting features prior to removal/chipping of the tree.
