83 Meltham Road, Huddersfield

Bat and Bird Survey Report

14th January 2025

Document ref: MBE/BAT/2024/134/01				
Purpose and Description	Originated	Checked	Reviewed	Date
For Planning	R Bell MCIEEM	P Middleton MCIEEM	R Bell MCIEEM	14/01/2025

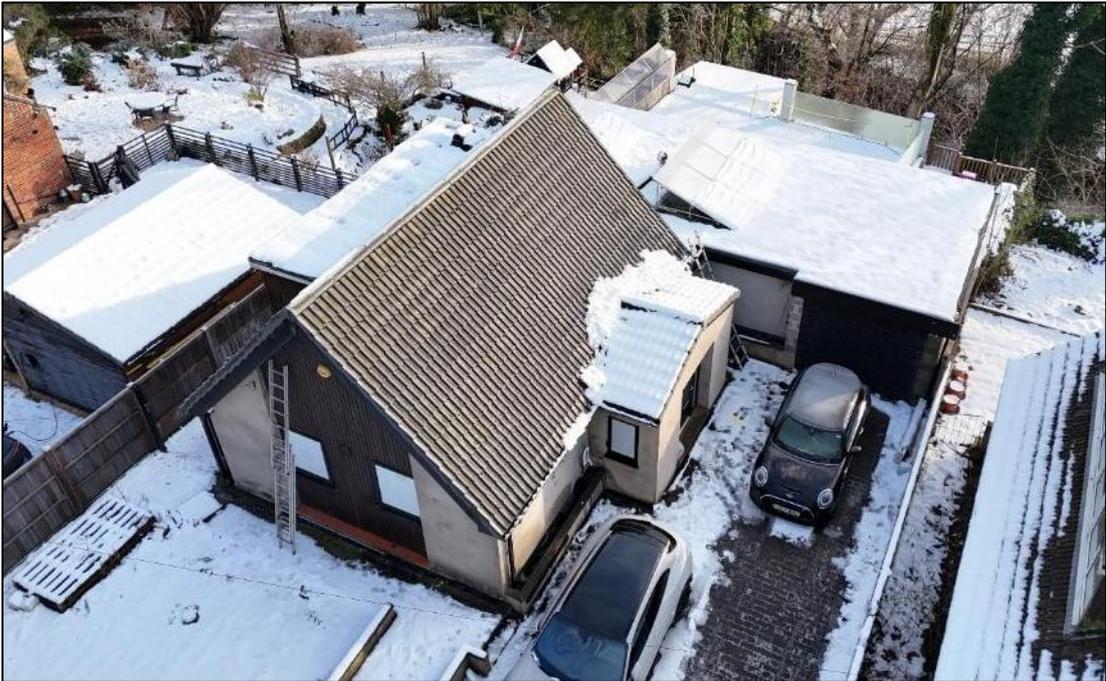
Plate 2. Western corner of surveyed dwelling

5.2.3 The surveyed dwelling comprised a rendered dormer bungalow with cavity walls (Plates 2-4). The main section of the dwelling has a dual-pitched concrete-tile covered roof, with a flat-roofed dormer in the northeast roof pitch and a porch extension on the southwest elevation. A substantial flat roofed extension, incorporating a garage, was present on the southeast elevation. The pitched roof had a dry ridge and dry verge, with wood cladding present on both gables. It was reported by the client that the pitched roof had been replaced/re-roofed c. 3 years prior to the inspection.

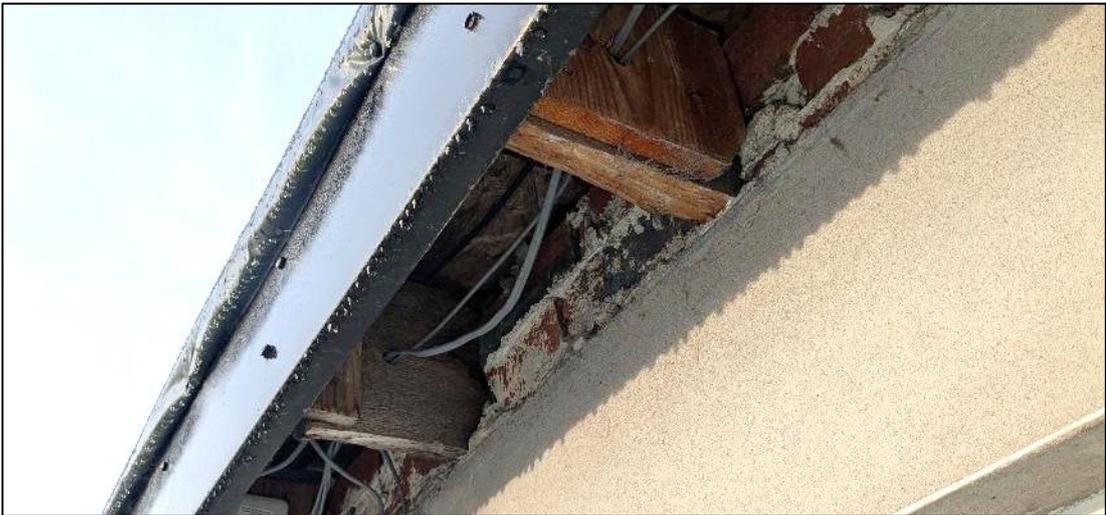
5.2.5 The removal of many of the soffit boards had exposed gaps onto wall tops across the building (Plate 5). These were all inspected using a torch and/or endoscope with no evidence of bat presence recorded. Whilst these gaps on wall tops could potentially be used by bats, it was noted that they had only fairly recently been exposed. Given the lack of evidence of current or historic bat use, it was considered possible to be confident they had not been used by roosting bats prior to the survey being undertaken.

Plate 5. Example of exposed section of wall top as a result of removed soffit panel

- 6.1.2 The removal of many of the soffit boards had exposed gaps onto wall tops across the building, some of which were suitable for use by roosting bats in the future. These areas were however subject to direct inspection, with no signs of bats recorded. In addition, these features had only fairly recently been exposed as a result of soffit removal. It is also noted that the accepted bat survey guidance (Collins, 2023) states that *'if all areas (including voids, cracks and crevices) of a structure have been inspected and no evidence found (and it is considered unlikely to have been removed by weather or cleaning or be hidden), then further surveys are not appropriate'*. Consequently, no further bat survey of these features was considered necessary.

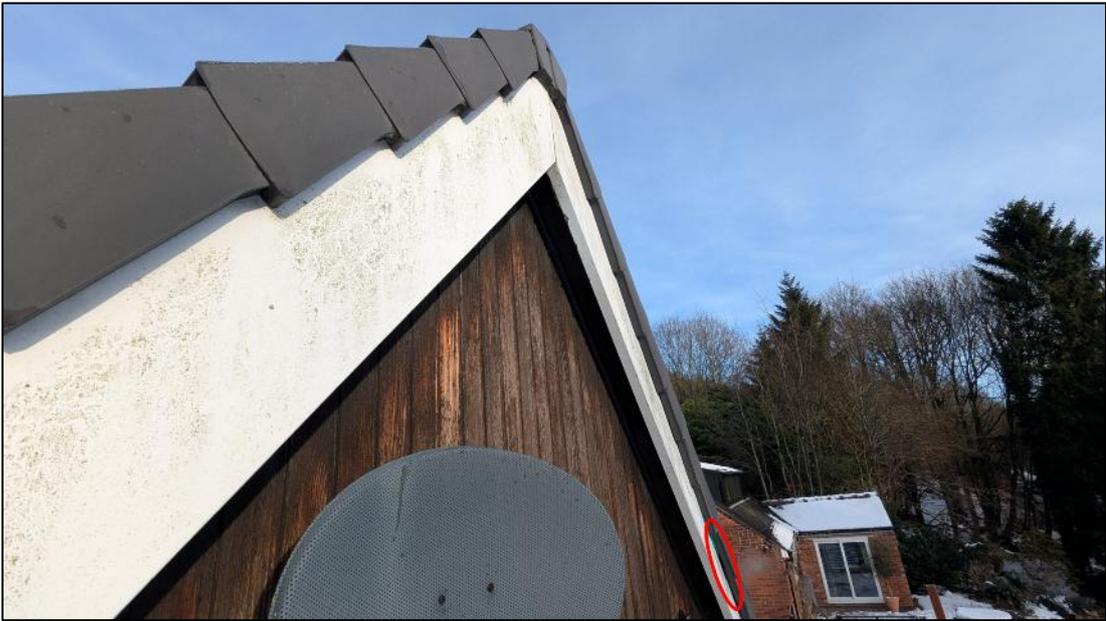
5.2.6 On the southeast gable, a single section of the dry verge was lifted away from the barge board, however, this feature was also accessed for direct inspection (Plate 6).

Plate 6. Red circle shows section of dry ridge lifted from barge board

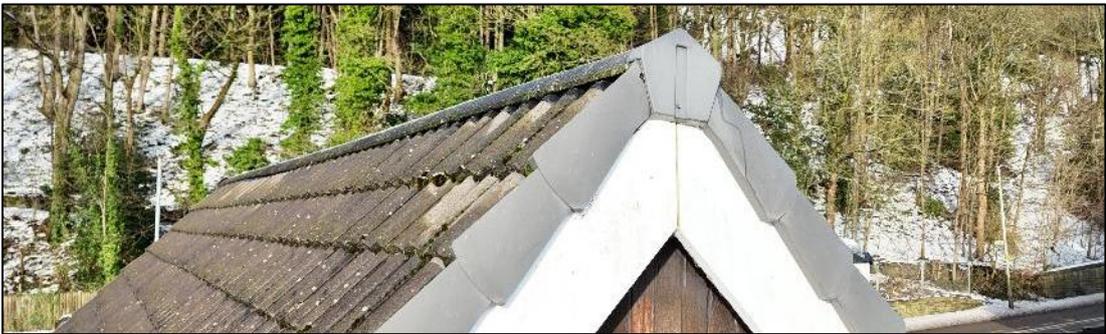
5.2.7 Inspection of the dry ridge showed the ridge roll was tightly adhered to the roof tiles (Plate 7), suggesting a lack of bat roosting suitability associated with this feature.

Plate 7. View under dry ridge

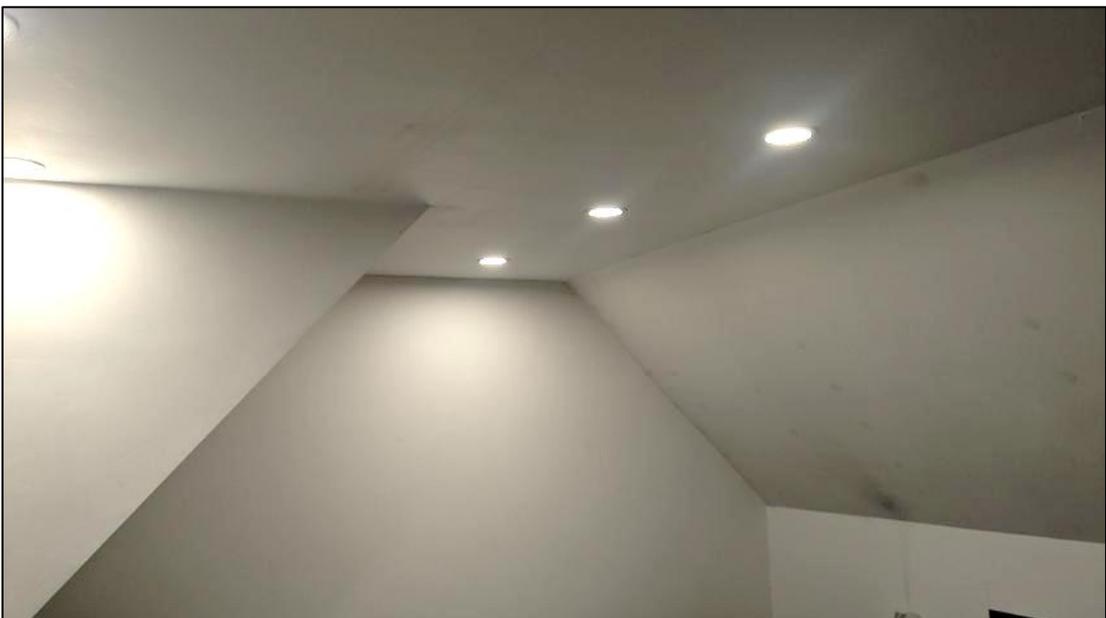
- 5.2.8 An internal inspection confirmed that a vaulted ceiling was present in the roof space, with this area used as bedrooms. A very small (<0.5 m high) inaccessible void was likely to be present at the top of the roof, however, due to its size and the lack of potential bat access points on the outside of the dwelling, it was considered highly unlikely this void would be used by bats.

Plate 8. Vaulted bedroom ceiling within roof space of dwelling

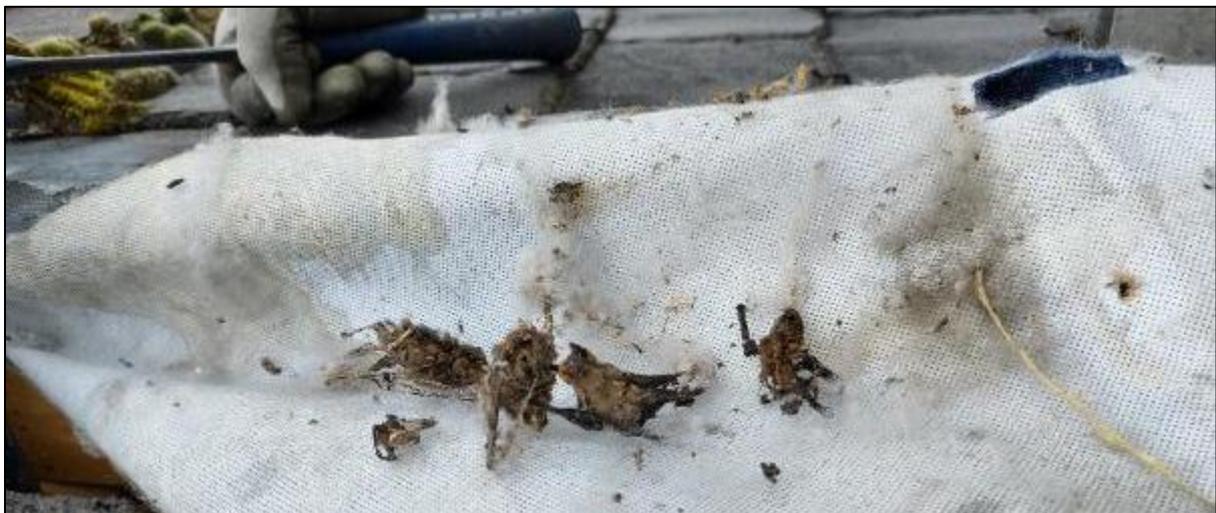
Non-bitumen coated membranes used below roof slates and tiles present a significant problem for bats. Over time, strands are pulled away from the surface of these materials as bats crawl over them. These fuzzy strands are very strong and can tangle and trap bats, sometimes causing the death of bats over multiple years¹.

One example we have encountered comprised a pipistrelle roost which formed in a building extension constructed in 2009. Over the course of just 13 years the roofing felt degraded to the extent that it trapped and killed more than 10 bats. Fortunately, the problem in this roost was identified and remedial work was undertaken to replace the roofing membrane in 2022.

Plate A2.1. Four dead pipistrelles tangled in breathable roofing felt

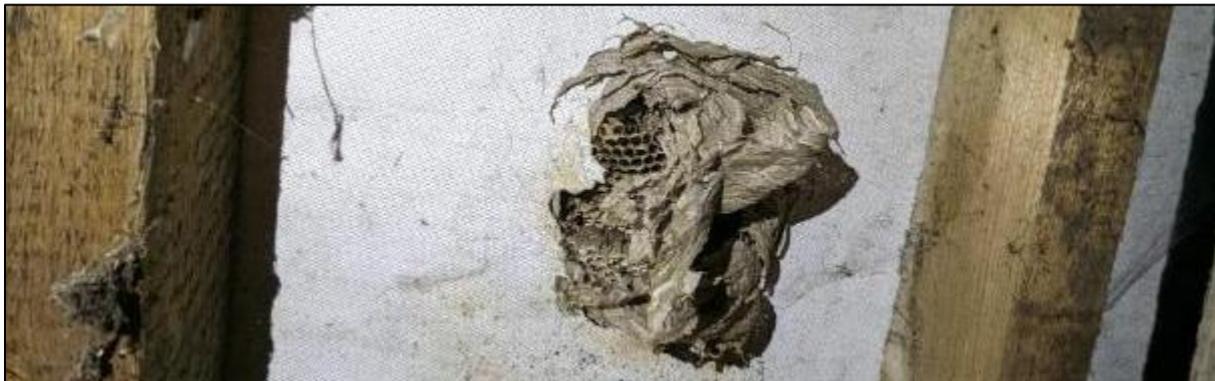
In recent years a fairly substantial proportion of the lofts we have surveyed which had existing breathable felt, were found to have been damaged by wasps (Plate A2.2). In these situations, the wasps appear to have chewed holes in the felt and formed nests in the holes. This doesn't appear to be a problem associated with the traditional bitumen coated roofing felt. Obviously, any holes within roofing felt would be likely to significantly reduce its functionality as a secondary weather barrier. Where bats or birds do come into contact with breathable roofing membranes, they can damage the membrane causing it to leak and they can also significantly reduce the breathability of the felt in that location.

Plate A2.2. Damage to a breathable roofing membrane adjacent to a wasp nest
