# 35 St Johns Road Birkby

## Bat Survey Report

3<sup>rd</sup> March 2025

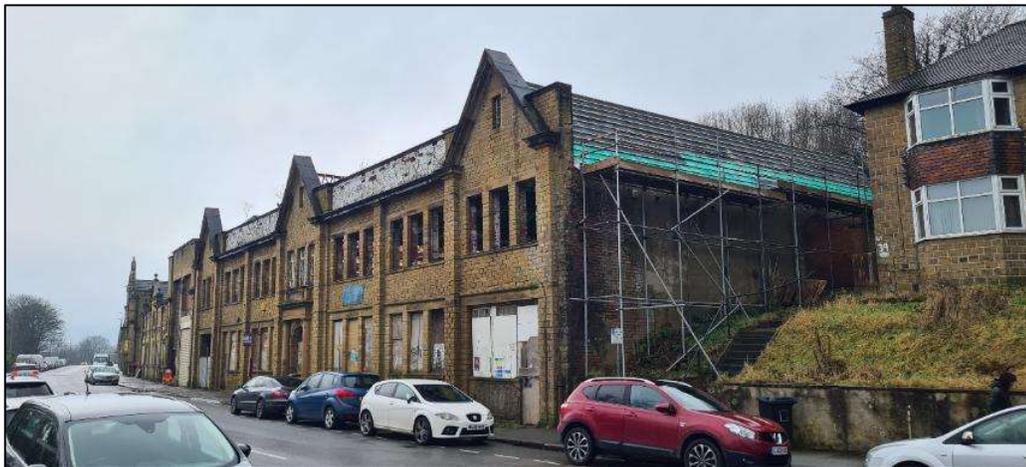
**Plate 3. The façade of 35 St Johns Road viewed from the north**

- 5.2.3 The building was constructed from brick and concrete blocks with a stone façade (Plate 3). The building comprised two distinct halves Section B1a at the front, and Section B1b at the rear (Figure 2).

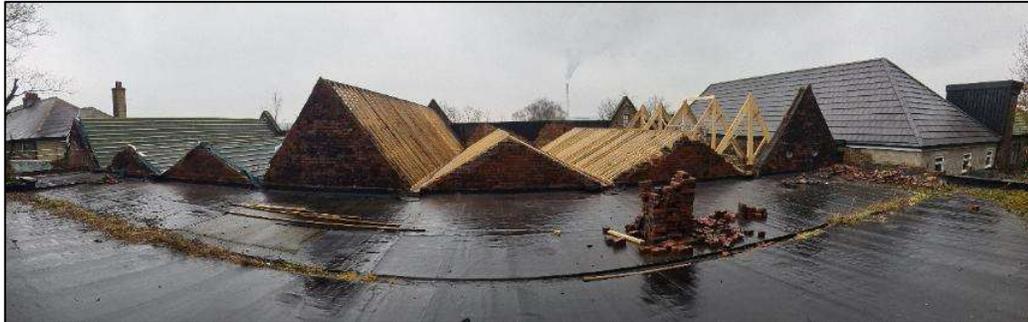
**Plate 4. The multi-pitched roof of 35 St Johns Road viewed from the flat roof section behind (to the southwest)**

- 5.2.4 The front of the building (section B1a) comprised a two storey area with a multi-pitched roof. The roof sections at either end of the building and in the centre had a higher ridge line than the sections between (Plate 4).

majority of the two storey section of the building. The wall tops were unfinished leaving the wall cavity open to the elements from above (Plates 4 and 5).

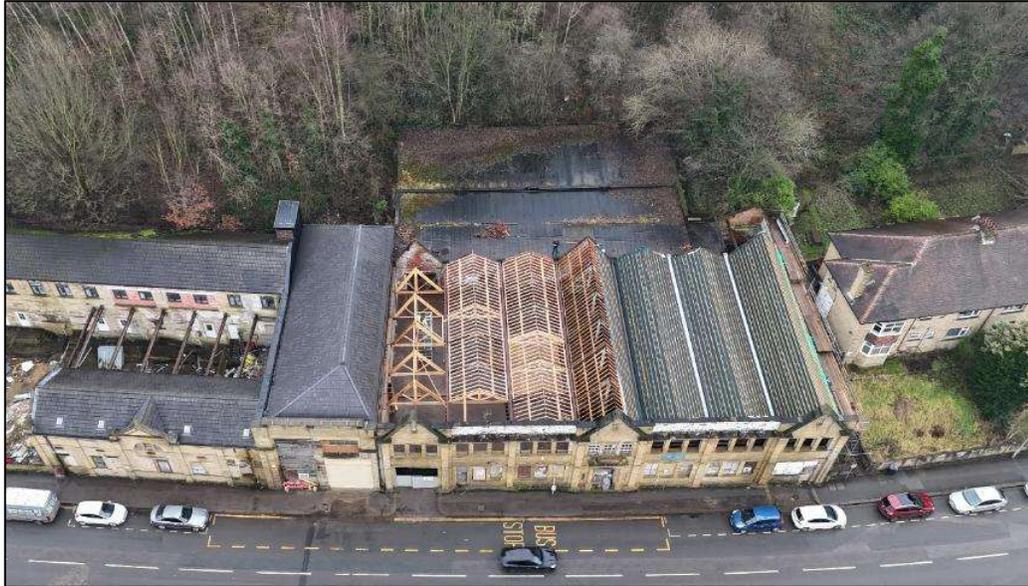
**Plate 6. The building with new roof timbers being installed and half of the roof covered with a breathable membrane**

- 5.2.5 On Section B1a the roof timbers were in the process of being installed as part of the ongoing repair process, and half of the pitches had been covered with a breathable roof membrane although no slates had been installed at the time of survey. Many of the floor joists had been replaced and a temporary first floor was present over the

6.3.1 The roofing membrane has already started to be installed on Building 1a, with battens fitted. It was noted that this roofing membrane was not one of the ones listed as safe for use in bat roosts. Given this membrane is located on Section 1a at the front of the property, this is considered much less likely to be used by roosting bats than the area over the roof of the rear building (Section 1b). It is recommended that the roofing membrane installed on the roof of the building to be located at the rear of the site (as shown on Figure 5) is one of the products identified as safer for use in areas with roosting bats. Further information on the issue of bats and roofing membranes is included in Appendix 2.

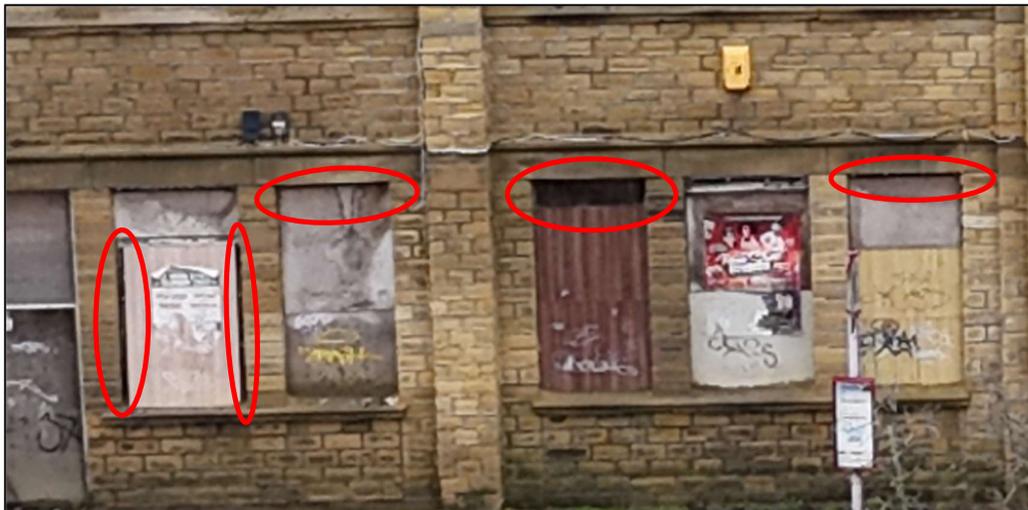
**Plate 7. Gaps around boarded up windows(circled red)**

5.2.8 Bats could freely enter the building via the missing roof, missing windows and open doorways. However, the pointing on the masonry was relatively good. The small sections of missing mortar that were present on the exterior were shallow and unsuitable to support roosting bats. Despite the poor condition of the building overall, potential bat roost features on the exterior of the building were limited to gaps around boarded up windows and doors (Plate 7), and two low-level vents present at the rear (southeast elevation) of B1b (Plate 8).

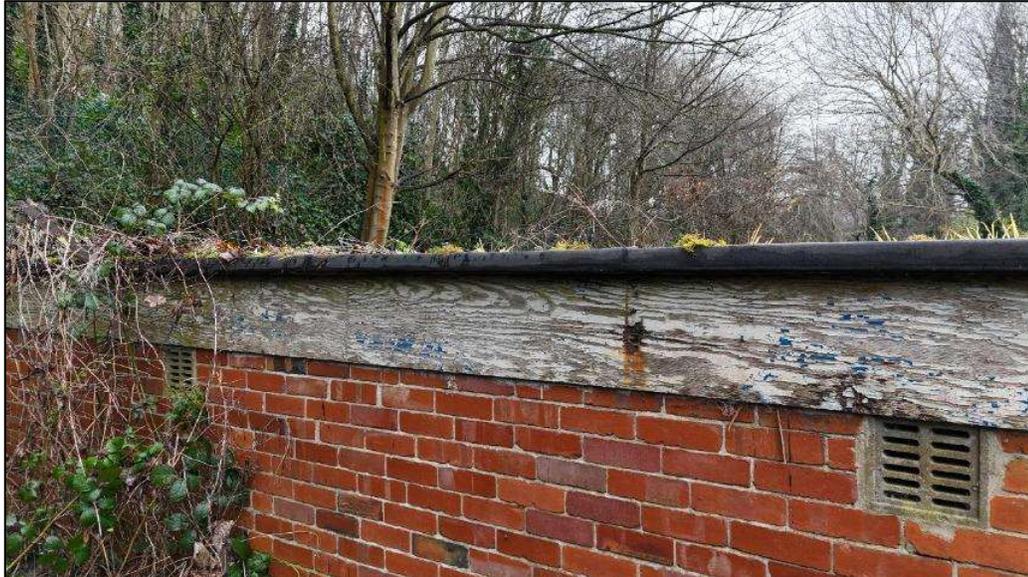
**Plate 8. Low bat roost suitability vent shown on the right with obscured vent on the left**

- 5.2.9 The low height of the vents (c. 1.4 m) reduced their suitability. A high-powered torch and endoscope was used to check the vents. No bats or signs of bats were present. Following the close inspection of the vents their bat roost suitability was considered to be negligible.
- 5.2.10 The boarded up windows and doors were at street level on a busy B road. They were checked from the inside with a high powered torch, and an additional search made around the gaps on the exterior. Given their location it was considered these features were also of negligible bat roost suitability.

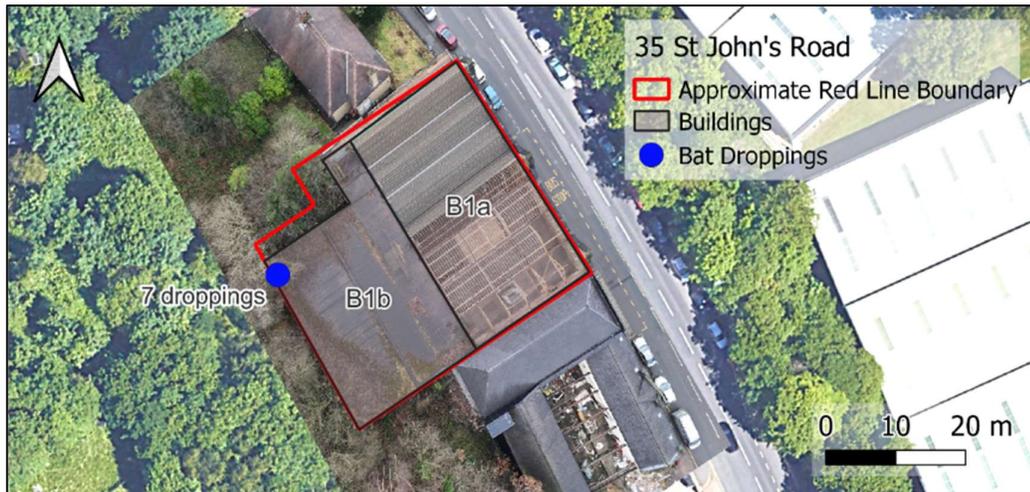
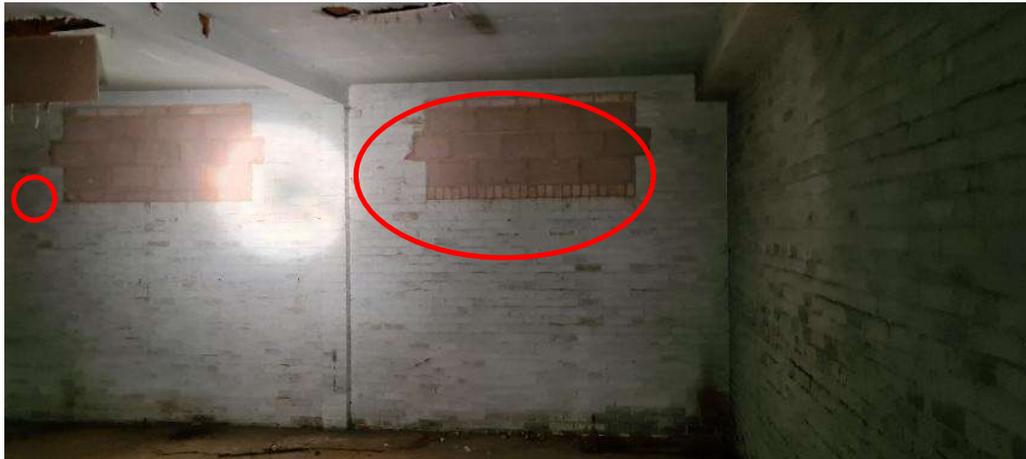
**Figure 3. Location of bat droppings**

- 5.2.11 During the interior inspection of the building seven bat droppings were recorded on the wall in the northwest corner of B1b. The location of the droppings is shown in Figure 3 and Plate 9.

**Plate 9. Approximate location of the seven bat droppings**

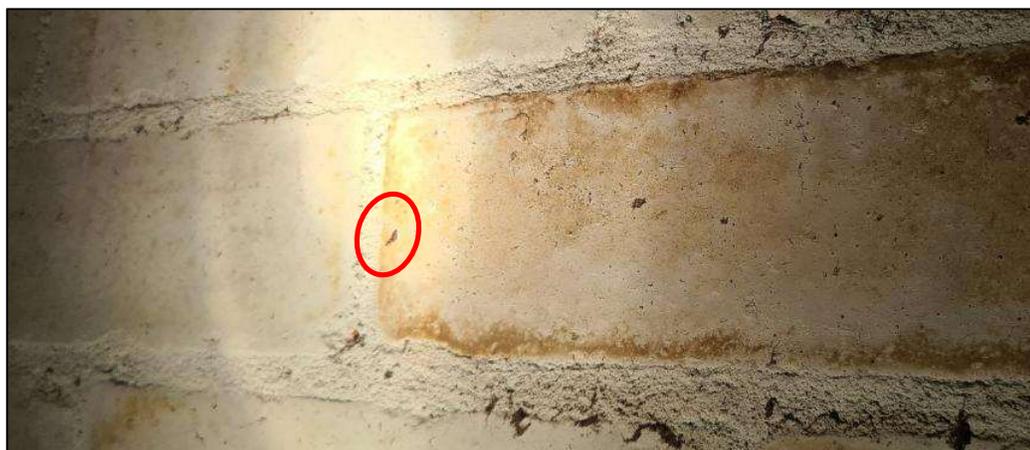
5.2.12 The size and shape of the bat droppings indicated that they were likely to be pipistrelle droppings (Plate 10).

**Plate 10. Shows one of the droppings in situ**

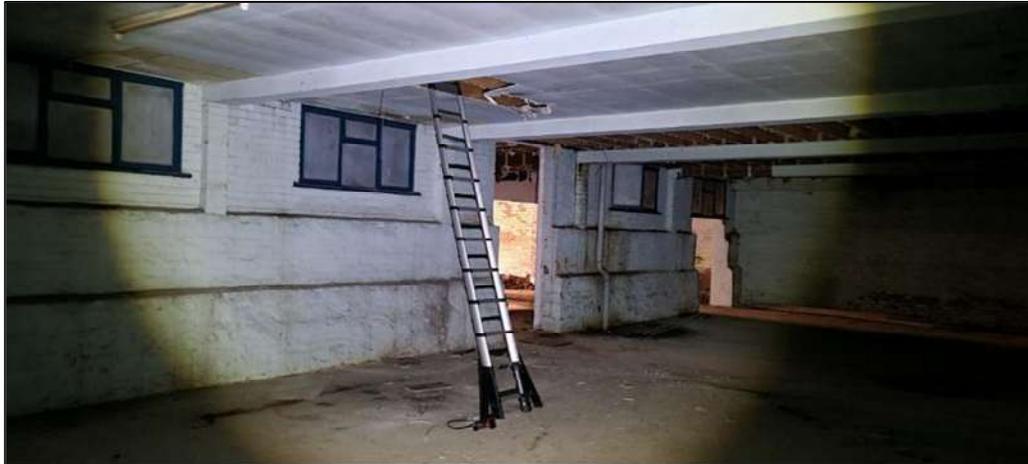
5.2.13 No potential bat roost features were present in the area where the bat droppings were located but it was noted that it was the darkest, and least disturbed area within the building. In eight locations in this room the plasterboard ceiling had been damaged (Plate 11). These eight locations were inspected but no bats or signs of bats were present. Some were fairly heavily cobwebbed and in all locations it was considered that bat droppings would have persisted on the upper surface of the adjacent plasterboard, if bats had been roosting within the spaces (Plate 12).

**Plate 11. Example of an area of damaged plasterboard**

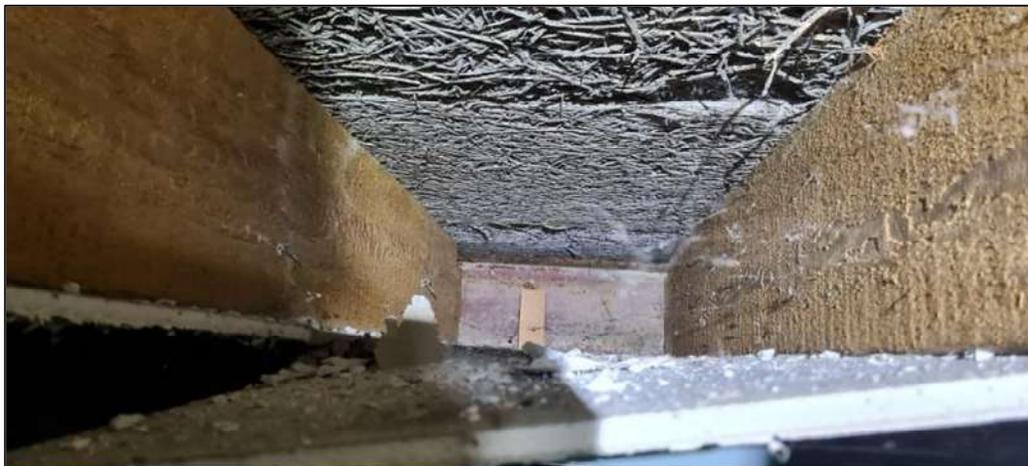
**Plate 12. The void opened up by the damage**

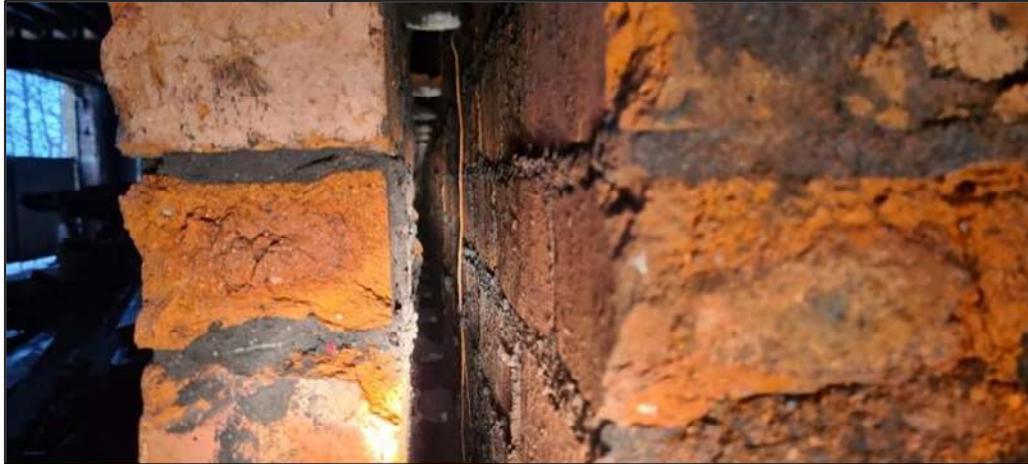
5.2.15 A section of damaged brickwork was present in the brick wall directly opposite the main building entrance. The section of damaged brickwork led into a cavity within this interior wall (Plate 15). It was anticipated that this cavity was likely to have been opened up during the recent repair work as it was directly beneath a set of stairs that had been installed to allow access to the first floor. A second area of damaged brickwork was also present in an internal brick wall nearby but no cavity was present in the second location.

**Plate 15. Cavity within the interior wall on the ground floor, viewed from the area of damaged brickwork**

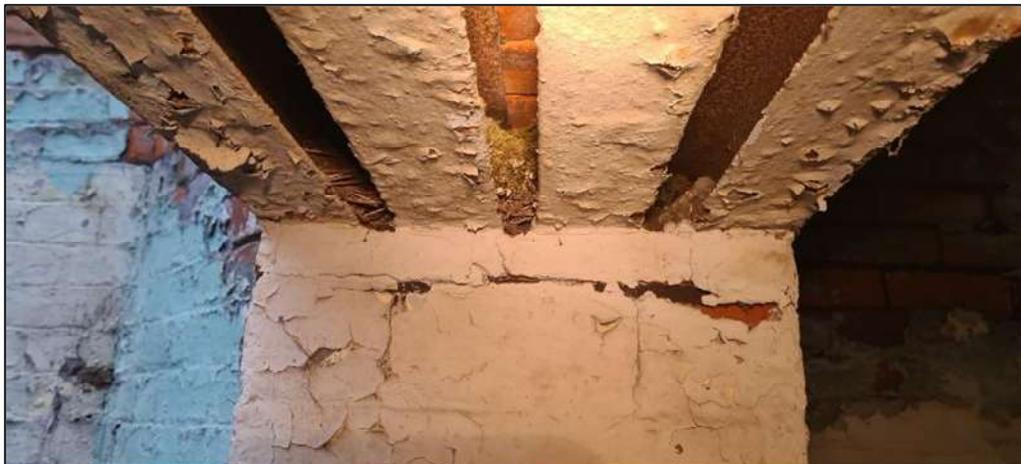
5.2.17 Two doorways separated Section B1a from B1b. Gaps were present in the lintels above these two doorways but not in the rest of the building. Within the lintel gaps at the northern end two old bird's nests were present (Plate 17).

**Plate 17. old bird nests over the brickwork at the edge of the doorway in the space between the metal lintels**

- 6.3.3 To replace the potential bat roost features and confirmed bird nesting opportunities within the building, the number of integrated bat and bird should be increased from three boxes for each species group, to eight boxes per species group. Bat boxes should comprise Vivara Pro UK bat boxes (or similar). The bird boxes should comprise swift bricks such as the S-bricks supplied by Action for Swifts<sup>1</sup>. The boxes should be located in adjacent pairs, with adjacent bat boxes connected internally (as shown in Figure 6).

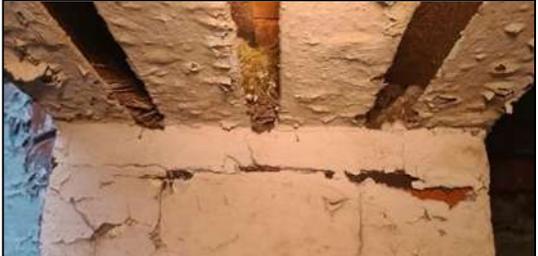
Gaps between lintels
B

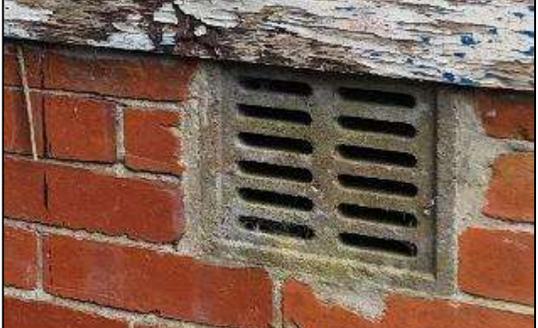
Low level air vents.

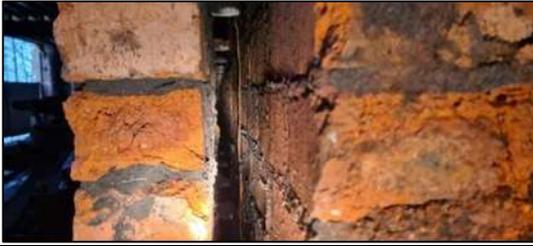
Damaged brickwork
D

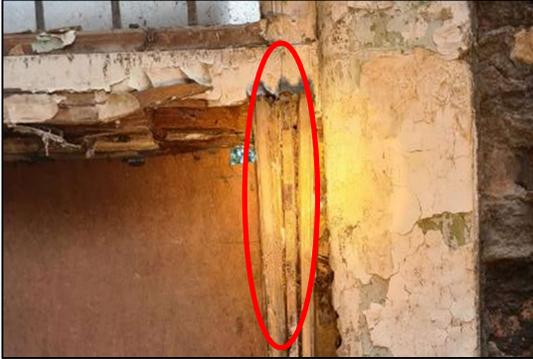
Gaps between wooden boarding.
E

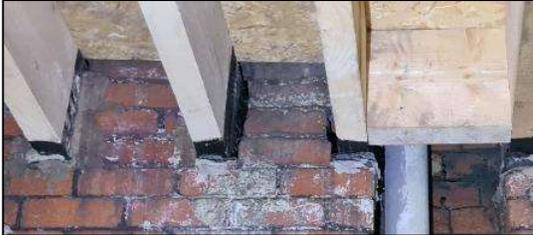
Gaps between new first floor joists and the brickwork
F

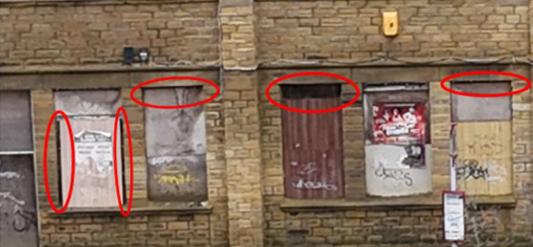
Gaps around boarded up windows.

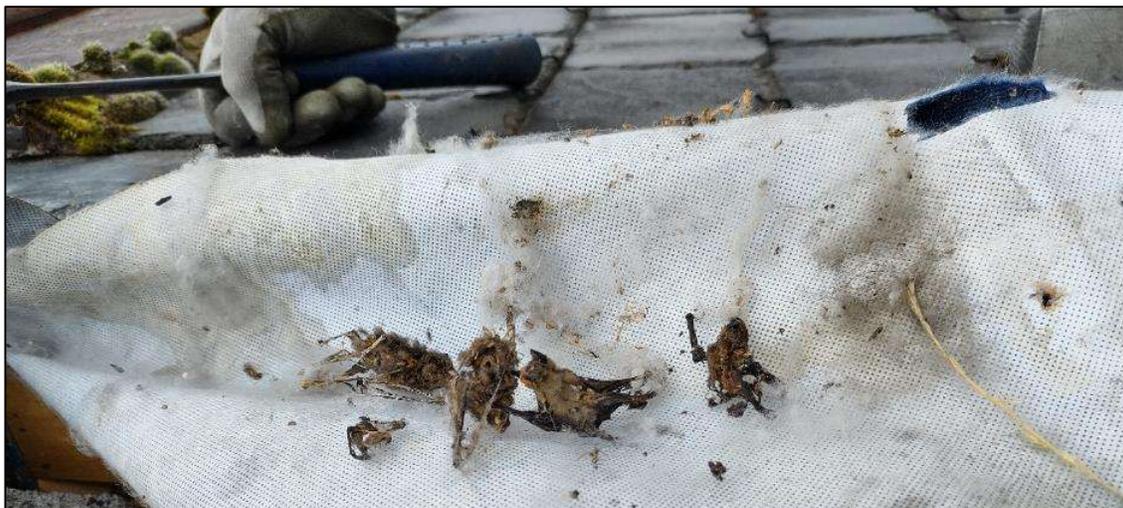
One example we have encountered comprised a pipistrelle roost which formed in a building extension constructed in 2009. Over the course of just 13 years the roofing felt degraded to the extent that it trapped and killed more than 10 bats. Fortunately, the problem in this roost was identified and remedial work was undertaken to replace the roofing membrane in 2022.

### Plate A2.1. Four dead pipistrelles tangled in breathable roofing membrane

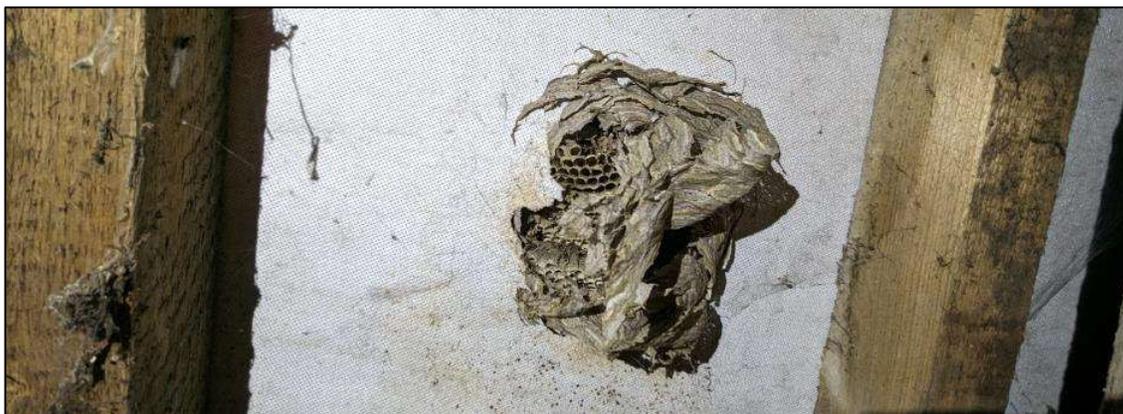
In recent years a fairly substantial proportion of the lofts we have surveyed which had existing breathable felt, were found to have been damaged by wasps (Plate A3.2). The wasps appear to have chewed holes in the felt and formed nests. This doesn't appear to be a problem associated with traditional bitumen coated roofing felt. Any holes within roofing felt are likely to significantly reduce its functionality as a secondary weather barrier. Where bats or birds come into contact with breathable roofing membranes, they can also damage it causing it to leak, they can also significantly reduce the breathability of the felt in that location.

#### **Plate A2.2. Damage to a breathable roofing membrane adjacent to a wasp nest**
