Arboricultural Impact Assessment

WC-371.1a

267/269 Spen Lane, Gomersal,
Cleckheaton BD19 4LT

Report type:	Arboricultural Impact Assessment
Report reference:	WC-371.1
Revision:	a
Client:	Natalie Maguire
Site address	267/269 Spen Lane, Gomersal, Cleckheaton BD19 4LT
Grid reference:	SE 20710 26002
Report prepared by:	Jack Delaney MICFor MArborA
Date:	9 th April 2025

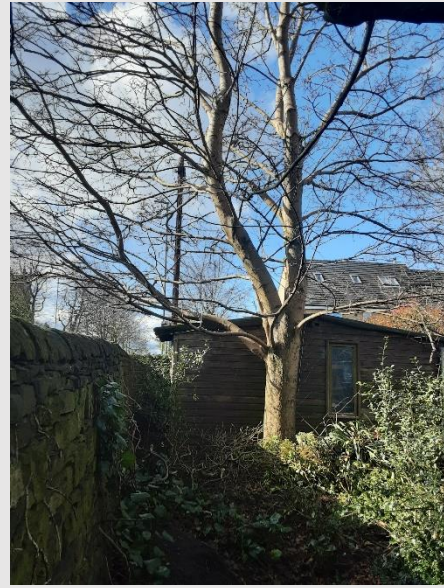
Plate 2: T003

Tree Ref:	Species	Age	SULE	Ht.	DBH	CS				CC	Comments	PC	SC	BS 5837: 2012 Category	Recommendations
						N	E	S	W						
T003	Norway maple <i>(Acer platanoides)</i>	EM	40-80	15	490	5	3	7.5	6	3	Bifurcates at 2 m into two co-dominant stems; union is acute and potentially may contain included bark. Mechanical damage to tertiary branches extending south over Spen Rd. which have been struck by high sided vehicles.	F	F	B2	No works recommended
T004	Common lime <i>(Tilia x europaea)</i>	M	40-80	21	620	5	4	6.5	4.5	3.5	Major deadwood > 100 mm in diameter scattered throughout the crown. Cavity opening on west aspect of main stem at 1 m, approx. 60 cm (l) x 10 cm (w); some visible decay to the exposed heartwood, though with extensive wound wood forming around margins of defect.	F	PD	B2	No works recommended
T005	Cultivar apple <i>(Malus domestica)</i>	Y	20-40	3	60	0.5	0.5	1	1	1	No obvious significant defects, though of limited arboricultural merit and lacking qualities for higher BS 5837 categorisation.	F	F	C1	No works recommended

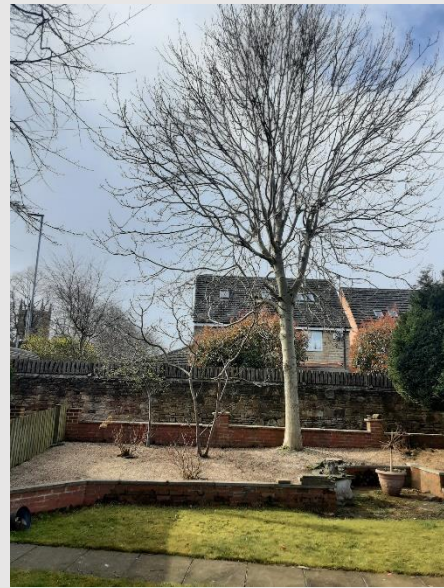
Plate 4: T005, T006, & T007 (left to right)

4.3.1. The RPAs of T005, T007, T008, and G003 will be impacted by the proposals to refurbish the hardstanding on the existing driveway. However, since the proposals are to install a permeable surface dressing, this potentially will help to improve the existing soil conditions.

4.3.2. To ensure that the proposals to refurbish the existing driveway do not adversely impact tree roots, these works should adhere to the guidance provided in **Section 7** of the **Outline AMS**.

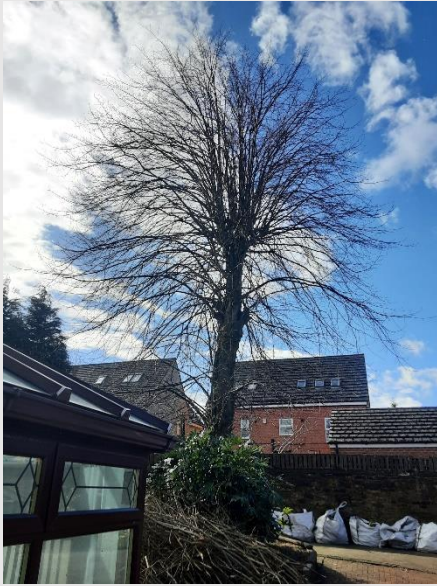
Plate 5: T008

A3.6.1 Due to site constraints, and to allow for suitable working space, the temporary tree protection fencing adjacent to T008 will be setback from the default *BS 5837:2012* positioning; as a result, soft-landscape within the RPA of T008 will be exposed to development activities.

A3.6.2 Temporary ground protection should therefore be installed throughout the exposed RPA of T008 - in the locations shown in **Tree Protection Plan** - and shall remain in place until the development is completed.
