**ARBORICULTURAL REPORT  
AND  
ARBORICULTURAL IMPACT ASSESSMENT  
to BS 5837:2012  
at  
198 Barnsley Road  
Denby Dale  
Huddersfield  
West Yorkshire  
HD8 8TS**

**Client:**  
Techwill Ltd

**JCA Ref:**  
22265d/DK

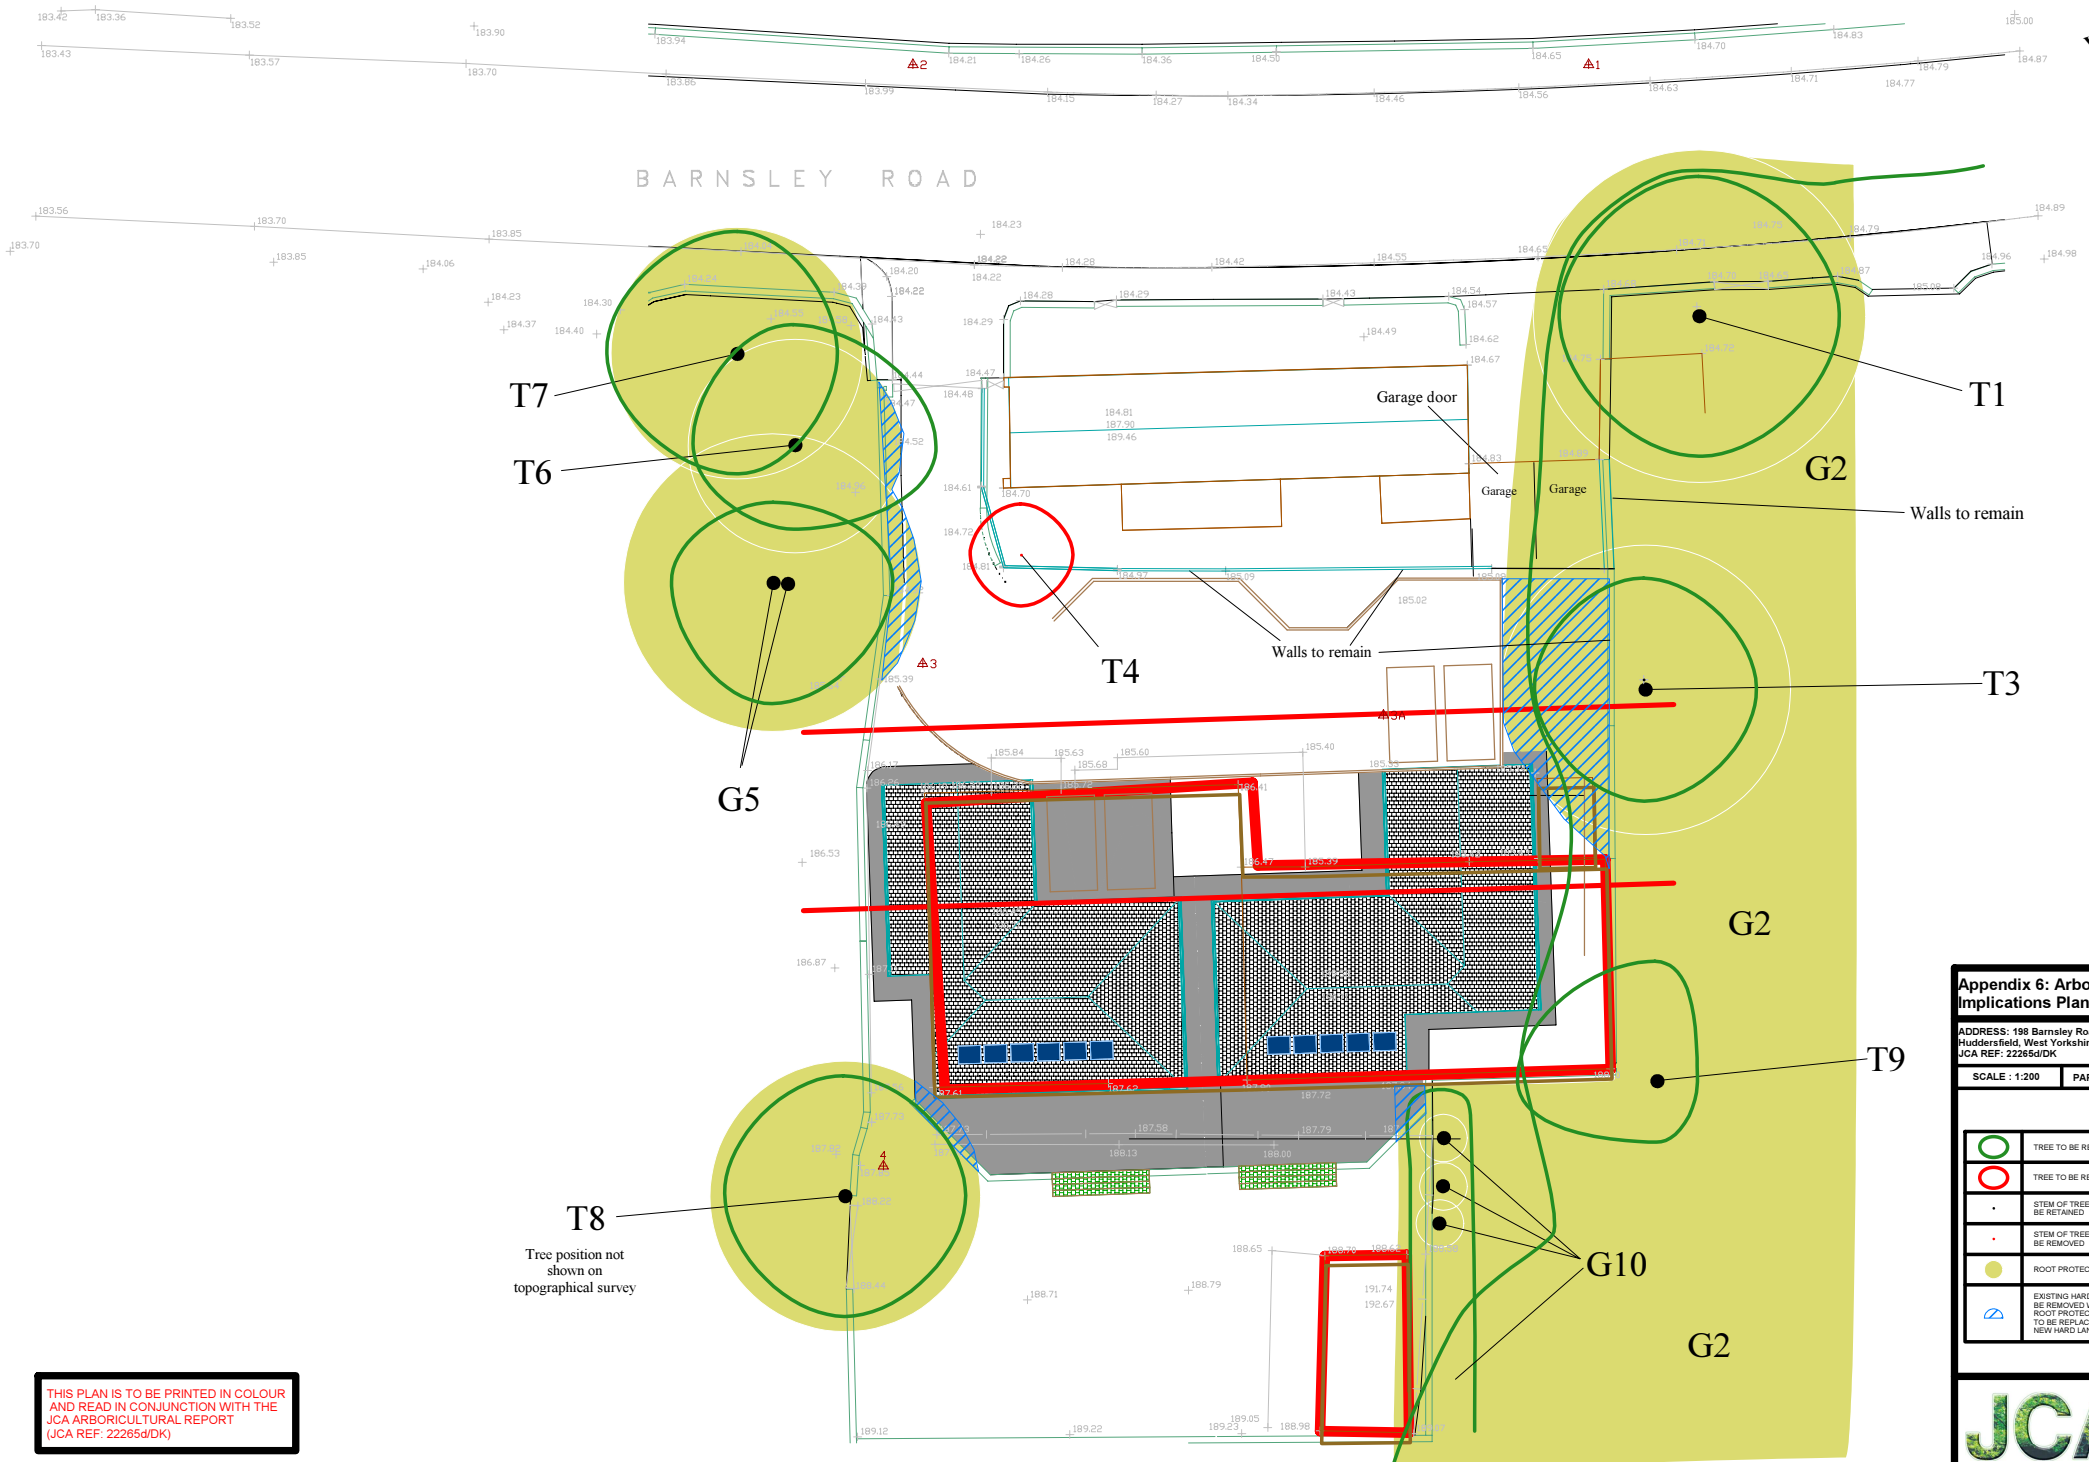
**Appendix 6: Arboricultural Implications Plan**

- 4.5.3.2 Proposed hard surfaces are present within the RPAs of **4** of the retained trees/tree groups (**G2**, **T3**, **G5** and **T6**). In this case, the proposed surfaces are situated within the footprint of existing hard surfacing. Where this is applicable, the existing surface will be retained in situ to prevent damage to tree roots. If required, it may then be resurfaced as appropriate, providing that the base is retained, and no excavation takes place within the RPA.

- 4.5.3.3 Some of the existing surfaces that are to be removed as part of the development proposals are present within the RPA of **2 of the** retained trees and **2** of the retained tree groups (see **Section 4.5.2** on demolition). The existing surfaces provide ground protection for the rooting areas and as such, these are to be retained during construction up until the final stages of development, at which point they may be removed. This will afford the maximum protection to these trees.

- 4.5.2.1 It is proposed to remove some relatively minor areas of existing hard surfaces within the RPAs of **G2**, **T3**, **G5** and **T6**. This operation will require the supervision of an arboriculturalist.

- 4.5.2.2 For this method, the existing hard surface will first be broken by mechanical means. Care will be taken to only break the existing hard surface and not to disturb the underlying soil (where the tree roots are located). Once the surfacing has been broken into manageable sizes, it will be carefully removed from the area.

- 4.5.2.3 Once all the rubble has been removed from the area, it will be re-instated with new hard standing.
- 4.5.2.4 Some of the existing structures areas of hard standing that are to be removed as part of the development proposals will provide ground protection for the retained trees outlined at point 4.5.2.2 above. Due to this, the structures can alternatively be retained during the construction process up until the final stages of development, at which point they may be removed. This will afford the maximum protection to these trees.

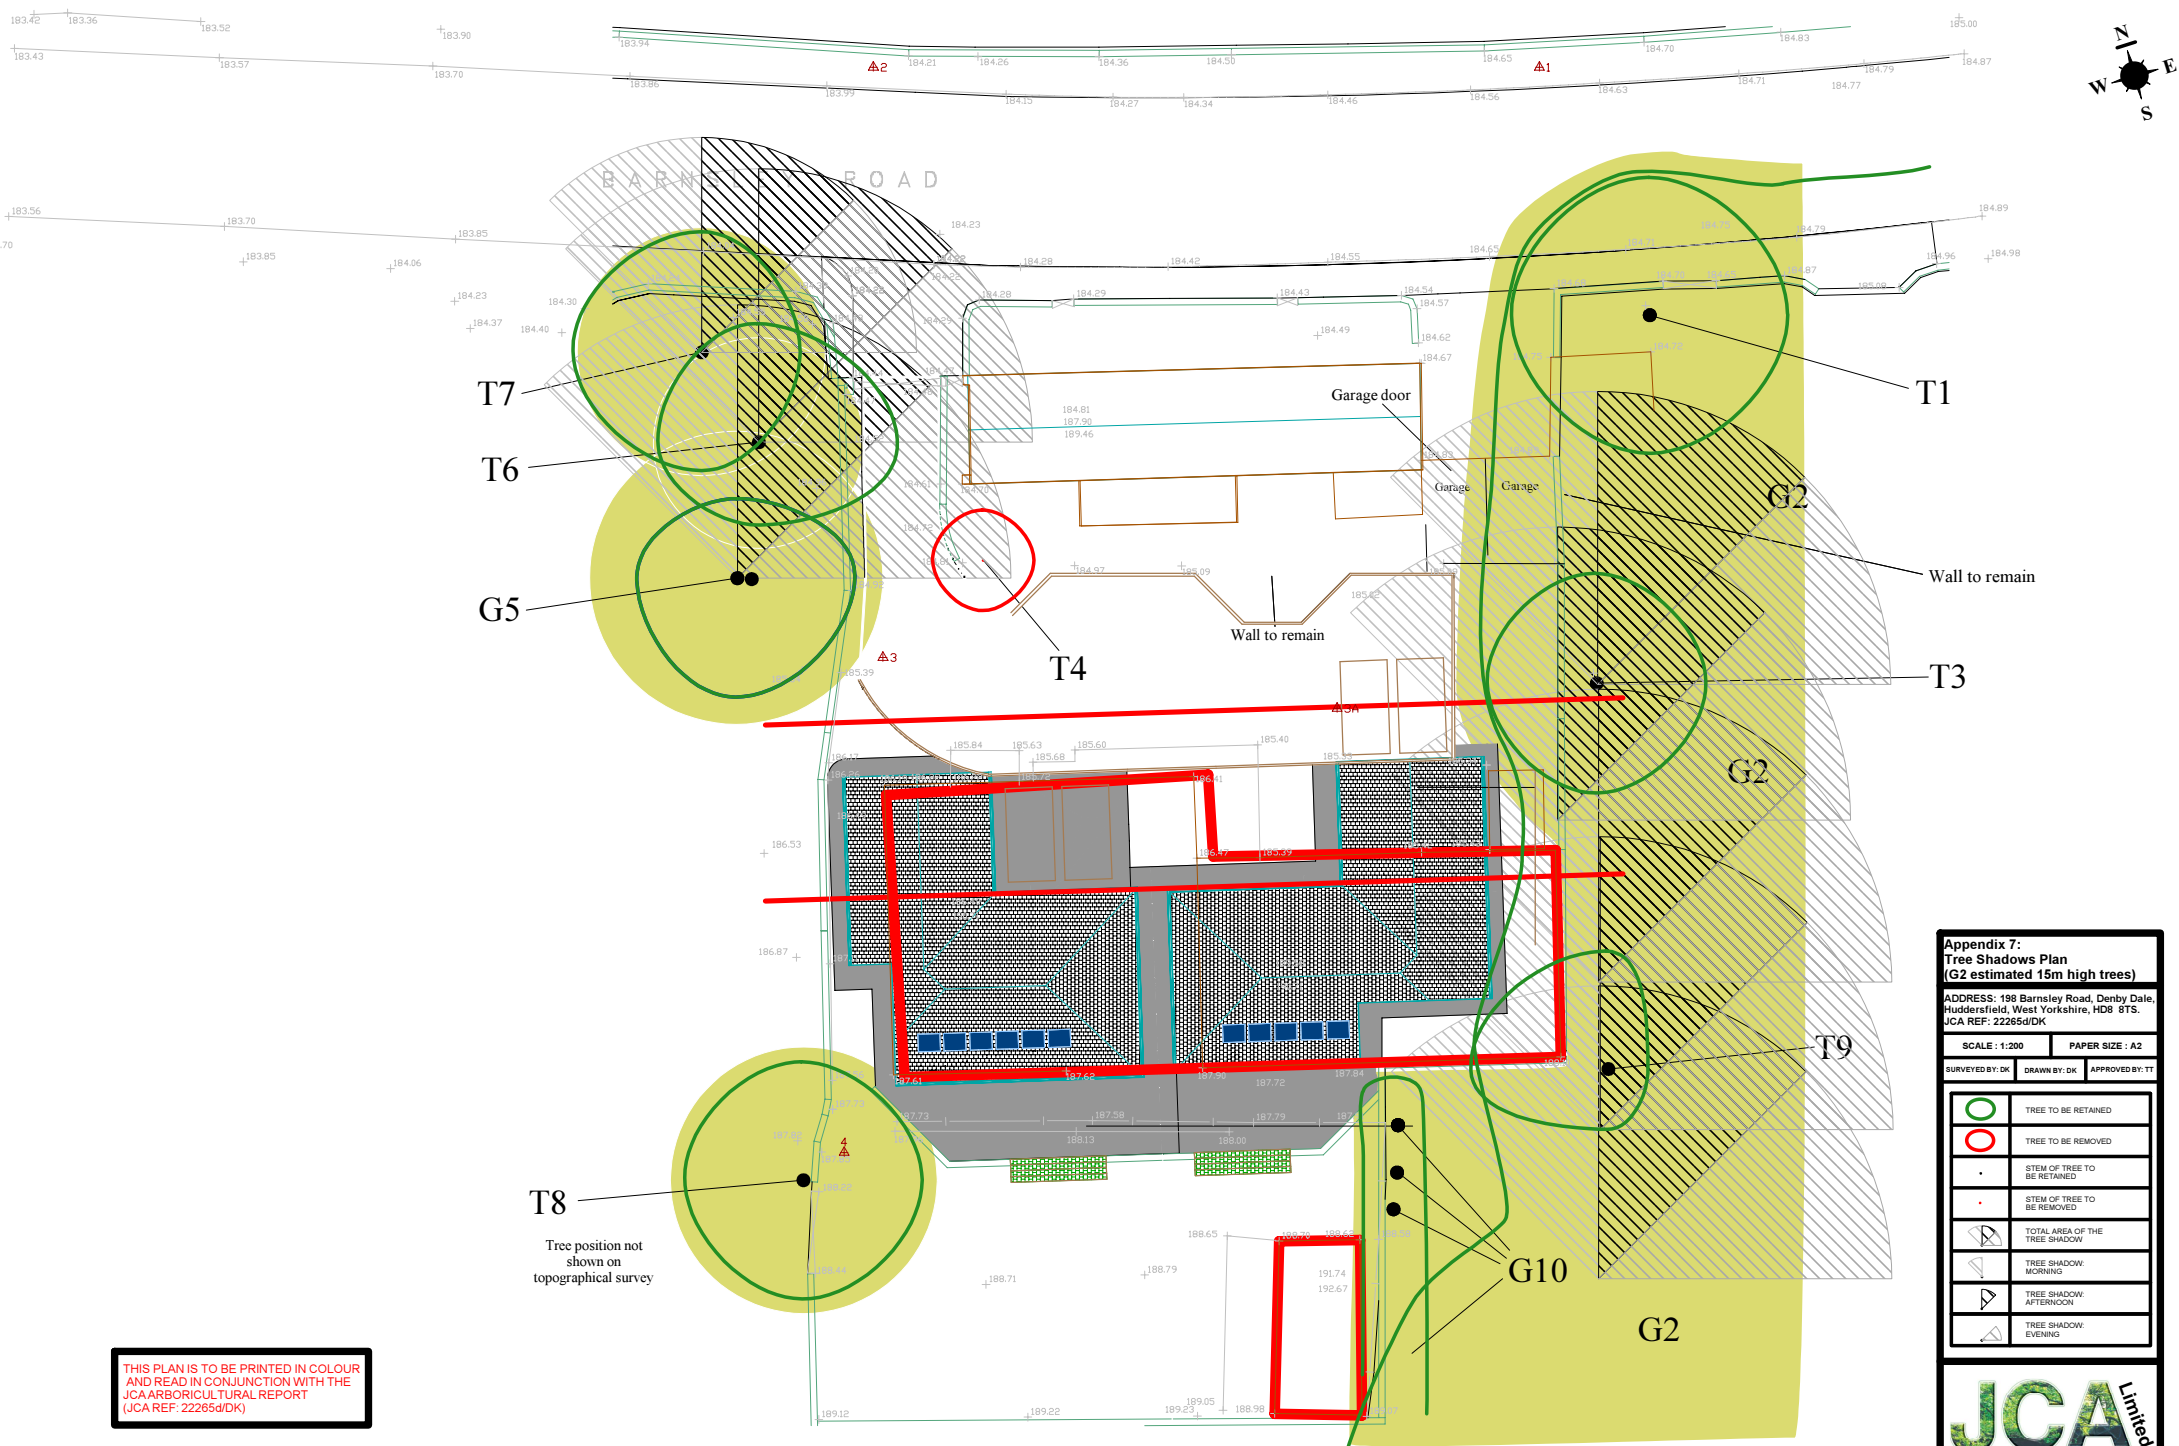
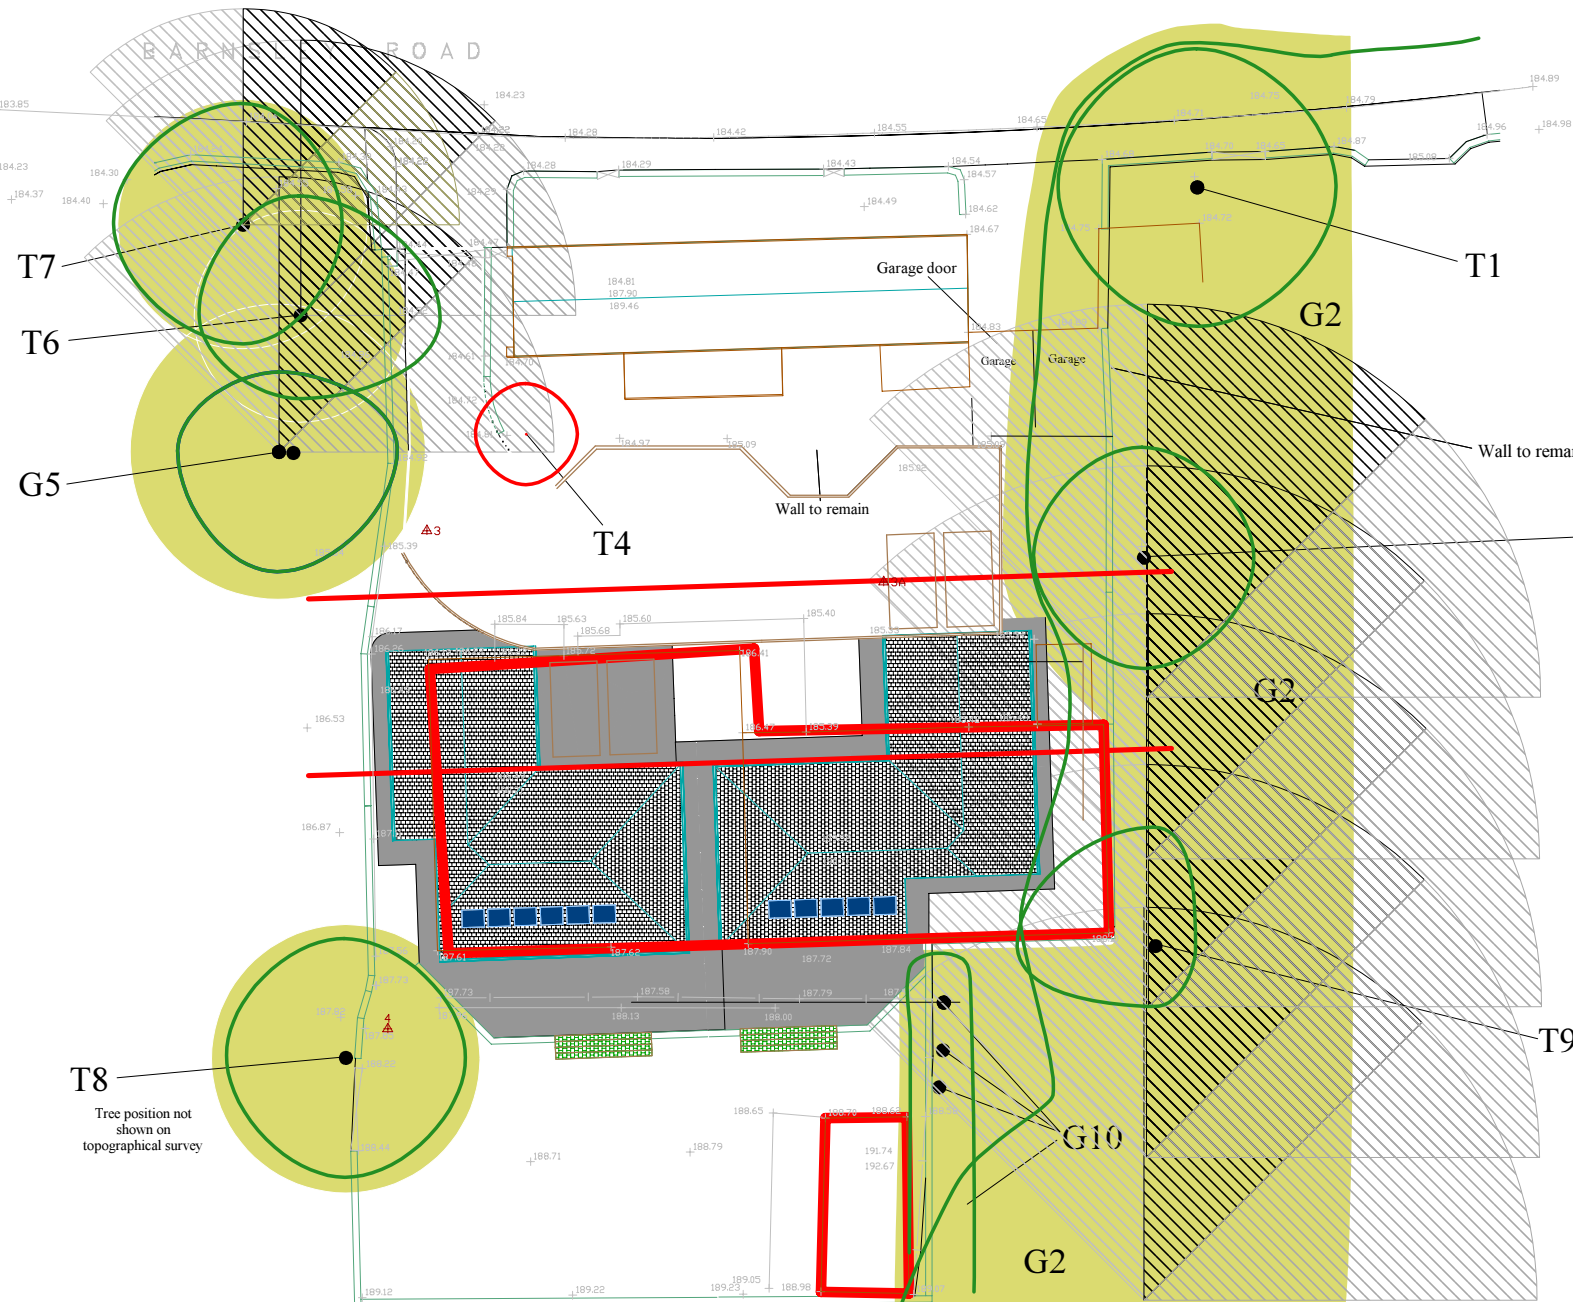
## **Appendix 7: Shade Cast Diagrams**

4.5.5.2 Two shade cast diagrams (**Appendix 7**) have been provided by JCA as part of this report. This shows the general expected areas being shaded from trees being retained, however, if any further investigation and information is required, a shade cast analysis expert should be sought.
