# **ARBORICULTURAL REPORT & Impact Assessment to BS 5837:2012 at:**

***150 Denby Lane,  
Upper Denby,  
HD8 8UN***

Prepared for:  
***R S Solutions Group Limited***

Reference: *AWA6411*

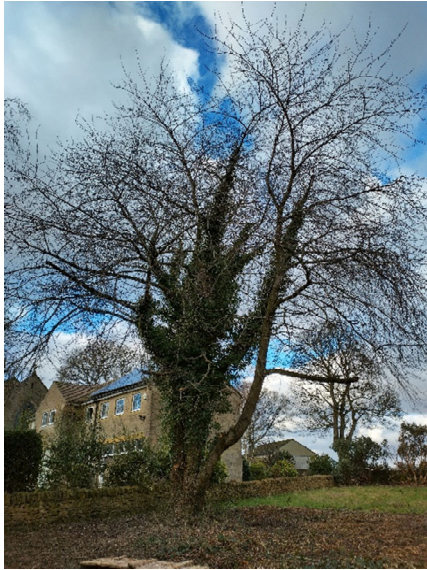
- 3.2.8 Mature Cherry trees T6 and T21 are both large, prominent trees which are situated more centrally within the site, close to the existing building. Both trees have moderate amenity value, however both are in fair condition with dieback and moderate deadwood within their crowns. Due to the size and species of these trees, it is likely they are nearing the end of their useful life.

Photo 1: T6 from south east.

- 4.2.5 T6 and T21 are both mature Cherry trees likely reaching the end of their useful life and are both in fair condition. Cedars T17 and T19, and Birch T20 are all trees situated within a cluster in the north western corner of the site and have all been suppressed by the nearby trees. Pear T26 is a small semi-mature planted individual and Poplar T27 and Poplar and Cherry group G28 are recently established self set individuals, with little value. Due to the low value of the trees to be removed the removals will have only a negligible negative arboricultural impact.

- 4.2.2 The trees that require removal to facilitate the development are T6, T17, T19, T20, T21, T26 and T27.
- 4.2.3 The tree group that requires removal to facilitate the development is G28.

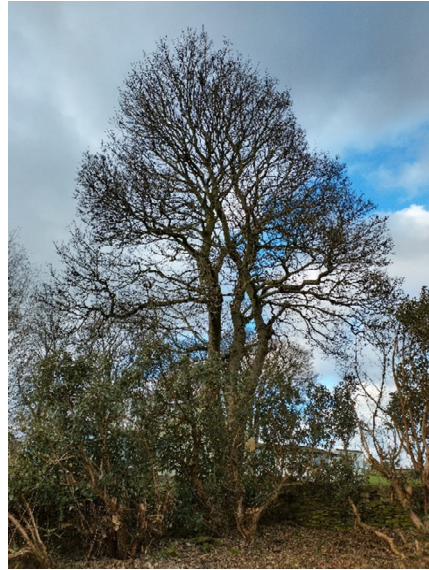
- 3.2.7 Sycamores T3 and T8 are also moderate value trees, both are retention category 'B' trees. Sycamores T3 and T8 are both situated within the adjacent garden on the western side of the site, and so all measurements were estimated due to limited access preventing detailed inspection. Both trees appear to be mature individuals in good condition. T3 is multiple stemmed at the base and is growing very close to the boundary wall, with some stems in contact with the wall. Both T3 and T8 have crowns which overhang into the site.

Photo 2: G7 and T8 from south east.

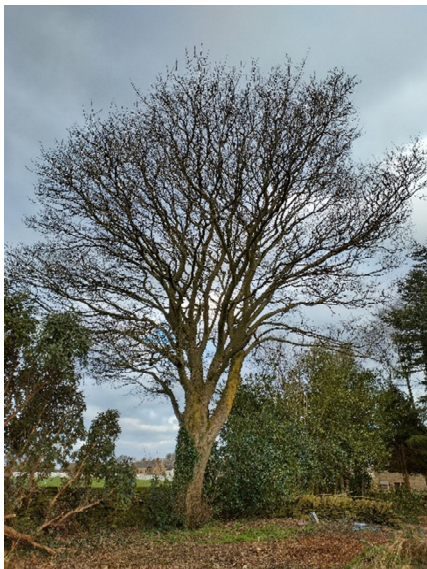
- 3.2.6 The sites most significant tree is Sycamore T9. T9 is situated on the northern border of the site, overhanging the adjacent cricket pitch. T9 is a

prominent, mature tree which appears in good condition, with only minor defects. T9 has moderate amenity value and good long term prospects, and as such is a retention category 'A' tree.

Photo 3: T9 from south west.

- 4.3.2 Potentially damaging activities are proposed in the vicinity of retained trees. The new development encroaches close to and into the edge of the RPA of T9. Construction within the RPA, can have negative impacts on tree roots. However, the encroachment is very minor, and the retained tree should remain largely unaffected by the works, provided care is taken during construction.

| | Tree Species | | | Measurements | | | Crown (m) | | | | Tree Condition | | | | | | | Value | | Management | | |
|---|---|---|---|---|---|---|---|---|---|---|---|---|---|---|---|---|---|---|---|---|---|---|
| T9 | Sycamore | Acer psuedoplatanus | Mature | 18 | 1 | 790 | No | 4 | 7.5 | 7 | 7.5 | 7 | No visual defects | Single stemmed. Vertical. Old pruning wounds. Epicormic growths. Stubs | Old pruning wounds. Minor dieback. Minor deadwood | | Good | Good | >40 yrs | Moderate | A | No works required. |

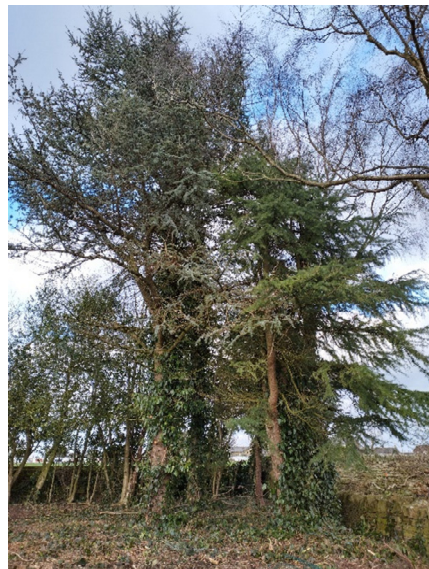
Photo 4: T14 – T16 from south.

| | Tree Species | | | Measurements | | | Crown (m) | | | | | Tree Condition | | | | | | | Value | | Management | |
|---|---|---|---|---|---|---|---|---|---|---|---|---|---|---|---|---|---|---|---|---|---|---|
| T14 | Cypress | Cupressus sp. | Semi-mature | 10 | 2 | 110, 200 | No | 2 | 3 | 1.5 | 1.5 | No visual defects | Twin stemmed at 1m. Vertical. Old pruning wounds. Epicormic growths. Stubs | Old pruning wounds. Minor dieback. Minor deadwood. Unbalanced | Crown raised historically over the adjacent garden. Crown is unbalanced over adjacent garden. Shaded out by adjacent trees. | Fair | Fair | 20 to 40 yrs | Low | C | No works required. | |
| T15 | Silver Birch | Betula pendula | Early-mature | 13 | 1 | 270 | No | 8 | 3 | 2.5 | 2 | 3 | No visual defects | Vertical. Single stemmed. Old pruning wounds. Epicormic growths | Old pruning wounds. Minor dieback. Minor deadwood | Shaded out by adjacent trees. | Fair | Fair | 20 to 40 yrs | Low | C | No works required. |
| T16 | Deodar Cedar | Cedrus deodara | Semi-mature | 13 | 1 | 250 | No | 2.5 | 1.5 | 3 | 3 | 1.5 | No visual defects | Single stemmed. Vertical. Old pruning wounds. Epicormic growths. Stubs. Ivy covered | Old pruning wounds. Minor dieback. Minor deadwood | Shaded out by adjacent trees. | Fair | Good | 20 to 40 yrs | Low | C | No works required. |

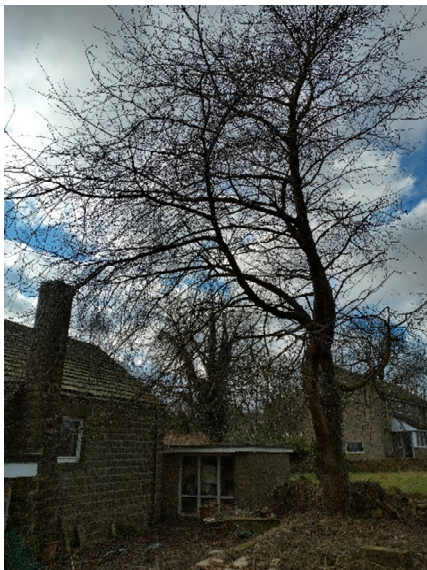
Photo 5: T21 from north east.

| Tree Species | | | | Measurements | | | Crown (m) | | | | Tree Condition | | | | | | | Value | | Management | | |
|---|---|---|---|---|---|---|---|---|---|---|---|---|---|---|---|---|---|---|---|---|---|---|
| T21 | Cherry | Prunus sp. | Mature | 17 | 1 | 700 | No | 2 | 3 | 9.5 | 7 | 9 | No visual defects | Single stemmed. Vertical. Old pruning wounds. Epicormic growths | Old pruning wounds. Minor dieback. Minor deadwood | Ivy beginning to establish on stem. Crown in contact with house to south | Good | Fair | 20 to 40 yrs | Moderate | C | Removal required to facilitate the development. |

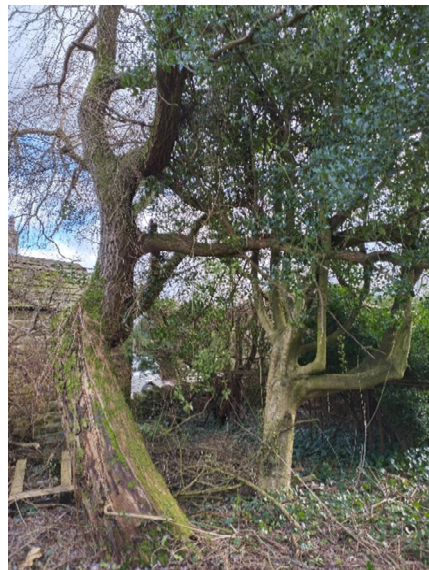
- 3.2.9 Willow T22 is the only retention category 'U' tree at the site. T22 is leaning significantly with major historical snapouts evident. Several cavities exist on the stem and within the crown, with moderate deadwood overhanging the adjacent property. The crown of T22 is in contact with the existing property at the site and the neighbouring garage. As such, T22 is recommended for removal regardless of any development works at the site.

Photo 6: T22 from north west.

| Tree Species | | | | Measurements | | | Crown (m) | | | | Tree Condition | | | | | | | Value | | Management | | |
|---|---|---|---|---|---|---|---|---|---|---|---|---|---|---|---|---|---|---|---|---|---|---|
| T22 | Willow | Salix sp. | Mature | 10 | 1 | 540 | No | 3 | 3.5 | 6 | 4.5 | 6 | No visual defects | Single stemmed. Significant lean. Epicormic growths. Old pruning wounds. Stubs. Minor cavities | Old pruning wounds. Cavities. Moderate dieback. Minor deadwood. Moderate deadwood. Snapped /hanging branches. Unbalanced. Overhanging adjacent land | Heavily unbalanced and leaning east over adjacent garage. Evidence of previous snapouts and moderate deadwood overhanging the adjacent garage. | Fair | Poor | <10 yrs | Low | U | Removal recommended regardless of any development works at the site. |

- 4.2.6 Willow T22 is also recommended for removal regardless of any development work that occurs at the site, due to its poor condition.
