Our Ref: HBB/01/JRjcl1

17<sup>th</sup> April 2025

Forge Lane, Dewsbury  
Coal Mining Risk Assessment

Project  
 LAND AT FORGE LANE  
 DEWSBURY

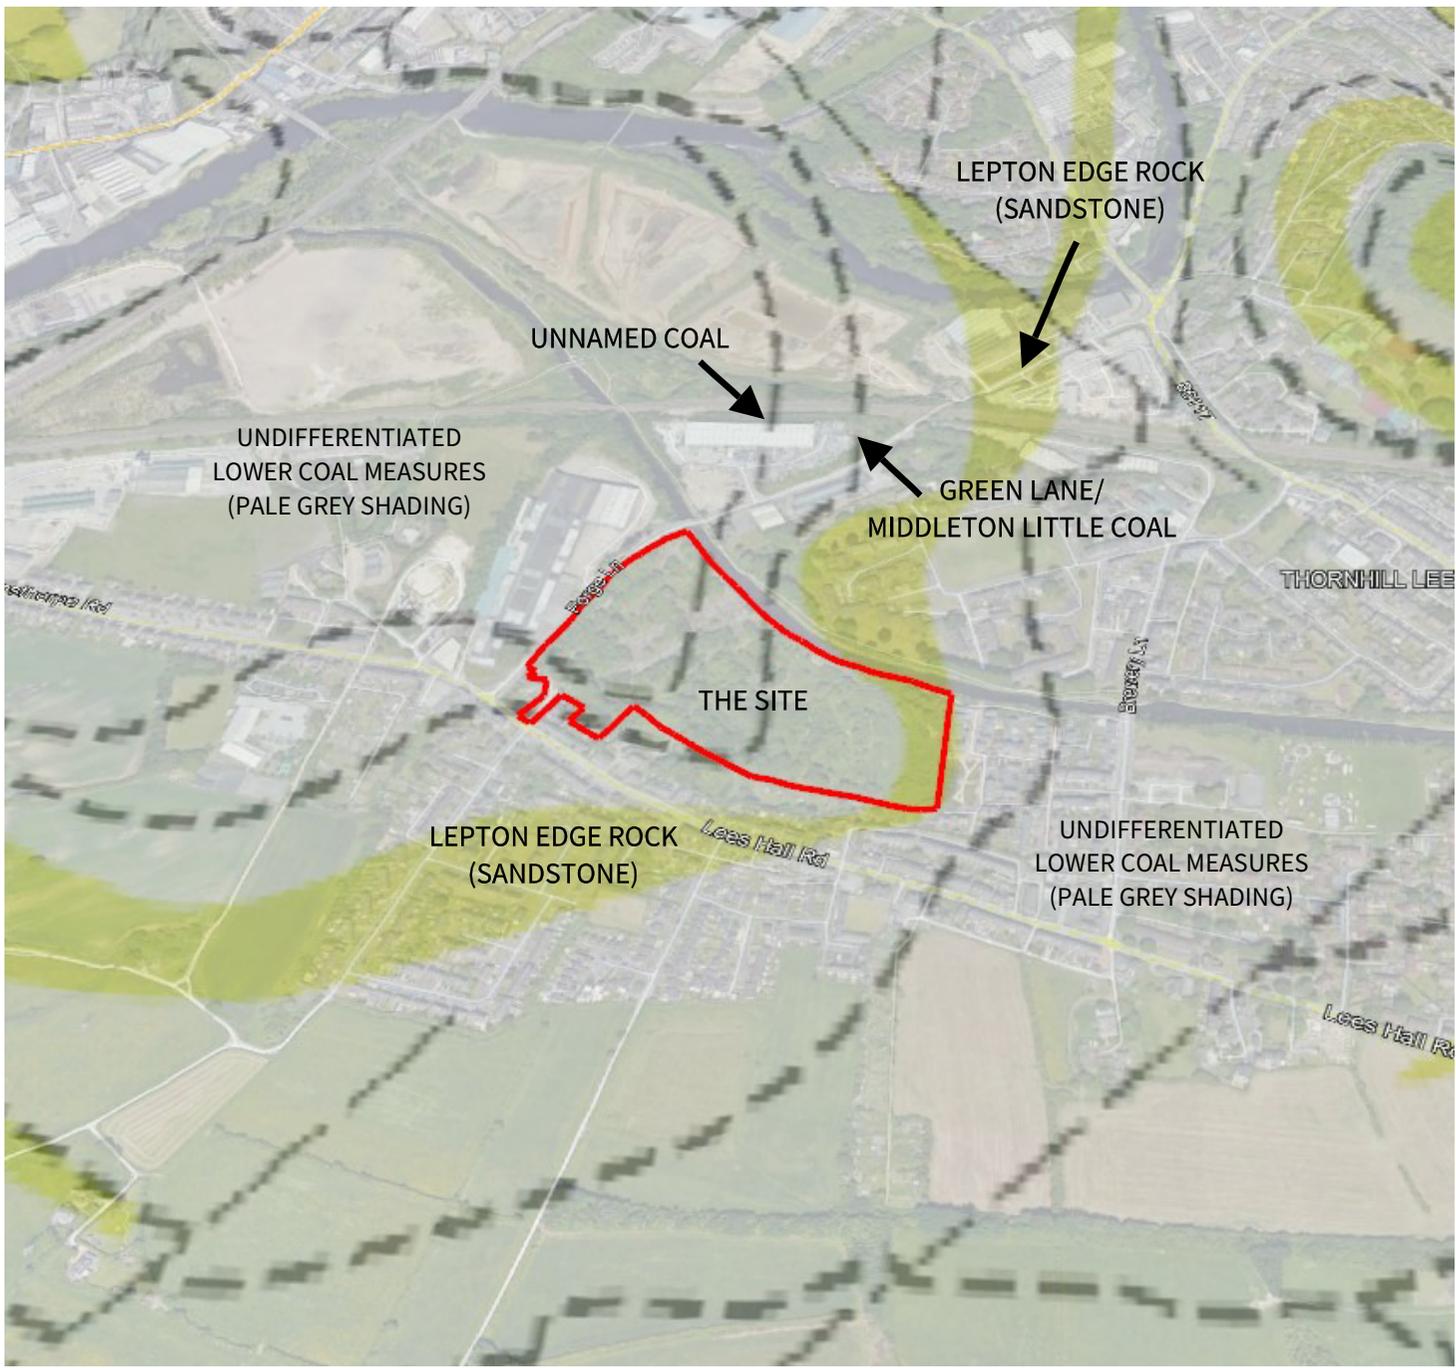
Title  
 OBLIQUE VIEW  
 GEOLOGICAL MAP

The maps show most of the site to be underlain by undifferentiated strata (mudstones, siltstones and minor sandstones) of the Pennine Lower Coal Measures of the Carboniferous Period. The eastern margins of the site are shown to be underlain by Lepton Edge Rock (sandstone), also of the Pennine Lower Coal Measures. Superficial deposits of alluvium (usually poorly consolidated clay, silt, sand and gravel, sometimes with peat) are shown to overlie the bedrock geology, and river terrace deposits of sand and gravel are shown close to the site, which may underlie the alluvium. No faults are shown on or near the site.

Two coal seams are conjectured to sub crop on the site, both trending approximately north to south, turning west near/at the southern boundary. The eastern seam is shown to be the Green Lane/Middleton Little Coal, with a thickness of between 0.3m and 0.7m in the locality. The western seam is unnamed, with a thickness up to 0.4m. The Generalised Vertical Section on the 1:10,00 map shows the unnamed seam is the lower of the two in the succession, and the next shallowest seam (beneath the unnamed seam) is 15m deeper, named the New Hards/Middleton Main Coal (thickness 0.2m to 0.4m in the locality). A further unnamed coal up to 0.4m thick is present 10m below this, and a further 8m down is the Wheatley Lime Coal (0.7m to 1.2m thick), with the Middleton Eleven Yards Coal (up to 0.8m thick) 5m below this.
