**Arboricultural Impact Assessment  
54 Victoria Street  
Clayton West Huddersfield  
HD8 9NW**

Report Reference: AIA-2121-1  
6 March 2025

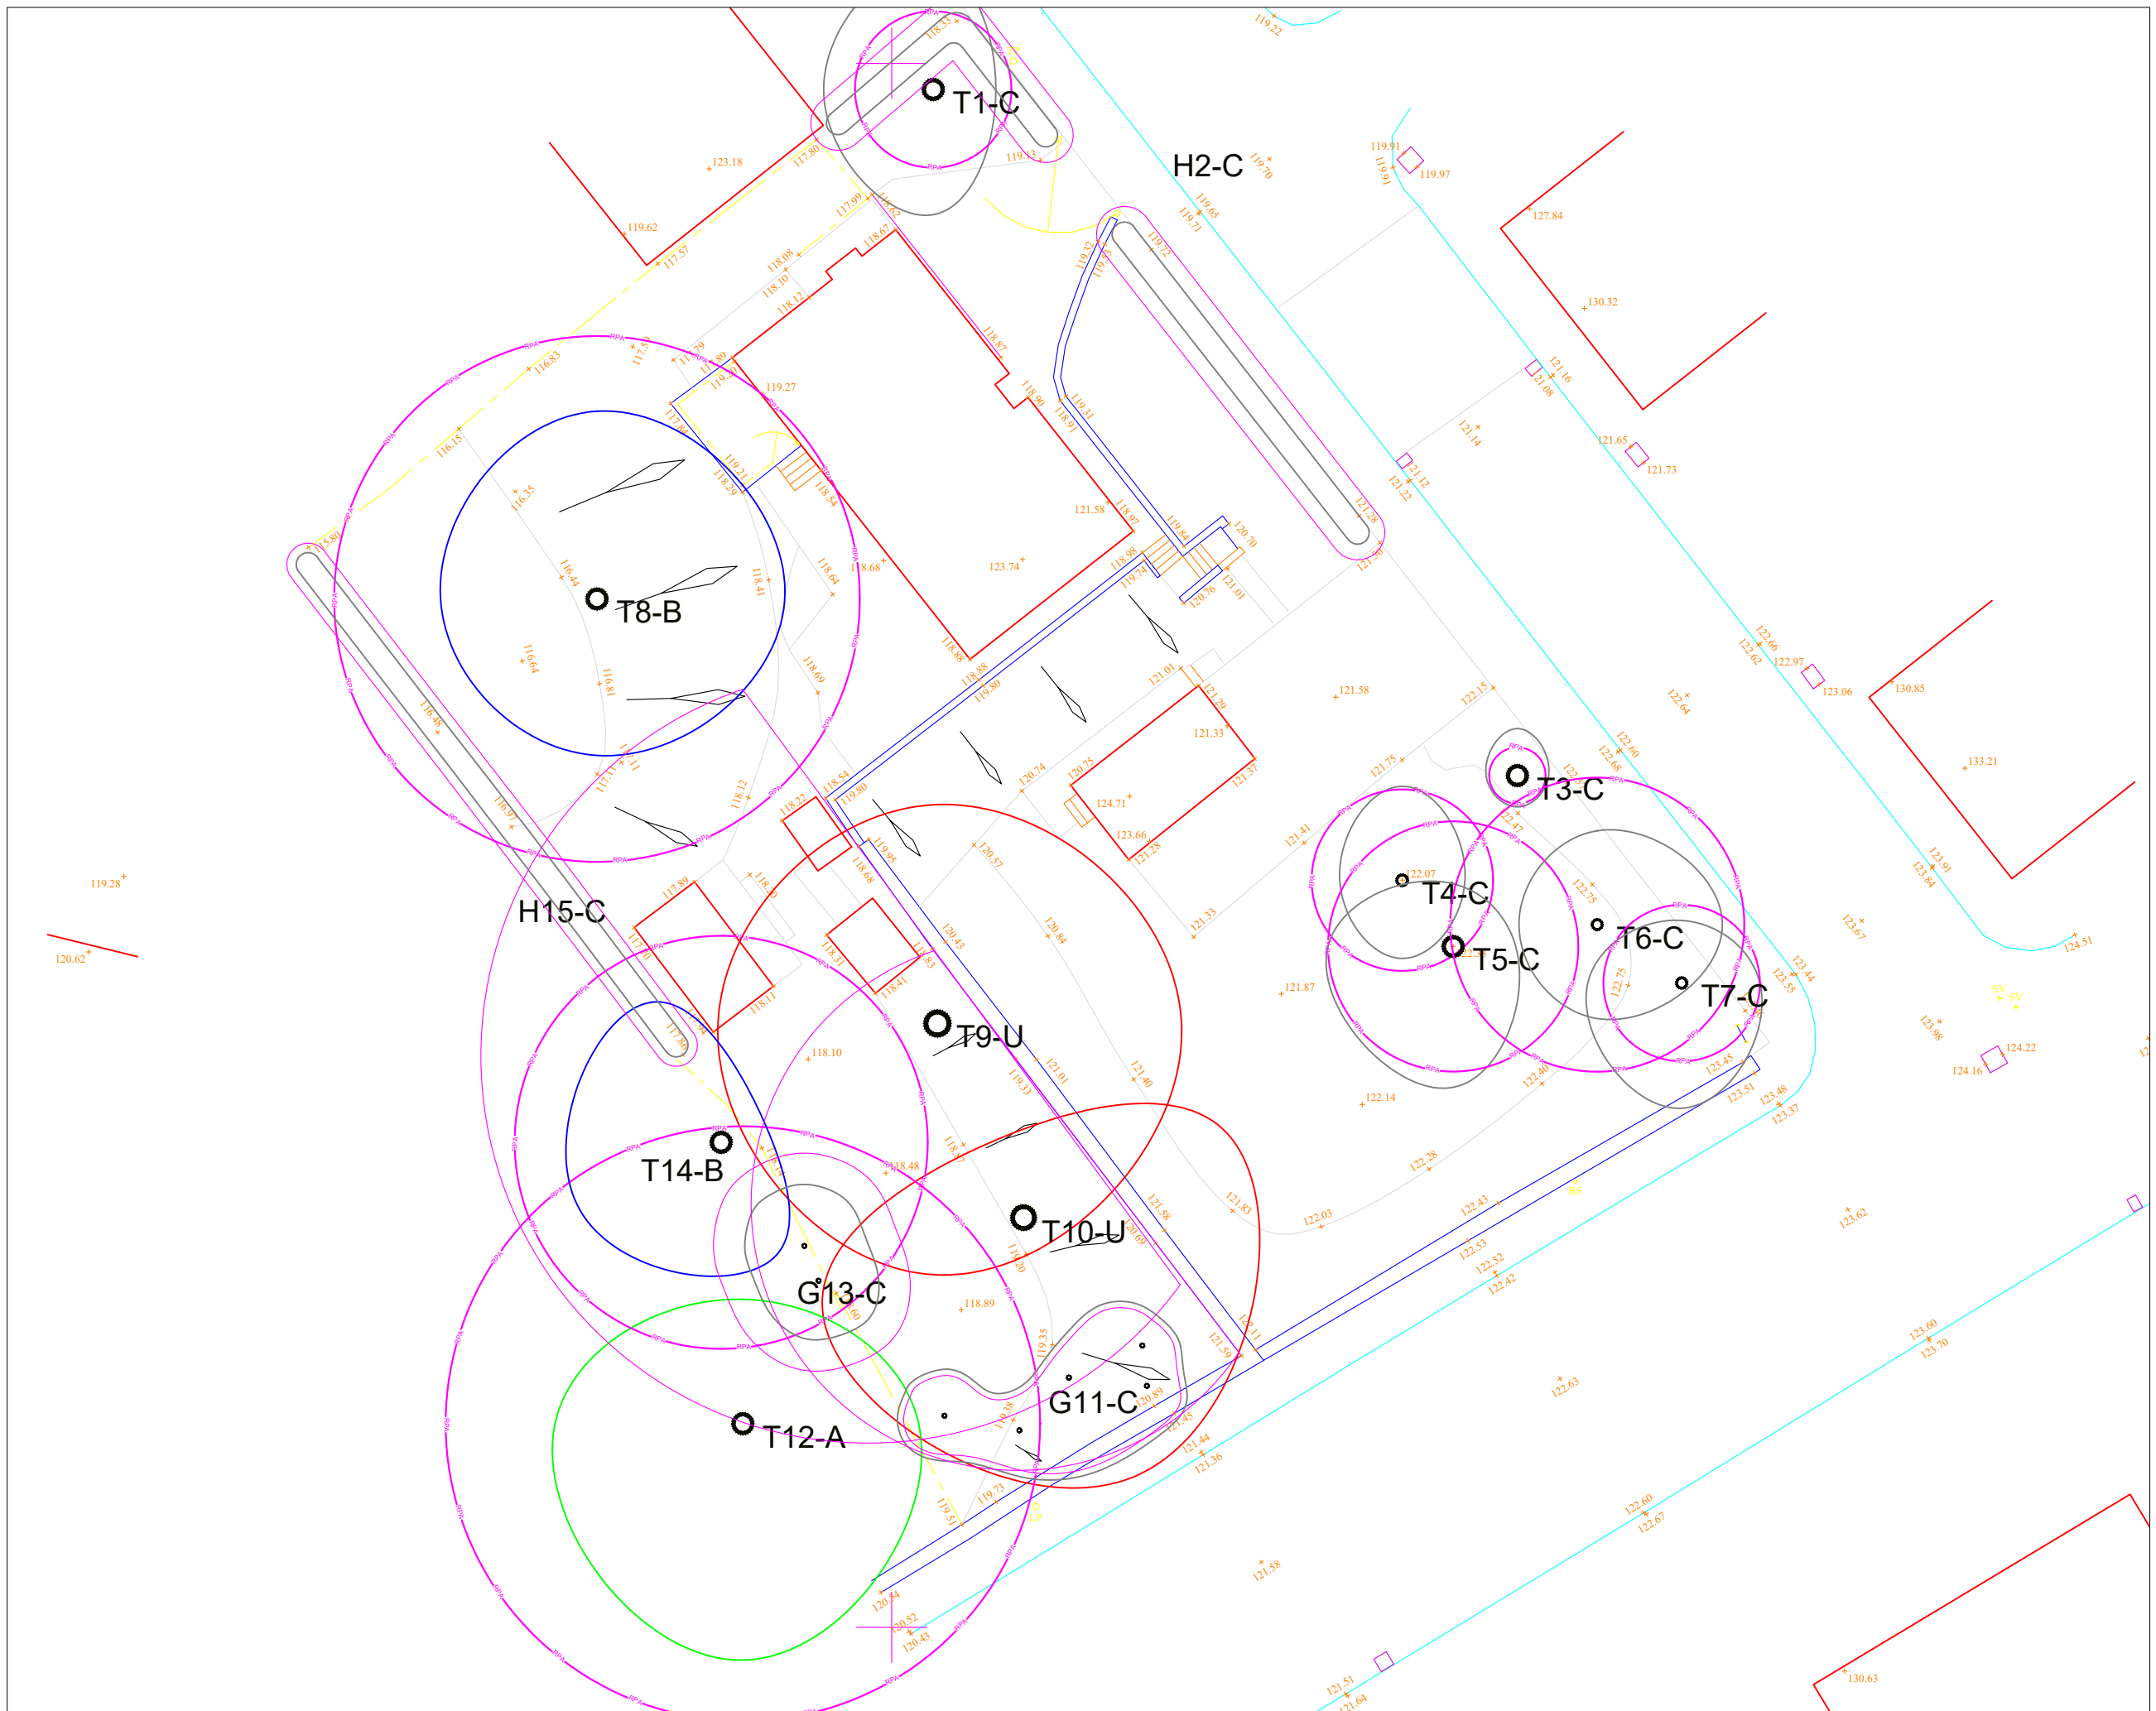
### Tree Constraints Plan

- 3.4.1 The area of roots that need to be protected around a tree to try to ensure it does not suffer damage during the construction process is called the Root Protection Area (RPA).
- 3.4.2 As recommended in BS5837 we have plotted the RPAs (in magenta) onto the TCP and TIP taking full account of the surrounding topographical factors, tree condition and the likely root disposition. Notwithstanding the recommended removal of T9 and T10 on arboricultural management grounds, for transparency the TCP and TIP indicate RPA's for each of the two trees that are likely to have been influenced by the presence of retaining wall that divides upper and lower areas of the site.
- 3.4.3 Accepting the proposed removal of trees T3-T10 there are no foreseeable conflicts between the proposed development footprint and the RPA's of all other retained trees and hedgerows.

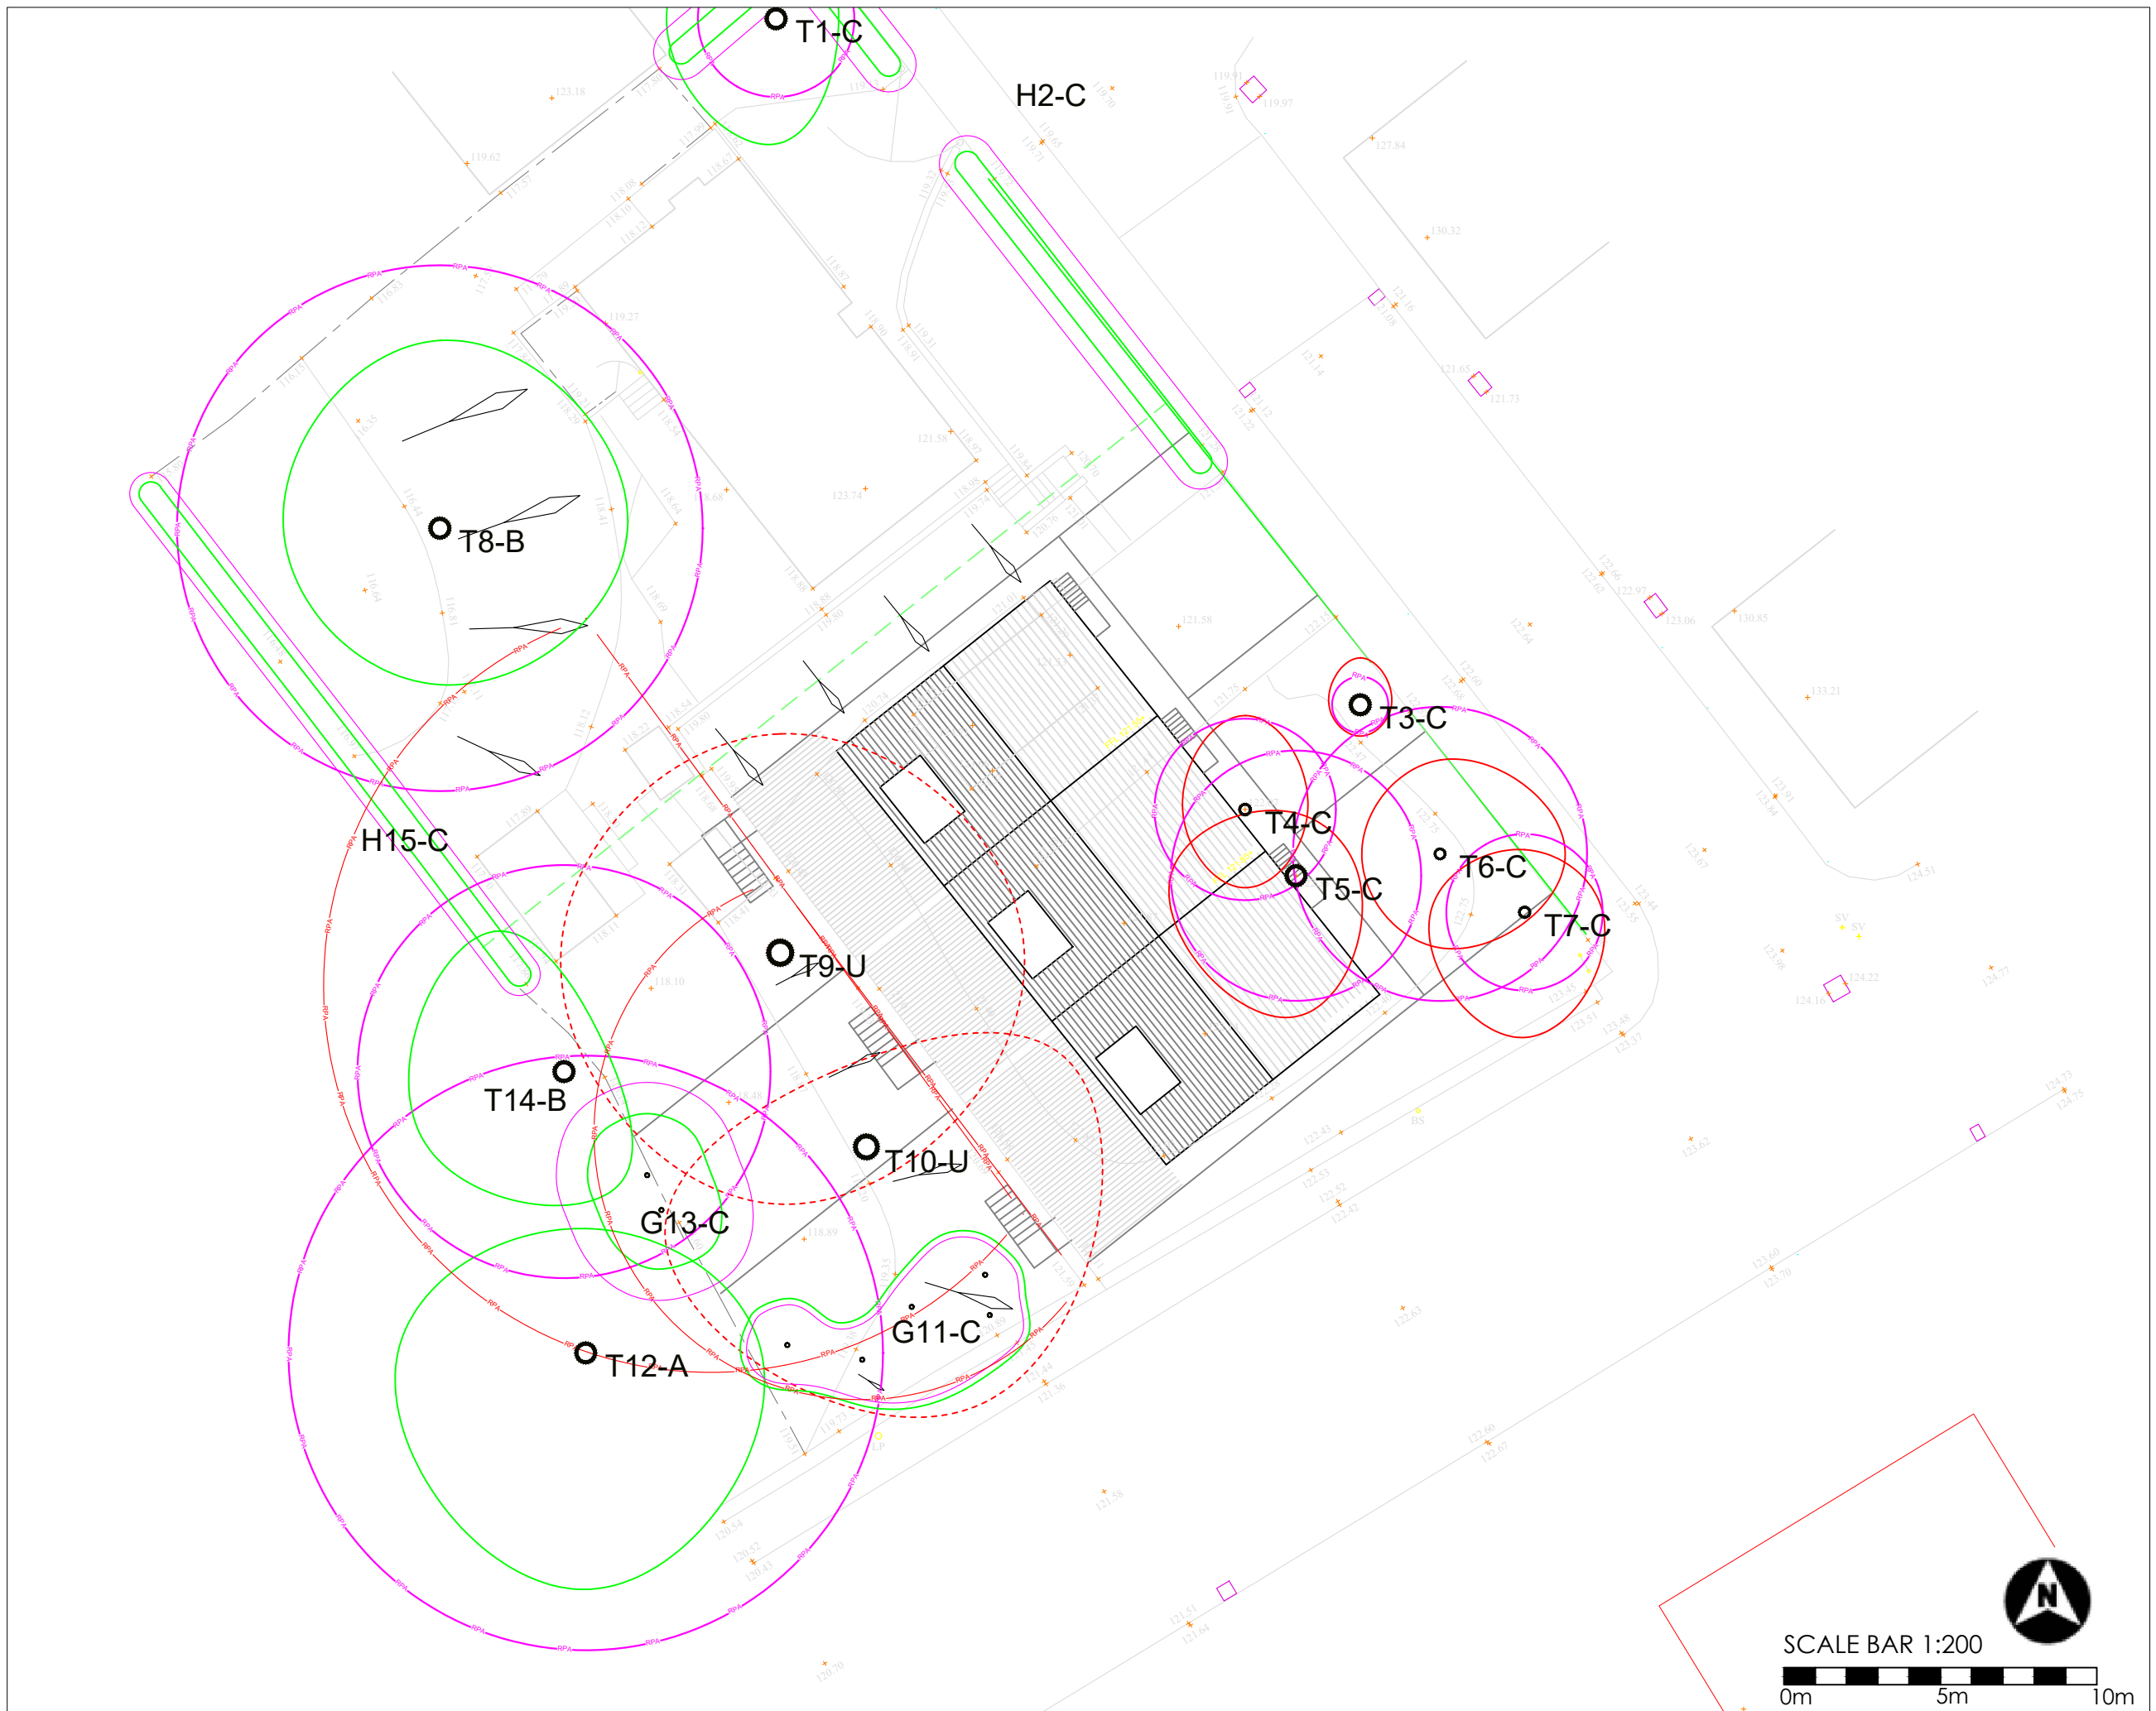
### Tree Impact Plan

3.2.1 As detailed Table 2 below Sycamore trees T9 and T10 were found to be seriously defective and quite reasonably afforded category "U". Moreover the trees contain serious structural and physiological defects such they will require removal in the relative short term. As such the removal of both trees is warranted irrespective of the development proposal now under consideration.

3.3.1 As highlighted in table 2 below, the removal of low category "C" trees T3, T4, T5, T6 and T7 will be required for the purpose of implementing the proposal. The stature of these trees is such that their removal will have a minor impact on the local streetscene. Nevertheless scope exists to plant 2No. trees at either end of the Victoria Street site frontage. In addition there is scope to establish a hedgerow fronting Chapel Hill. Such planting will mitigate the necessary loss of the frontage trees.

- 3.6.1 A protective fence and ground protection will be installed prior to the commencement of any site works e.g., before demolition, machinery and materials are delivered to site. Tree protection fencing will have signs attached to it stating that this is a Construction Exclusion Zone (CEZ) and that NO WORKS are permitted within the CEZ. The tree protection fence will only be removed following completion of all construction works.
- 3.6.2 The positioning and implementation of protection can be effectively controlled by imposition of a suitably worded planning condition.
