15 Towngate, Marsden, Huddersfield HD7 6DD
Design and Access Statement / Heritage Statement

Submitted to Kirklees Council on
behalf of Miss Clarke & Mr Leigh-
Jones

March 2025

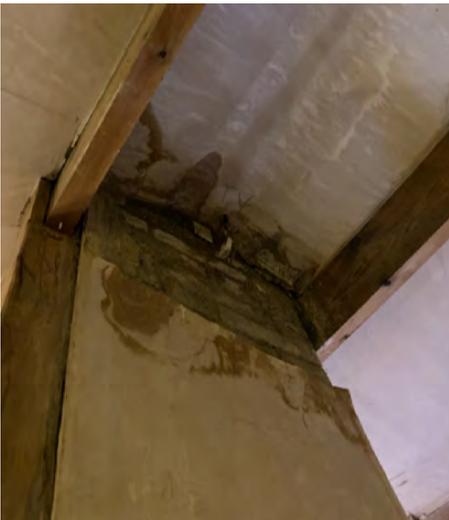
Leaks around chimney stack, 5 Feb 2025

Flashings around the chimney require repair work as there have been some leaks.

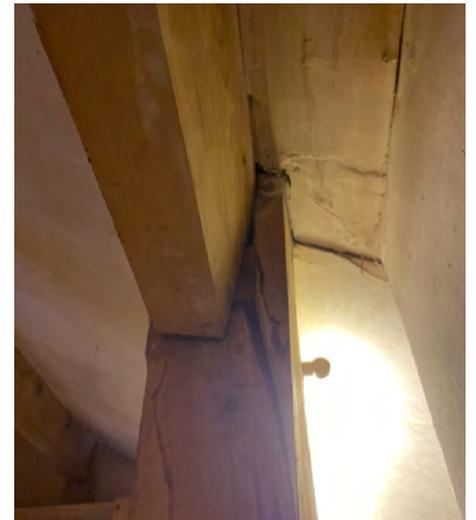
Split post at purlin junction 5 Feb 2025

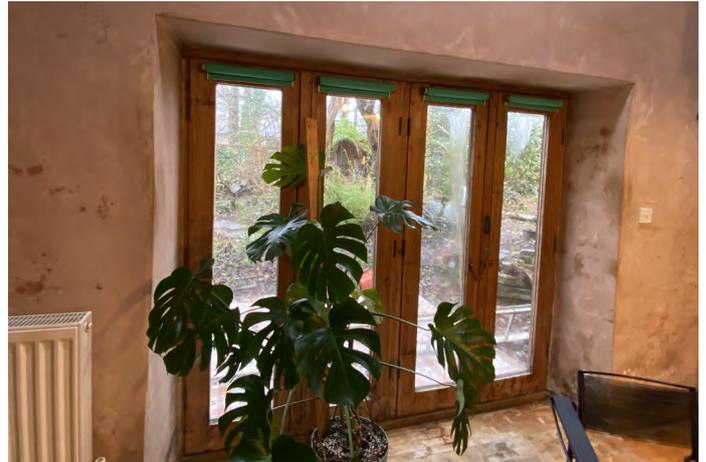
DS2/3
 c.1983 double glazed timber doors. Crack noted in glass

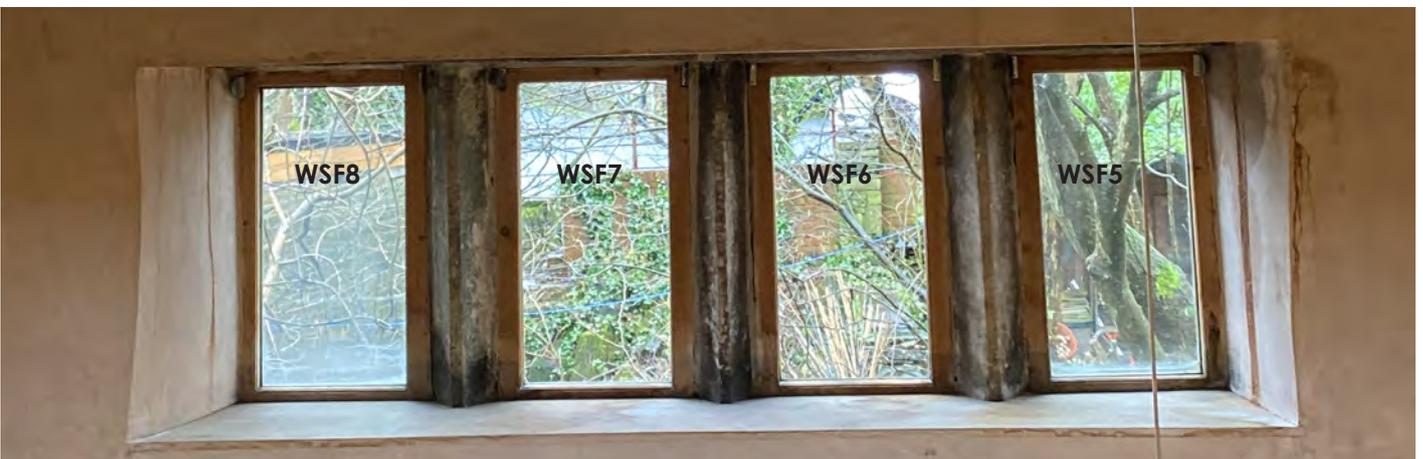
WSF8
 c.1983 double glazed
 timber window, fixed,
 seals in unit defective

WSF5
 c.1983 double glazed
 timber window, fixed,
 seals in unit defective

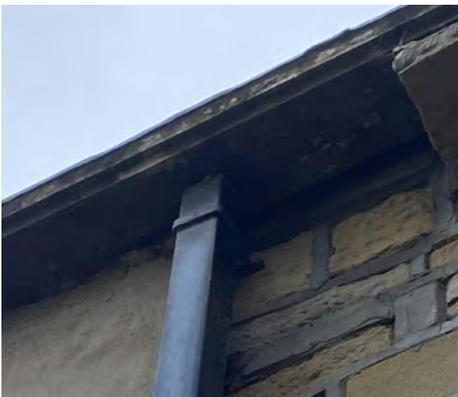
Hard render, probably cement based, cement strap pointing, PVC downpipe and leaking gutters, all to be improved in the proposals

Several areas of the building require repairs and maintenance work. Gutters are leaking and rainwater goods generally require improvement. Historic photos from before the refurbishment in the 80s show cast iron hoppers and downpipes from the timber gutters. The existing PVC downpipes detract from the listed building and are defective. Hoppers were present before the 1980s works but were removed. Hoppers help to improve the flow of rainwater in heavy rainfall and new cast iron hoppers and downpipes are therefore proposed for the building, in the existing positions.

Render on the external walls is defective in many areas and re-rendering is proposed, with improved breathability by using lime renders. This also offers the opportunity to enhance the thermal performance by using insulating lime render. Strap cement pointing shall be removed and re-pointed using lime mortar, to reduce the problems caused to the stonework by the overly hard pointing. Similarly, internal plasterwork is defective in several areas and is to be replaced as required using lime plasters and breathable paints.

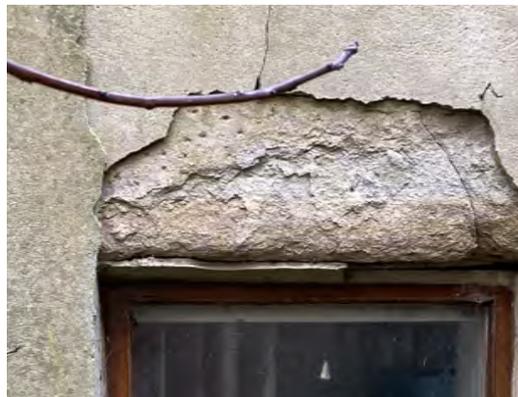
Layers of defective render / cracked lintel, rear elevation

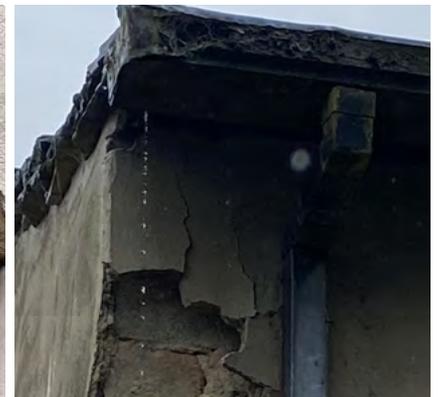
Leaking gutter, defective render, PVC downpipe.

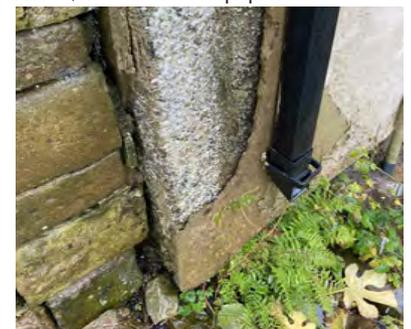
Layers of poor render, high discharge of pipe above gully
