1162 – 16 Towngate
Upperthong

**BS 5837:2012 Arboricultural
Report, Impact Assessment
and Method Statement**

Site: 16 Town Gate, Upperthong, HD9 3UX
 Report: BS 5837:2012 Arboricultural Report, Impact Assessment and Method Statement
 Reference: 1162
 Client: Cameron Sanderson
 Issue Date: 28/02/2025
 Produced By:

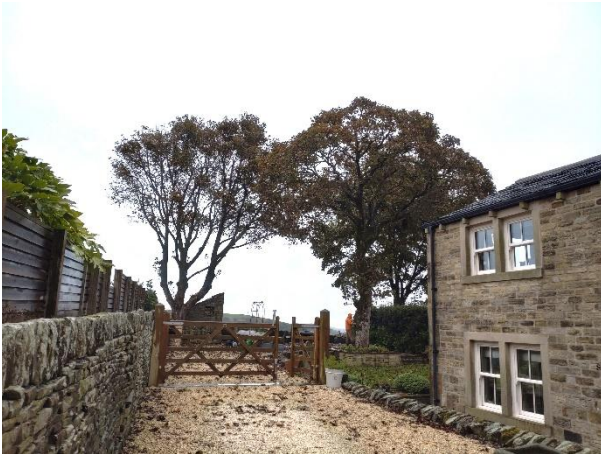
- 4.6 The Trees T002 and T003 were both growing within small planting areas, in close proximity to recent landscaping works including the driveway and lawn areas.

- 4.7 The previous landscaping works in these areas may have caused some root damage in the past, and the extent of subsequent root growth may have been restricted by newly installed retaining features and the compaction of the underlying soil beneath the gravelled driveway. As such the calculated RPA of T002 and T003 is likely to be an exaggerated representation of their actual rooting area.

Photo 1: T002 and T003 from the South

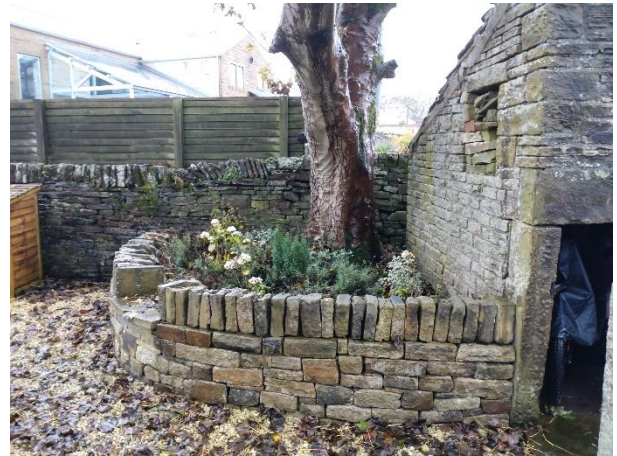
5.7 If works are required to the southern wall of the existing outbuilding care will be required, as this forms part of the retaining wall supporting the raised bed in which T003 is growing. The advice of a structural engineer may be required to ensure that the structural integrity of this retaining structure is not compromised.

5.8 As works will be required in such close proximity to the stem of T003, some form of protection will be needed, such as a stem protection box, to avoid the potential for accidental damage occurring.

| Tree No. | Species | Height (m) | No. of Stems | Stem Dia. @ 1.5m (mm) | Crown Spreads (m) | | | | Height of Crown Clearance (m) | Age Class | SLE | Overall Condition | Comments | Management | Category | RPA Radius (m) | RPA Area (m ²) |
|---|--|---|---|---|---|---|---|---|---|---|---|---|---|---|---|---|---|
| T003 | Sycamore (<i>Acer pseudoplatanus</i>) | 14.0 | 1 | 680 | 6.0 | 6.0 | 4.5 | 5.0 | 5.0 | Mature | 20+ Years | Fair | Growing in small raised bed. Multi-stemmed at 1.8m. Pruning wounds on all stems. Epicormic growth on all stems. Minor deadwood throughout. | | B1 | 8.2 | 211 |

Photo 4: T003 stem from the east

The existing outbuilding is located in very close proximity to the otherwise unprotected stem of the retained tree T003. A stem protection box will be required here to avoid the potential for accidental damage to the bark layer of the tree.

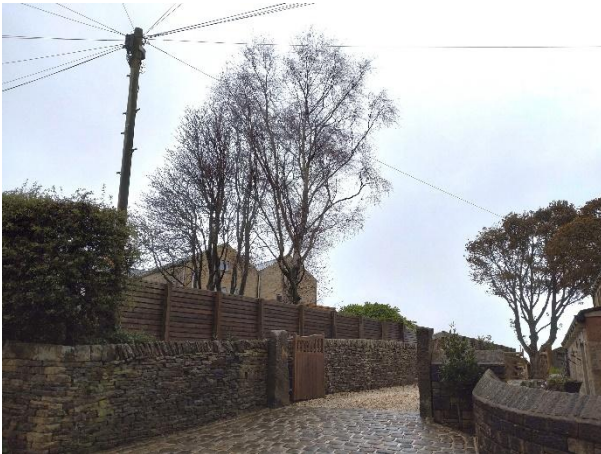
| Tree No. | Species | Height (m) | No. of Stems | Stem Dia. @ 1.5m (mm) | Crown Spreads (m) | | | | Height of Crown Clearance (m) | Age Class | SLE | Overall Condition | Comments | Management | Category | RPA Radius (m) | RPA Area (m ²) |
|---|--|---|---|---|---|---|---|---|---|---|---|---|---|---|---|---|---|
| T001 | Birch (<i>Betula pendula</i>) | 12.0 | 2 | 140, 270 # | 4.0 | 4.0 | 4.0 | 4.0 | 2.0 | Semi Mature | 40+ Years | Fair | Located in neighboring garden. Growing in ground approx 50cm higher than in the site. Limited visibility due to boundary fence. Epicormic growth at base. Many old pruning wounds. Minor deadwood throughout. | | B1 | 3.6 | 41 |

Photo 2: T001 from the south east

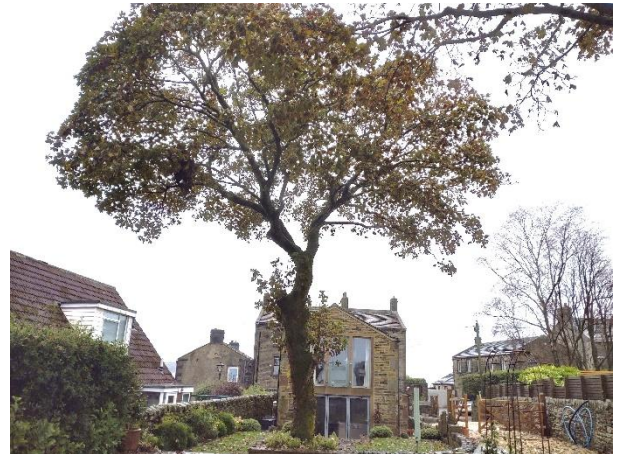
| Tree No. | Species | Height (m) | No. of Stems | Stem Dia. @ 1.5m (mm) | Crown Spreads (m) | | | | Height of Crown Clearance (m) | Age Class | SLE | Overall Condition | Comments | Management | Category | RPA Radius (m) | RPA Area (m ²) |
|---|--|---|---|---|---|---|---|---|---|---|---|---|---|---|---|---|---|
| T002 | Sycamore (<i>Acer pseudoplatanus</i>) | 12.0 | 1 | 540 | 4.5 | 4.0 | 4.0 | 4.0 | 4.0 | Early Mature | 20+ Years | Fair | Growing in slightly raised 1.2m wide square planted bed. Old pruning wounds on main stem. Epicormic growth at 2m to 3m. | | B1 | 6.5 | 133 |

Photo 5: T002 from the north

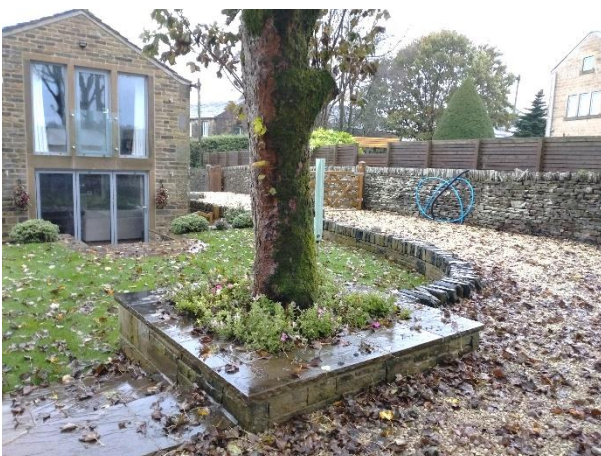
Photo 3: T002 stem from the north east

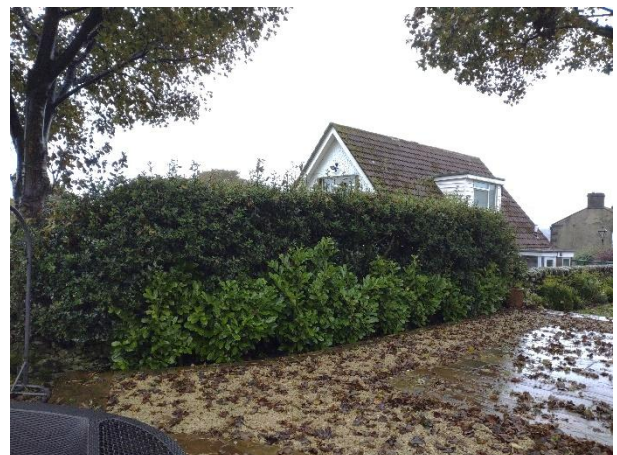
| Tree No. | Species | Height (m) | No. of Stems | Stem Dia. @ 1.5m (mm) | Crown Spreads (m) | | | | Height of Crown Clearance (m) | Age Class | SLE | Overall Condition | Comments | Management | Category | RPA Radius (m) | RPA Area (m ²) |
|---|---|---|---|---|---|---|---|---|---|---|---|---|--|---|---|---|---|
| T004 | Sycamore (<i>Acer pseudoplatanus</i>) | 14.0 | 2 | 380, 430 # | 5.0 | 5.0 | 5.0 | 5.0 | 3.0 | Early Mature | 40+ Years | Fair | Located in neighbouring garden. Growing in ground approx 1m lower than in site. Lifting flag stones at base. Twin stemmed at 1.5m with included bark union. Several old pruning wounds on stems. | | B1 | 6.9 | 150 |
| H005 | Laurel (<i>Prunus laurocerasus</i>) Holly (<i>Ilex aquifolium</i>) | 2.0 | >10 | 60 avg | See Plan | | | | 0.0 | Semi Mature | 40+ Years | Good | Well maintained holly hedge. Under planted with laurel. | | C2 | - | - |

Photo 6: T004 and H005 from the west

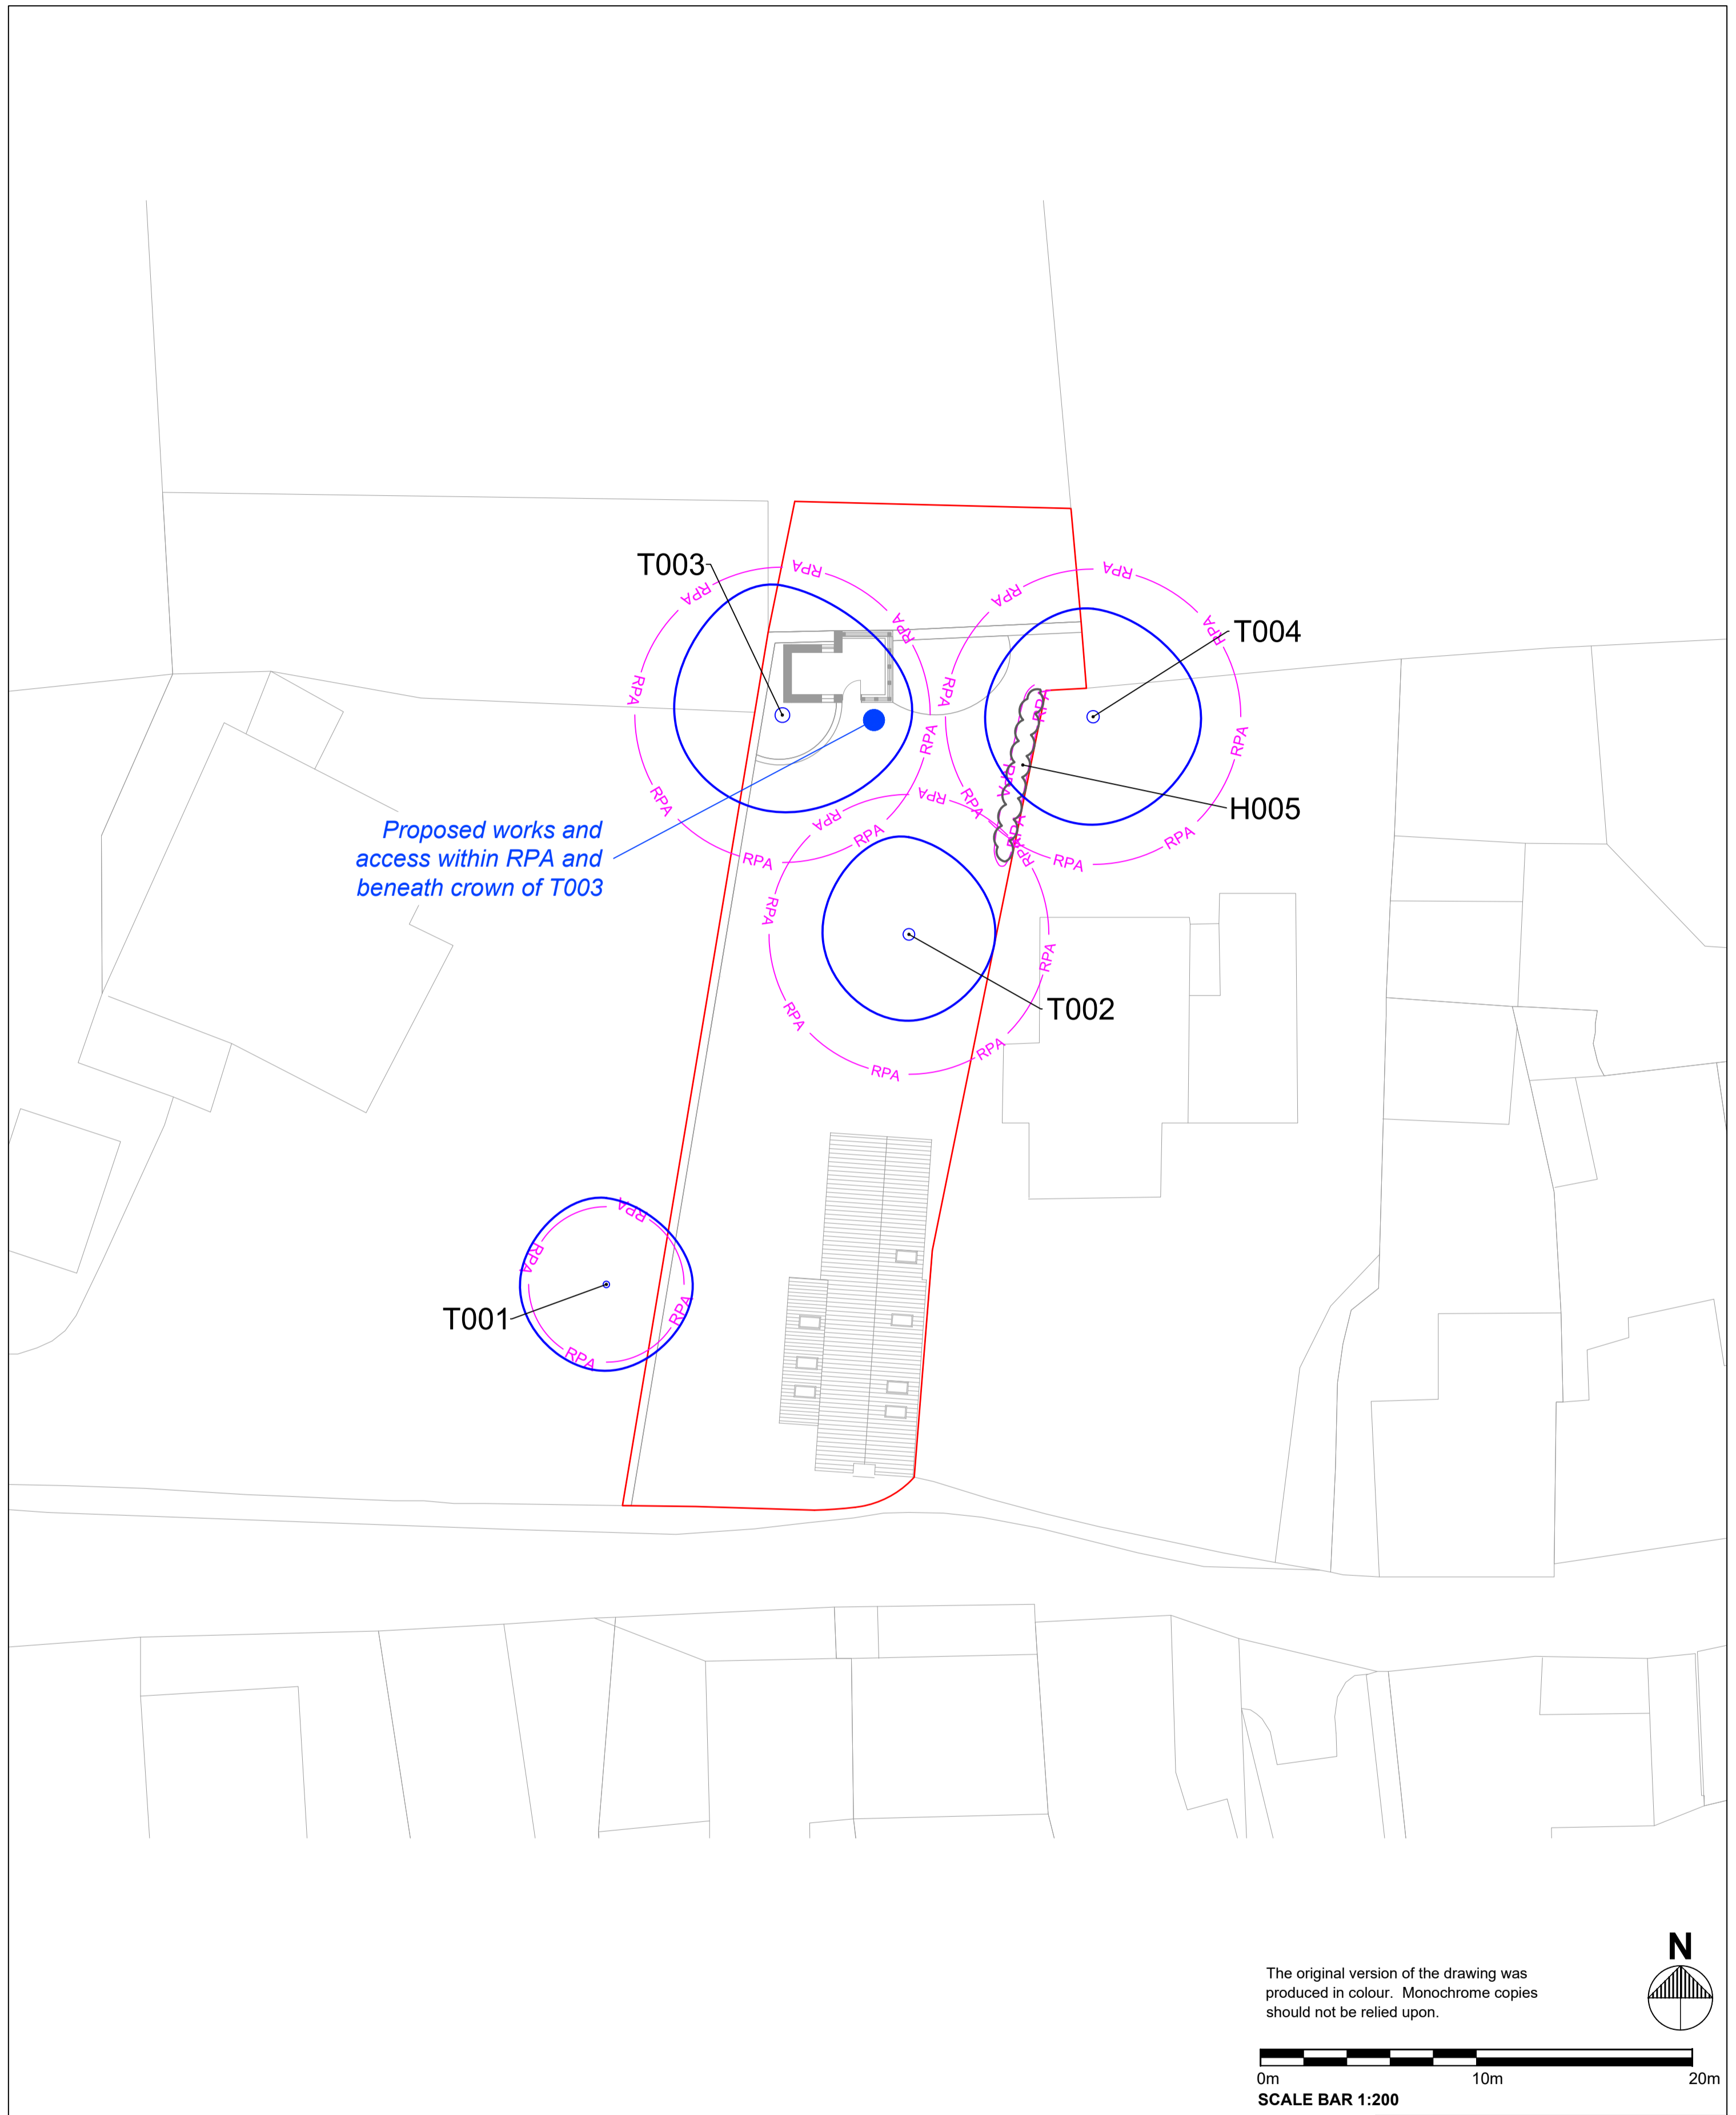
| Figure 3 - Tree Impacts Plan | | 1162-TAL-02 | |

5.6 The proposed works and the access for machinery and materials fall within the RPA of the retained tree T003, as shown on the Tree Impacts Plan at Appendix 3. As there is existing hard surfacing throughout this area there are unlikely to be any significant impacts to any tree roots which may be present here.

Proposed works and access within RPA and beneath crown of T003

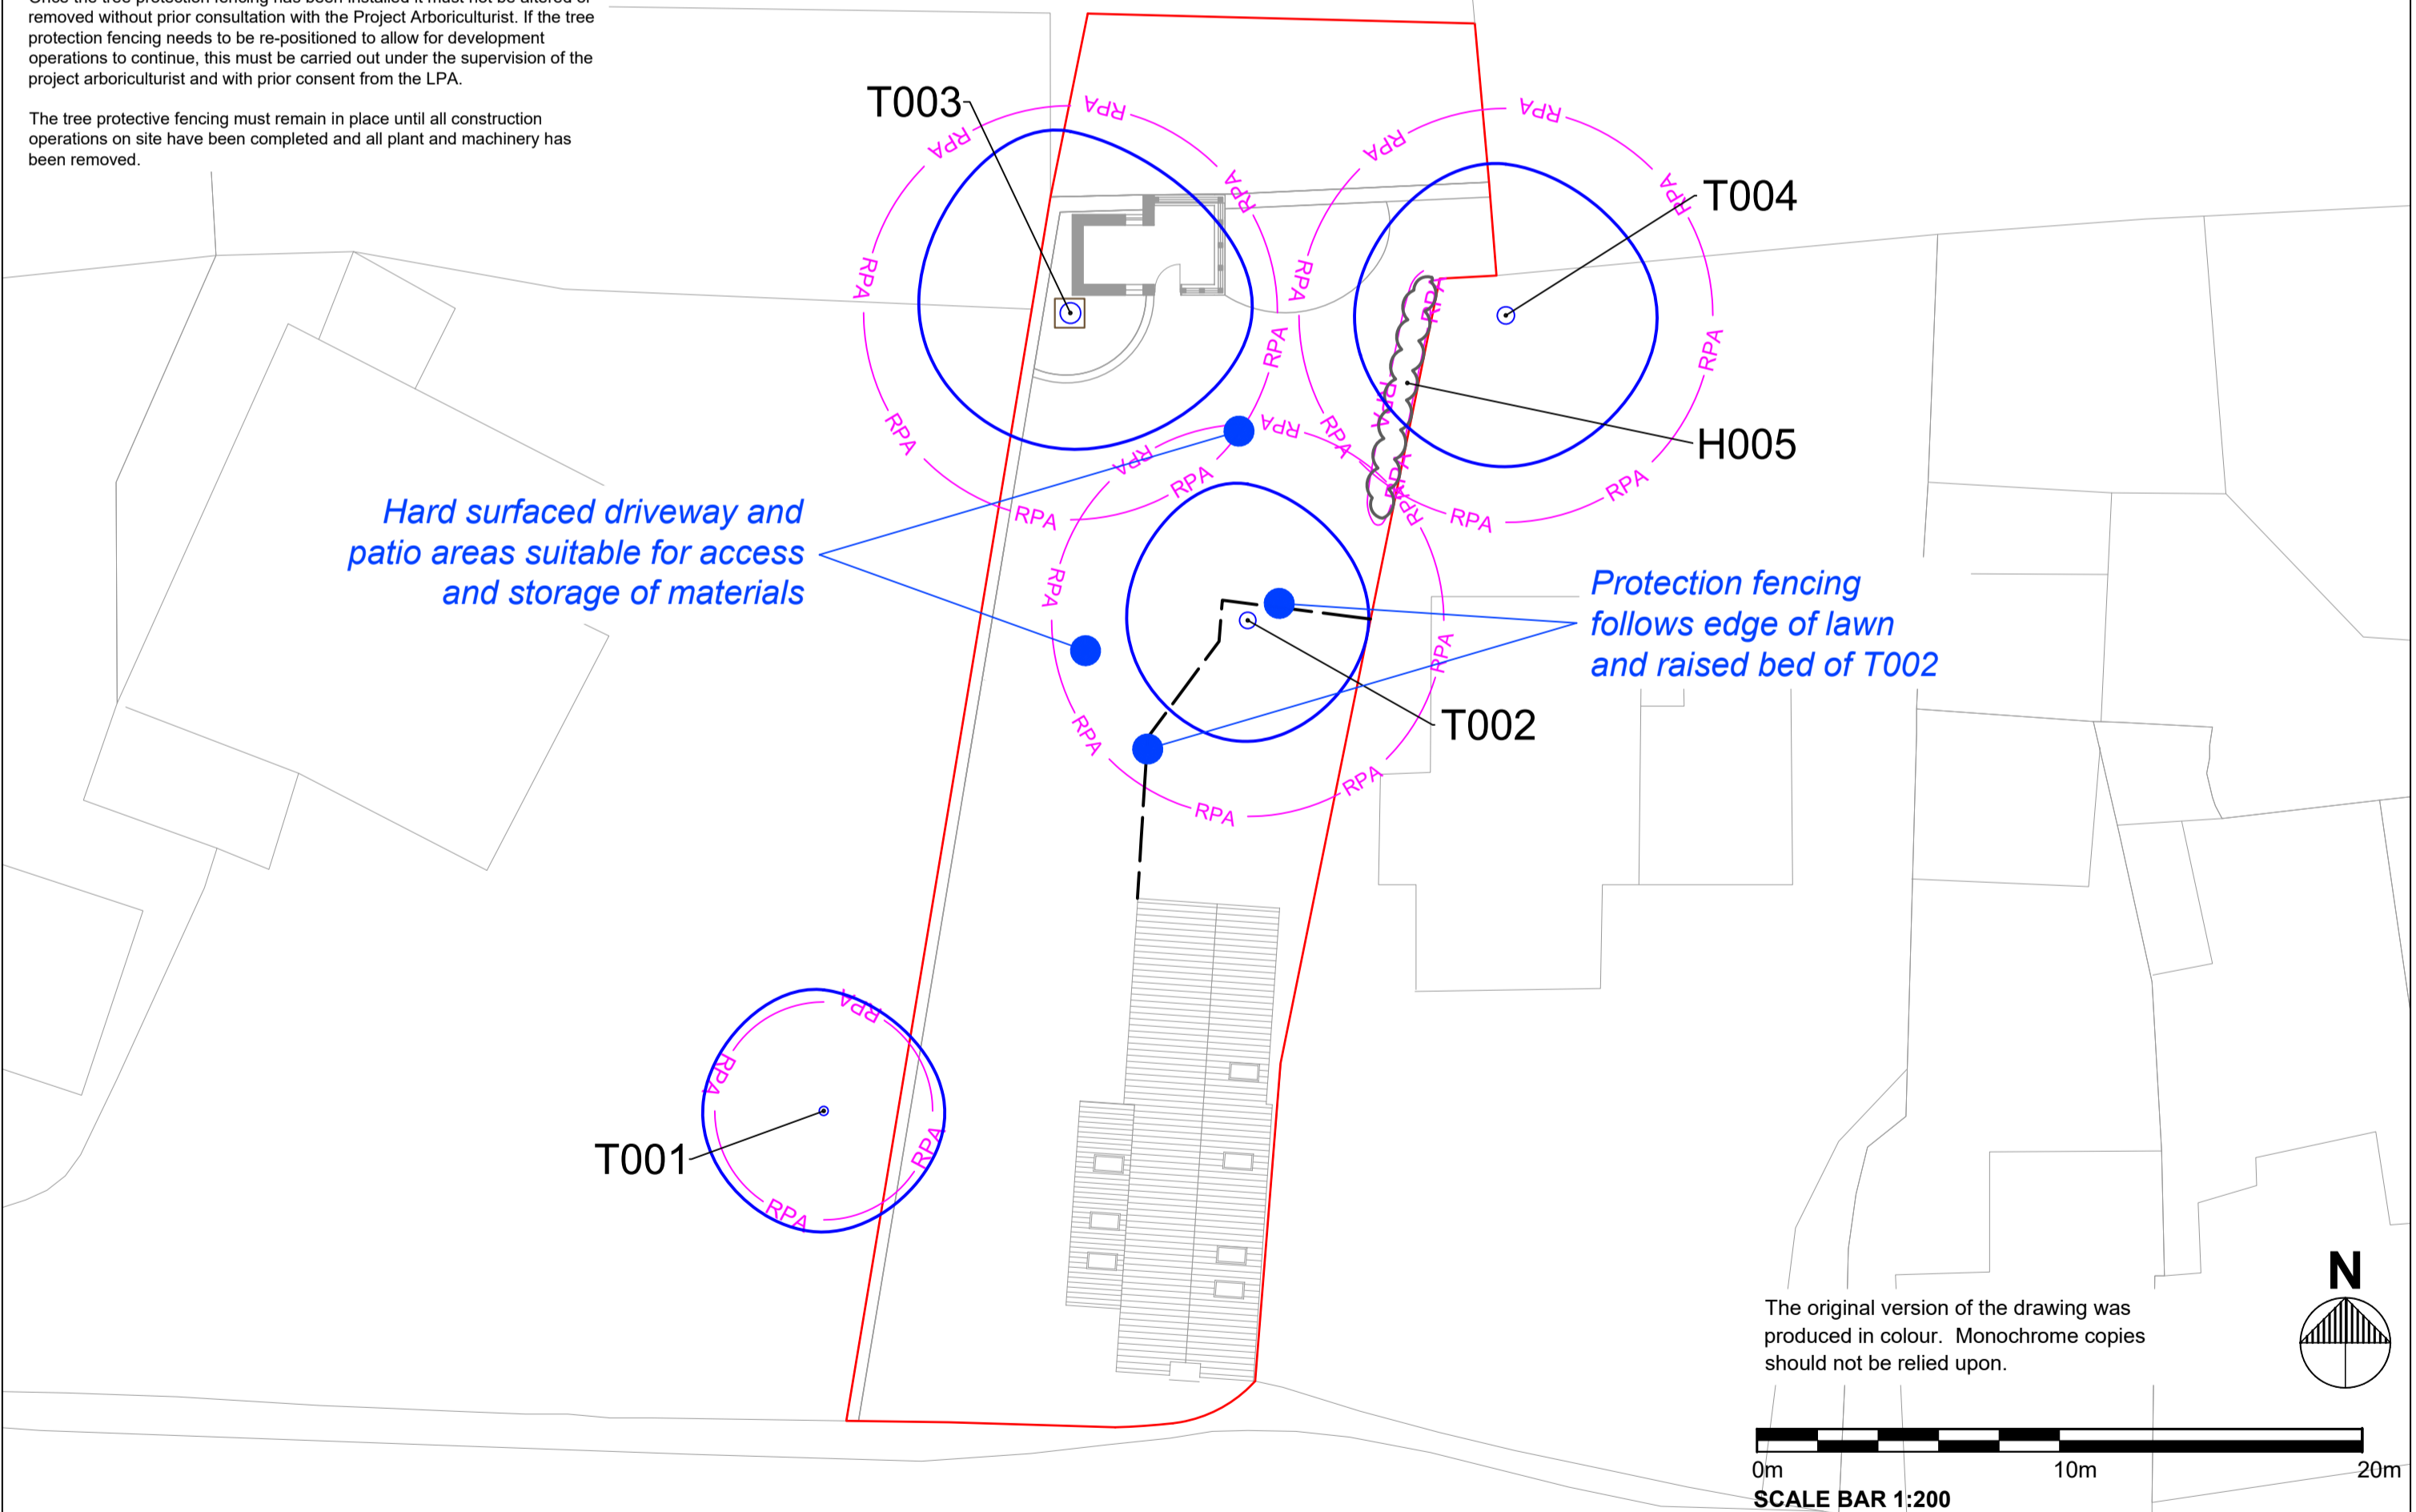
| Drawing Title Figure 4 - Arboricultural Method Statement | | Drawing Number 1088-TAL-03 | |

Hard surfaced driveway and patio areas suitable for access and storage of materials

Protection fencing follows edge of lawn and raised bed of T002

Before the commencement of any development operations or the storage of plant, machinery and materials on Site, the tree protective fencing must be installed as shown. Where possible this fencing should exclude all site activities from the open ground within the RPA of retained trees, creating a sacrosanct Construction Exclusion Zone (CEZ).
