Arboricultural Impact Assessment

WC-420.1a

Moorlands Cricket Club, Huddersfield Road,
Mirfield WF14 9HP

Report type:	Arboricultural Impact Assessment
Report reference:	WC-420.1
Revision:	a
Client:	Moorlands Cricket Club
Site address	Moorlands Cricket Club, Huddersfield Road, Mirfield WF14 9HP
Grid reference:	SE 20781 19826
Report prepared by:	Jack Delaney MICFor MArborA
Date:	12 th August 2025

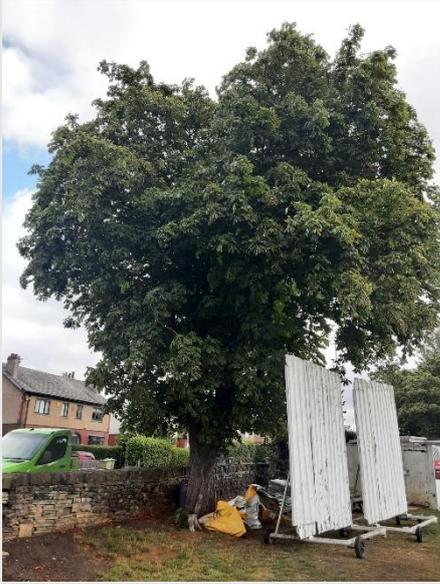
Plate 1: T001 (left) & T002 (right)

Tree Ref:	Species	Age	SULE	Ht.	DBH	CS				CC	Comments	PC	SC	BS 5837: 2012 Category	Recommendations
						N	E	S	W						
T001	Horse chestnut (<i>Aesculus hippocastanum</i>)	M	40-80	15	710	6	4	6	4.5	2	Bifurcates between 2-3 m into multiple co-dominant stems; the angles of these branch unions are all > 25°, and therefore these are unlikely to contain included bark. Damage to foliage throughout the crown caused by horse chestnut leaf miner moth <i>Cameraria ohridella</i> and horse chestnut leaf blotch <i>Phyllosticta paviae</i> .	F	G	B2	No works recommended
T002	Broad-leaved lime (<i>Tilia platyphyllos</i>)	EM	40-80	15	500	7	5	5.5	4	4.5	Fist order branch at 2 m on south-east aspect of main stem has historically been removed, with 1.5 m branch stub remaining. Dense epicormic growth on main stem up to 6 m.	G	F	B2	No works recommended

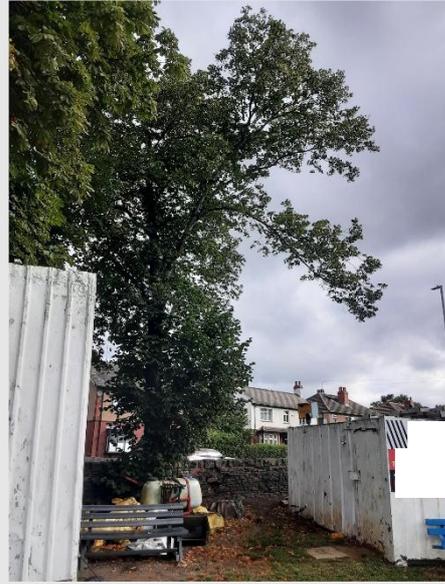
Plate 2: T002

4.3.1. The RPA of T002 will be encroached onto by a proposed extension to the pavilion, by approximately 0.47 m², which equates to < 1% of the total RPA (113.1 m²).

4.3.2. This relatively small area of encroachment suggests that the impacts of the proposals upon T002 will be negligible. However, the following mitigation measures should be implemented during construction, which will help to further minimise disturbance to tree roots:

- Any excavations and/or ground works that are required within the RPA of T002 to install the footings of the extension should be carried out using hand-operated tools or compressed air soil displacement.
- If tree roots are encountered during construction that occur in clumps, or which are greater than 25 mm diameter, then these should not be severed without first consulting with the Project Arboriculturalist. If roots under this diameter are present, then these can be pruned using an appropriate sharp pruning tool, such as pruning saw or secateurs.
- Any tree roots which are temporarily exposed during construction should be covered with sharp sand or dampened hessian sacks to prevent desiccation.

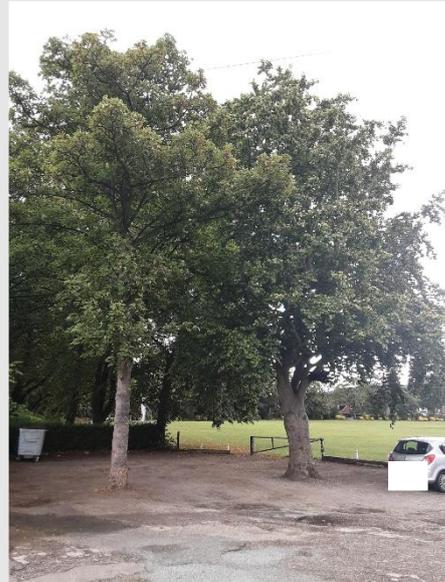
Plate 4: T003 (left) & T004 (right)

Tree Ref:	Species	Age	SULE	Ht.	DBH	CS				CC	Comments	PC	SC	BS 5837: 2012 Category	Recommendations
						N	E	S	W						
T003	Sycamore (<i>Acer pseudoplatanus</i>)	EM	40-80	13	370	4	6	4.5	4	3	No obvious significant defects, though lacks the necessary qualities for higher BS 5837 categorisation.	G	G	B2	No works recommended
T004	European beech (<i>Fagus sylvatica</i>)	EM	40-80	15	710	4.5	7	6.5	6	2	Bifurcates between 2-4 m into multiple co-dominant stems; the angles of some of these branch unions are < 25°, and therefore these may contain included bark. Branch cavity at 2 m on west aspect of main stem.	G	F	B2	No works recommended
T005	Sycamore (<i>Acer pseudoplatanus</i>)	EM	40-80	13	440	6	4.5	5	4	5	No obvious significant defects, though lacks the necessary qualities for higher BS 5837 categorisation.	G	G	B2	No works recommended
T006	Common ash (<i>Fraxinus excelsior</i>)	SM	40-80	10	330	4.5	5	2	4	1.5	Bifurcates between 1.5-2 m into three co-dominant stems; the angles of these branch unions are < 25°, and therefore these may contain included bark. Minor deadwood < 100 mm in diameter scattered throughout the crown.	F	F	B1	No works recommended

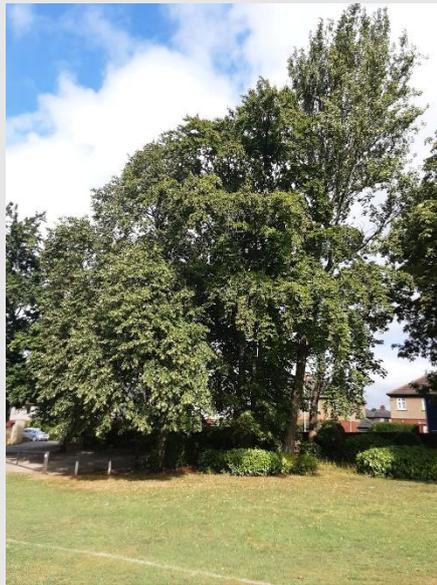
Plate 7: G001

Group Ref:	Species Composition	Age	SULE	Mx. Ht.	Mx. DBH	Approx. No. of Stems	CC	Comments	V	SC	BS 5837:2012 Category	Recommendations
G001	Hybrid-black poplar (<i>Populus x canadensis</i>) Sycamore (<i>Acer pseudoplatanus</i>) European beech (<i>Fagus sylvatica</i>) Broad-leaved lime (<i>Tilia platyphyllos</i>)	EM M	40-80	28	590	5	1.5	Group of trees positioned along eastern boundary of car park. Multiple trees display acute branch unions, leaning main stems and/or asymmetrical forms, and branch cavities. Minor deadwood < 100 mm in diameter scattered throughout the group.	F	F	B2	No works recommended
