**Canal &  
River Trust**

# **Arboricultural Impact Assessment (AIA)**

**P/12553 Slaithwaite Reservoir  
Spillway Project**

March 2025

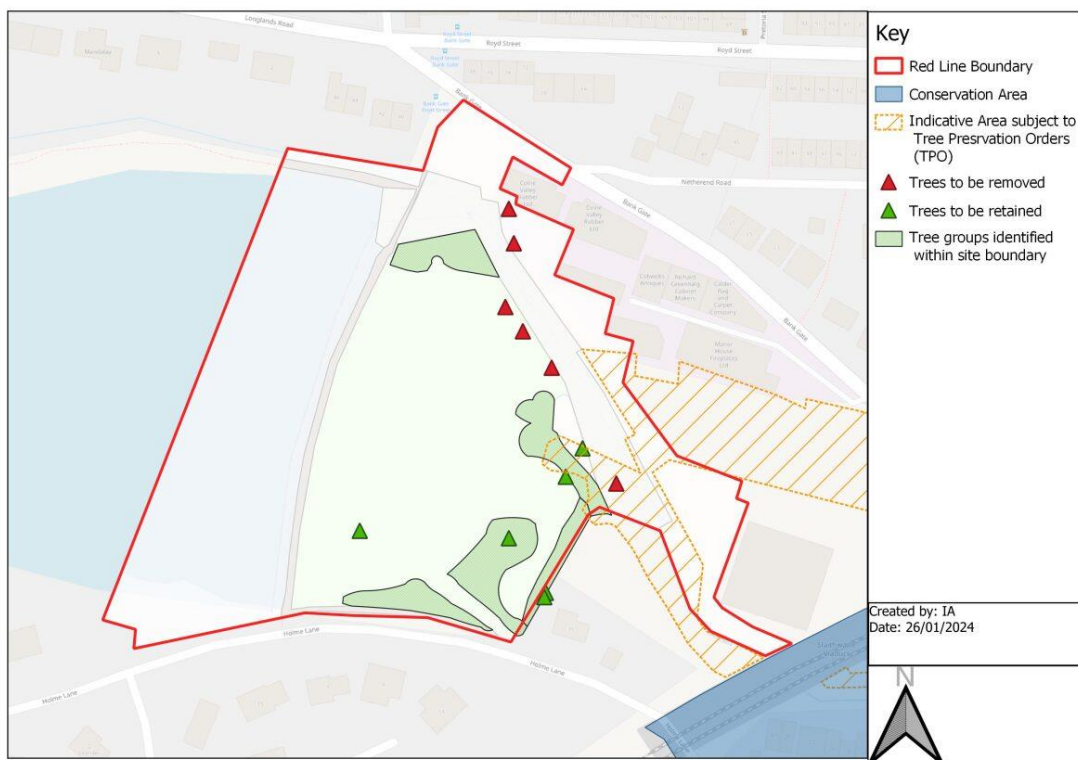
The site is located within the local authority district of Kirklees Council. At the time of writing this report, access to the online interactive map revealed the presence of a TPO area (ID:37/95/w1) to the east of the site (Figure 2). The TPO in relation to the trees and tree groups can be seen in Appendix 2. In addition, there are several TPO's present around the wider reservoir, however, these will not be impacted by the scheme.

Figure 2. Map of Tree Preservation Order and Conservation Areas in relation to proposed tree removal.

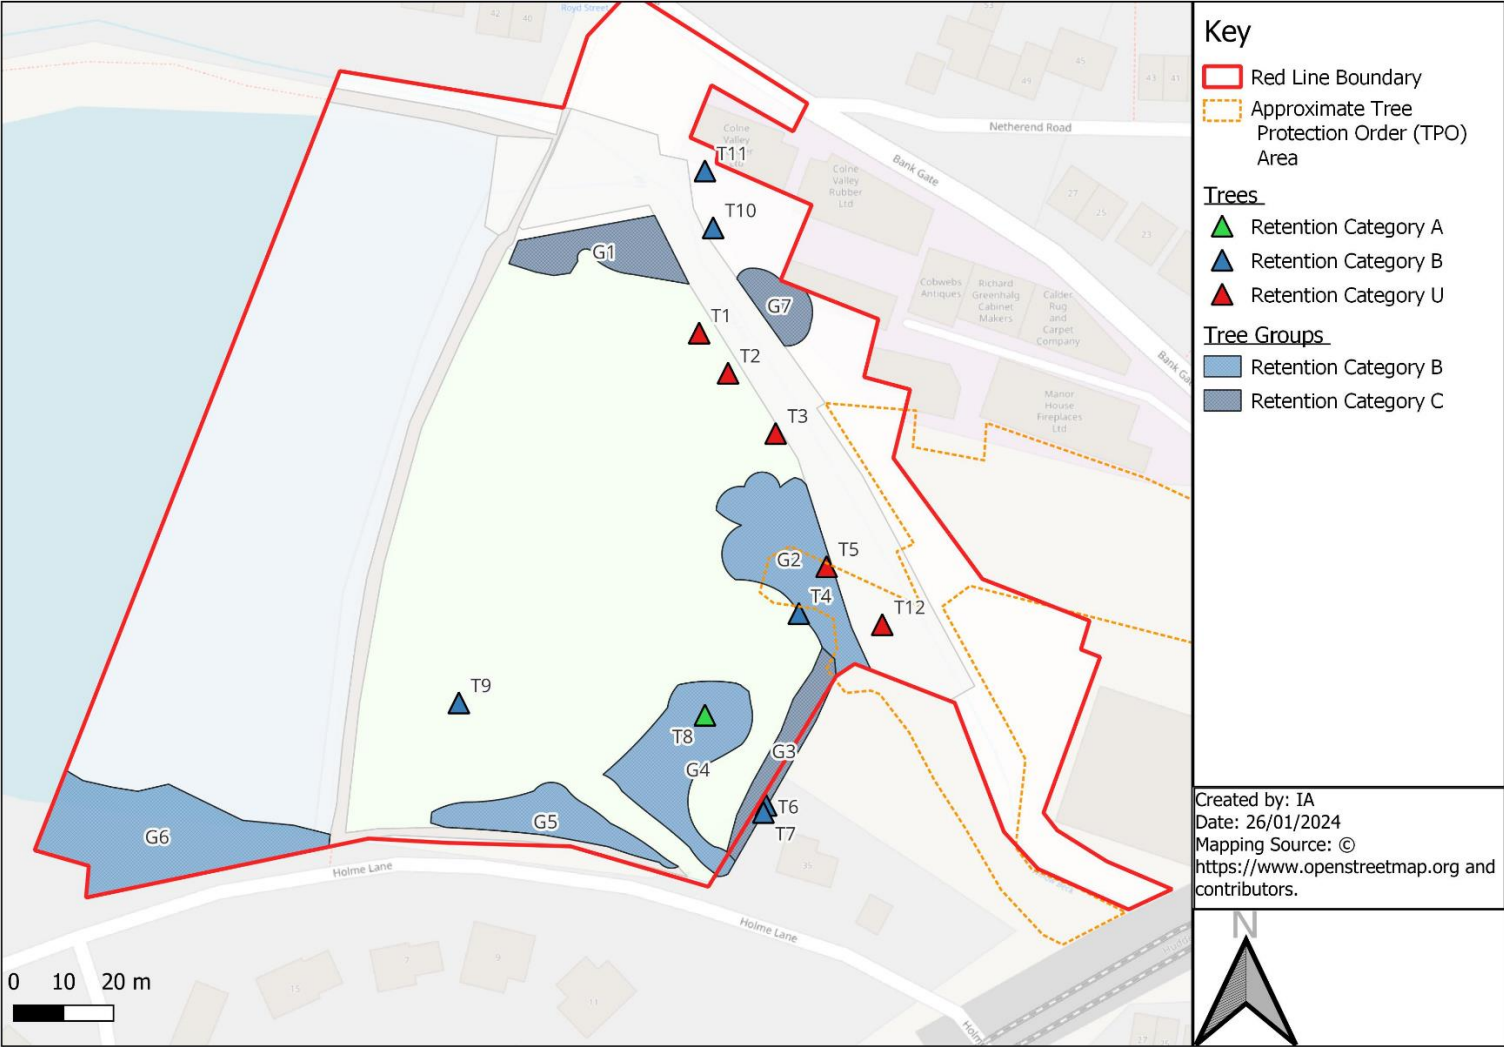
Appendix 2 - Tree Constraints Plan

A Tree Constraints Plan can be found in Appendix 2.

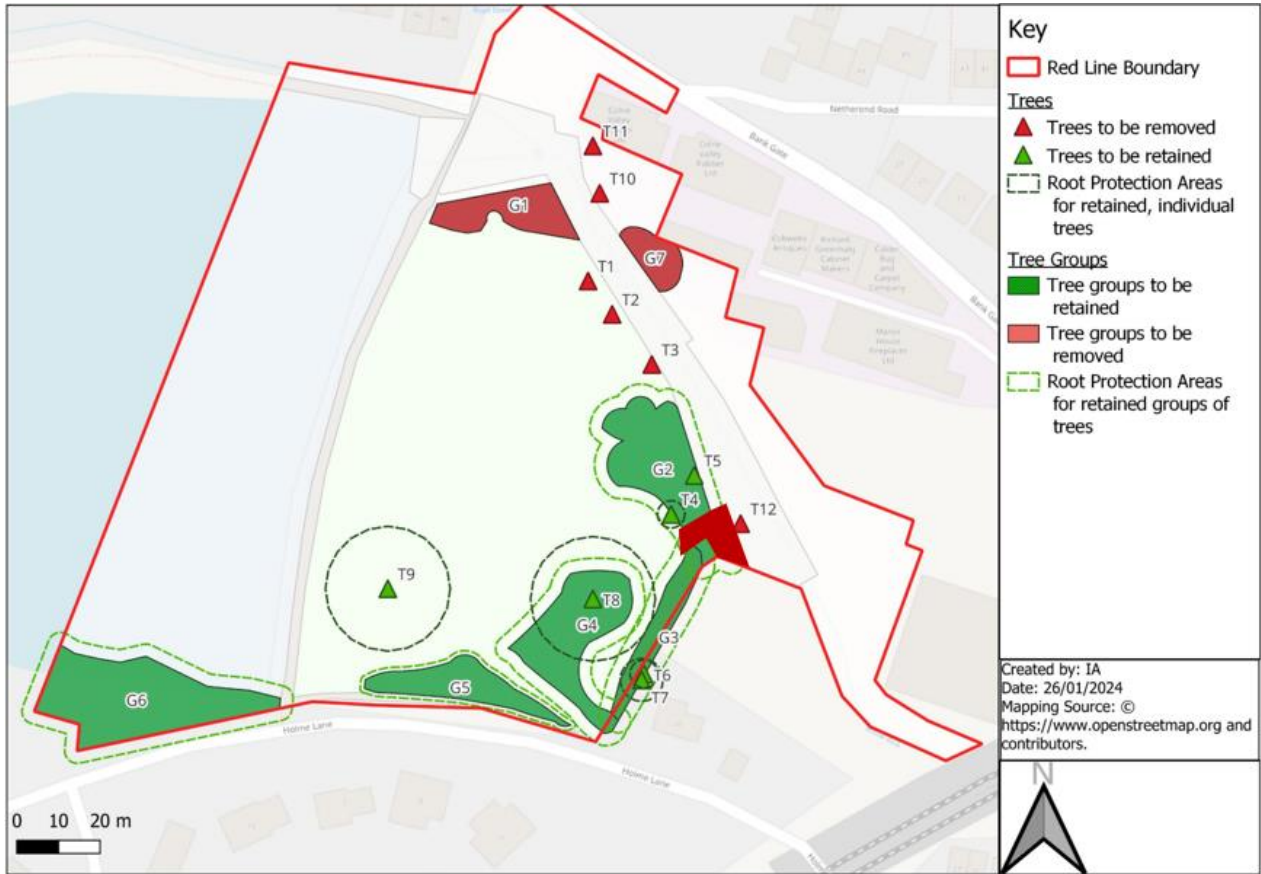
Appendix 3 - Tree Removal and Tree Protection Plan

The proposed scheme would require the removal of mainly category C and U trees and tree groups, however, it would also require the removal of 'moderate quality' B category trees and tree groups. The following trees and tree groups are not compatible with the repair works and as such will be removed: G1, G7, T10, T11, T12.

An access track will be installed through a section of G2 (access route 2). This has required a 10m wide strip to be cleared through the eastern end of the woodland block. In addition, trees around the perimeter of G2 have been removed to facilitate the construction of the crane pad and construction of the spillway. The remainder of G2 will be crown reduced by 20% so that the crane can lift materials without damaging the tree group. The work described above has required the clearance of 16 trees with a dbh of 75mm or greater, the majority of which were below 200mm and Ash (*Fraxinus excelsior*) with advanced stages of Ash Dieback. It has also required the removal of a number of saplings/shrubs. This route has been determined alongside a qualified arborist and ecologist to minimise impact through the wooded area. Replacement planting would take place following the repairs.

For the first access track across the face of the dam, facilitation pruning is required G5 and the removal of two non-native trees in G4 and the coppicing of one multi-stem Willow in G4.

- Identifies trees to be retained (coloured green in Appendix 3)
- Identifies Construction Exclusion Zones for trees been retained.
