# Arboricultural Impact Assessment

**WC-421.1a**

30, Oxford Road, Dewsbury WF13 4LL

| <b>Report type:</b> | Arboricultural Impact Assessment |

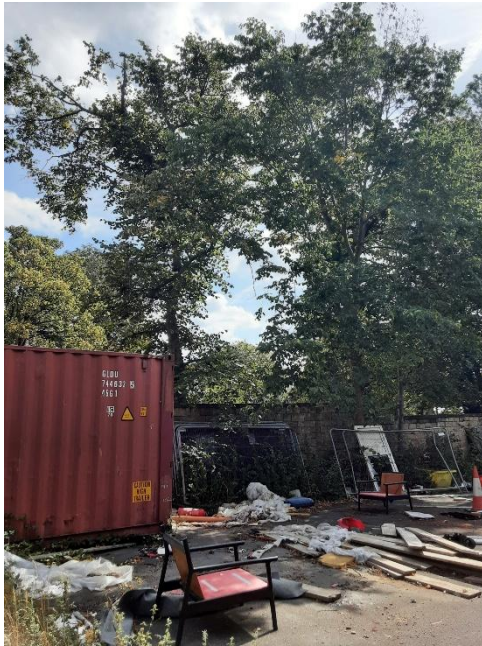
**Plate 1:** T001 (left) & T002 (right)

- 4.2.1. Branches extending north-west from T001 would encroach onto the roof of the proposed coach house building. To create sufficient clearance for this building, it is recommended that branches extending north-west from T001 are reduced by approximately 2 m.
- 4.2.2. T008 and T011 are positioned adjacent to the site entrance, and currently display crown clearances of 3 m and 0 m, respectively. To facilitate access during and upon completion of the development, it is recommended that the crowns of both these trees are lifted over the main entrance, so that the lowest branches measure approximately 4-5 m from ground level.

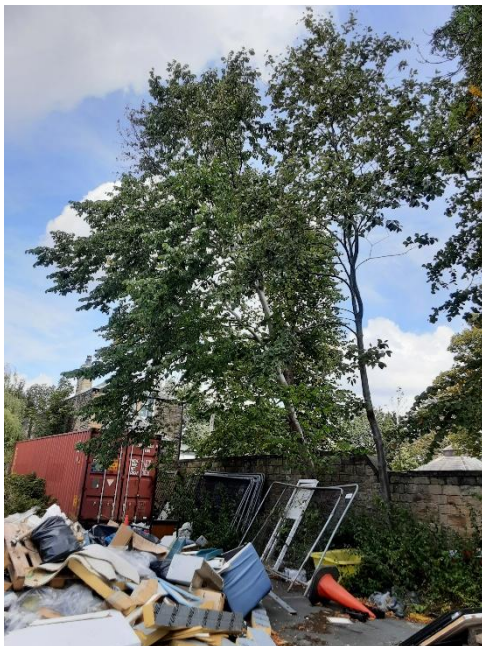
**Plate 3:** T002 (left) & T003 (right)

- 4.1.1. The development proposals do not directly necessitate the removal of trees from the site.
- 4.1.2. However, T002, T003, and T010 are all self-seeded category C trees of low-quality, which are growing from the bases of boundary walls. Removal of these trees is therefore recommended to mitigate future damage to the walls.
- 4.1.3. G005 is a category C group of trees, which historically has been maintained as a hedge. Due to a lapse in management these trees now encroach upon the existing building. G005 is therefore recommended to be partially removed.

| Tree Ref: | Species | Age | SULE | Ht. | DBH | CS | | | | CC | Comments | PC | SC | BS 5837: 2012 Category | Recommendations |
|---|---|---|---|---|---|---|---|---|---|---|---|---|---|---|---|
| T003 | Whitebeam<br>( <i>Sorbus aria</i> ) | SM | 20-40 | 12 | 180 | 2 | 2# | 3 | 3.5 | 3 | Self-seeded tree growing from base of boundary wall. Asymmetrical form due to proximity with adjacent trees. No obvious significant defects, | F | F | C1 | Remove tree |

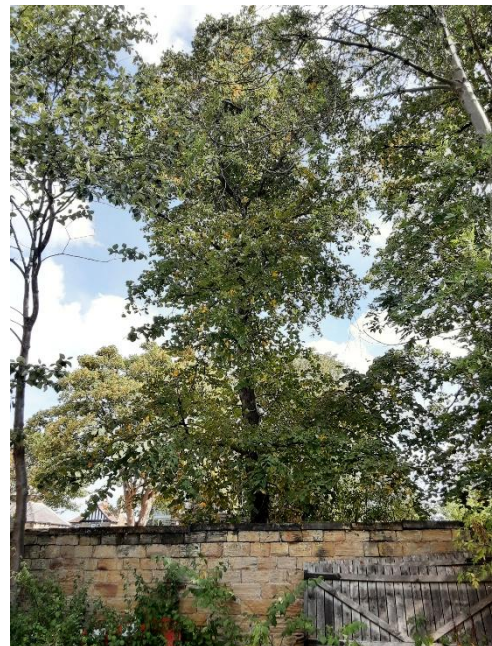
**Plate 4:** T004

| Tree Ref: | Species | Age | SULE | Ht. | DBH | CS | | | | CC | Comments | PC | SC | BS 5837: 2012 Category | Recommendations |
|---|---|---|---|---|---|---|---|---|---|---|---|---|---|---|---|
| T004 | Small-leaved lime<br>( <i>Tilia cordata</i> ) | EM | 40-80 | 14 | 400# | 4# | 5# | 5 | 5# | 2 | Positioned on adjacent property and unable to access base of tree. Minor deadwood < 100 mm in diameter scattered throughout the crown | F | G | B2 | No works recommended |

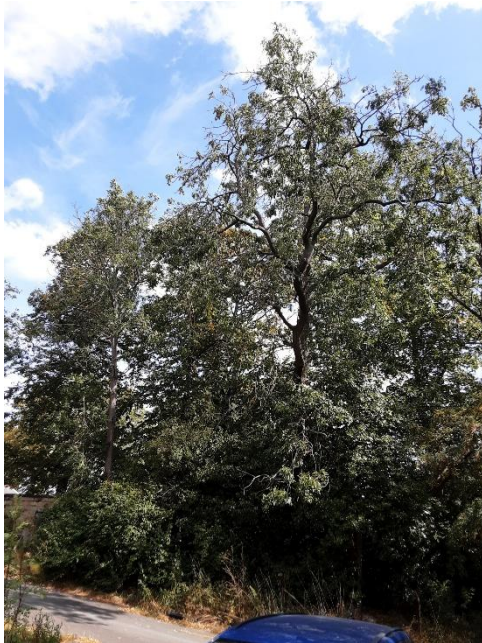
***Plate 5: T005***

| Tree Ref: | Species | Age | SULE | Ht. | DBH | CS | | | | CC | Comments | PC | SC | BS 5837: 2012 Category | Recommendations |
|---|---|---|---|---|---|---|---|---|---|---|---|---|---|---|---|
| T005 | Common ash<br>( <i>Fraxinus excelsior</i> ) | EM | 10-20 | 15 | 370 | 5 | 2 | 4 | 4.5 | 2 | Slightly sparse foliage with deadwood < 100 mm in diameter accumulating around extremities of the crown, which may indicate the early stages of Chalara ash dieback <i>Hymenoscyphus fraxineus</i> . | F | F | C2 | No works recommended |

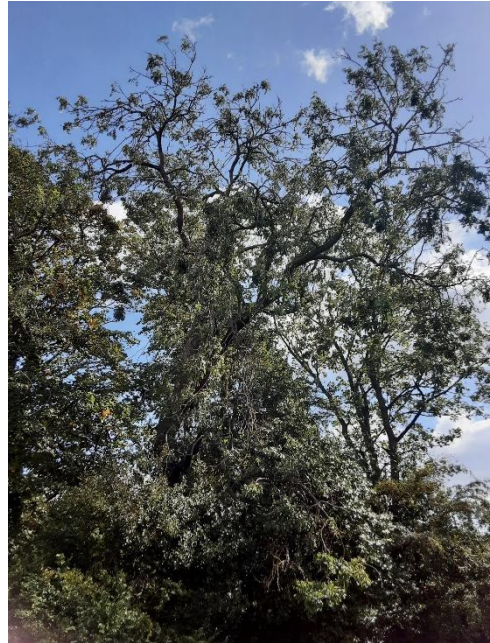
***Plate 6: T006***

| Tree Ref: | Species | Age | SULE | Ht. | DBH | CS | | | | CC | Comments | PC | SC | BS 5837: 2012 Category | Recommendations |
|---|---|---|---|---|---|---|---|---|---|---|---|---|---|---|---|
| T006 | Common ash<br>( <i>Fraxinus excelsior</i> ) | M | 10-20 | 20 | 810 | 7 | 5# | 7# | 10 | 2.5 | Slightly sparse foliage with deadwood < 100 mm in diameter accumulating around extremities of the crown, which may indicate the early stages of Chalara ash dieback <i>Hymenoscyphus fraxineus</i> . | F | F | B2 | No works recommended |

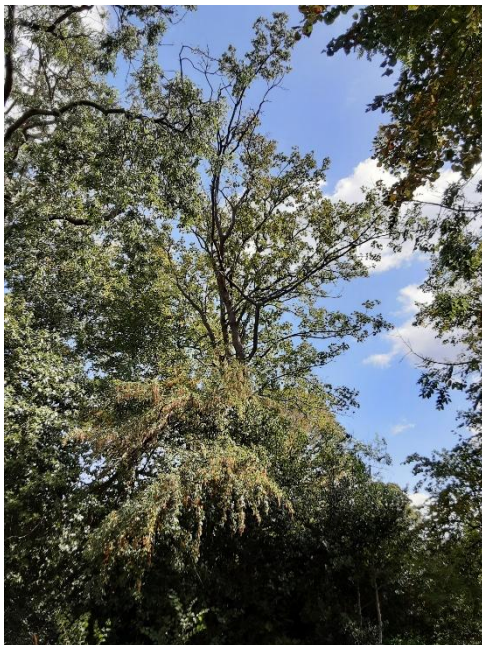
***Plate 7: T007***

| Tree Ref: | Species | Age | SULE | Ht. | DBH | CS | | | | CC | Comments | PC | SC | BS 5837: 2012 Category | Recommendations |
|---|---|---|---|---|---|---|---|---|---|---|---|---|---|---|---|
| T007 | Sycamore<br>( <i>Acer pseudoplatanus</i> ) | EM | 20-40 | 19 | 490 | 2.5# | 5# | 7 | 5 | 9 | Major deadwood > 100 mm in diameter scattered throughout though crown. Historic mechanical damage to base of main stem on east aspect. | F | PD | B2 | No works recommended |

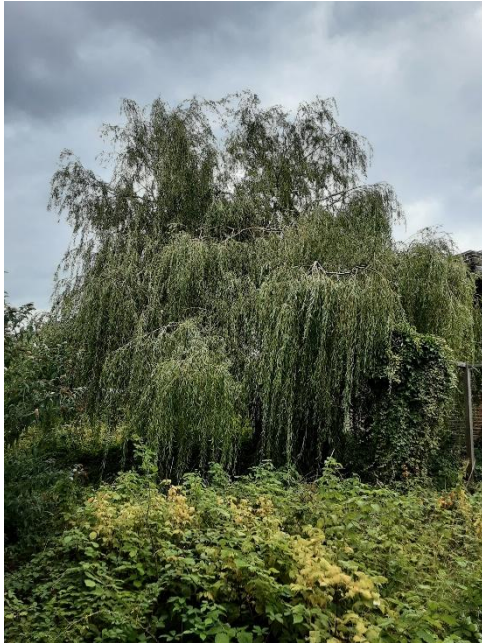
***Plate 9: T009***

| Tree Ref: | Species | Age | SULE | Ht. | DBH | CS | | | | CC | Comments | PC | SC | BS 5837: 2012 Category | Recommendations |
|---|---|---|---|---|---|---|---|---|---|---|---|---|---|---|---|
| T009 | Weeping willow<br>( <i>Salix x sepulcralis</i> ) | EM | 40-80 | 11 | 460 | 5.5 | 5.5 | 6 | 6 | 1 | Memorial tree. Minor deadwood < 100 mm in diameter scattered throughout the crown | F | F | B2 | No works recommended |

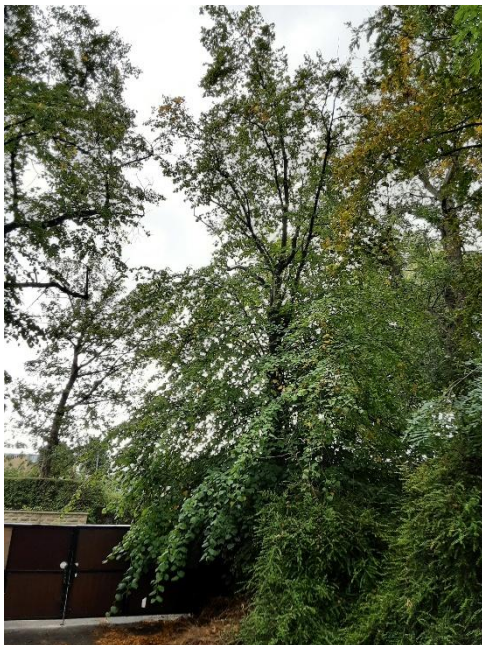
***Plate 11: T011***

| Tree Ref: | Species | Age | SULE | Ht. | DBH | CS | | | | CC | Comments | PC | SC | BS 5837: 2012 Category | Recommendations |
|---|---|---|---|---|---|---|---|---|---|---|---|---|---|---|---|
| T011 | Small-leaved lime<br>( <i>Tilia cordata</i> ) | EM | 40-80 | 14 | 450 | 4.5 | 4.5 | 5 | 3 | 0 | Dense epicormic on main stem up to 5 m. Tear-out wound at 7 m, sustained from historic failure of main leader. | F | PD | B2 | Crown lift to 5 m over site entrance |

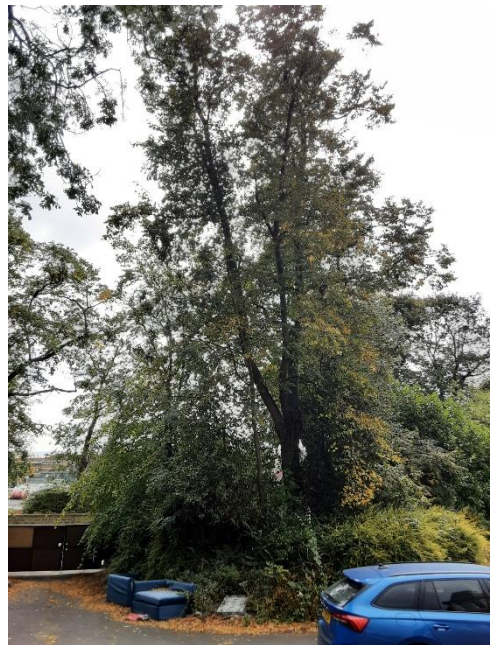
***Plate 12: T012***

| Tree Ref: | Species | Age | SULE | Ht. | DBH | CS | | | | CC | Comments | PC | SC | BS 5837: 2012 Category | Recommendations |
|---|---|---|---|---|---|---|---|---|---|---|---|---|---|---|---|
| T012 | Small-leaved lime<br>( <i>Tilia cordata</i> ) | EM | 40-80 | 18 | 500# | 6.5 | 6 | 5# | 6# | 4.5 | Unable to access base of tree due to dense understory vegetation. No obvious significant defects, though lacks the necessary qualities for higher BS 5837 categorisation. | G | F | B2 | No works recommended |

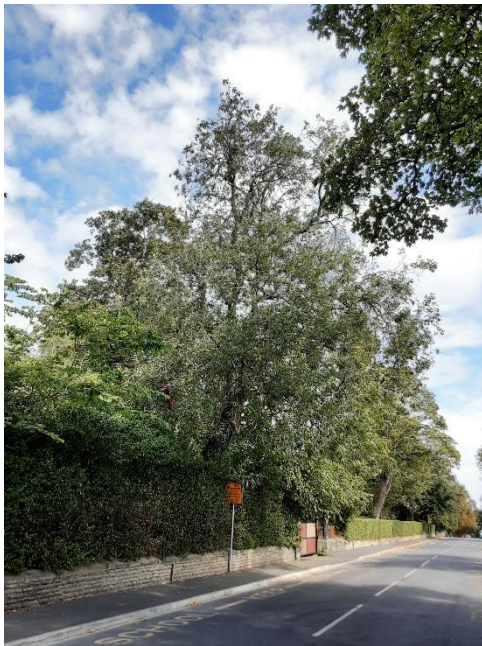
***Plate 13: T013***

| Tree Ref: | Species | Age | SULE | Ht. | DBH | CS | | | | CC | Comments | PC | SC | BS 5837: 2012 Category | Recommendations |
|---|---|---|---|---|---|---|---|---|---|---|---|---|---|---|---|
| T013 | Common ash<br>( <i>Fraxinus excelsior</i> ) | M | 10-20 | 18 | 700# | 8# | 8# | 8 | 8# | 5 | Unable to access base of tree due to dense understory vegetation. No obvious significant defects, though lacks the necessary qualities for higher BS 5837 categorisation. | F | F | B2 | No works recommended |

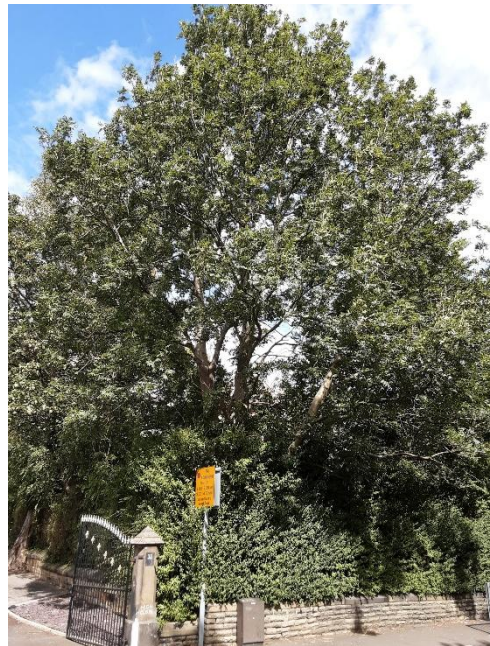
***Plate 14: T014***

| Tree Ref: | Species | Age | SULE | Ht. | DBH | CS | | | | CC | Comments | PC | SC | BS 5837: 2012 Category | Recommendations |
|---|---|---|---|---|---|---|---|---|---|---|---|---|---|---|---|
| T014 | Common ash<br>( <i>Fraxinus excelsior</i> ) | EM | 40-80 | 16 | 300#<br>300#<br>300# | 5# | 7# | 6 | 5 | 3 | Unable to access base of tree due to dense understory vegetation. No obvious significant defects, though lacks the necessary qualities for higher BS 5837 categorisation. | G | F | B2 | No works recommended |

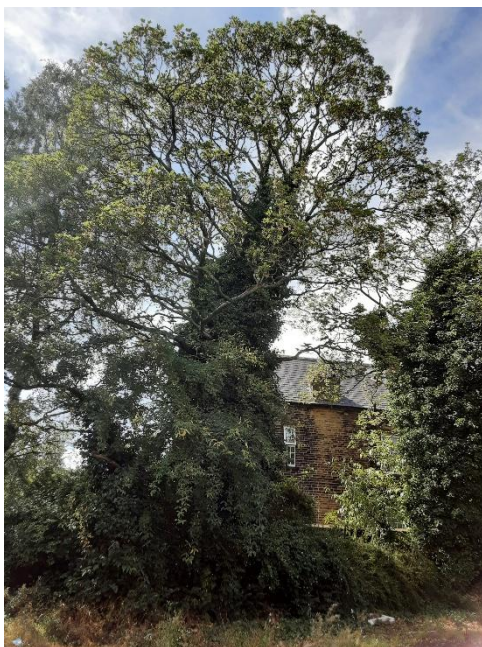
***Plate 15: T015***

| Tree Ref: | Species | Age | SULE | Ht. | DBH | CS | | | | CC | Comments | PC | SC | BS 5837: 2012 Category | Recommendations |
|---|---|---|---|---|---|---|---|---|---|---|---|---|---|---|---|
| T015 | Sycamore<br>( <i>Acer pseudoplatanus</i> ) | EM | 40-80 | 16 | 500# | 5 | 6 | 6 | 6# | 5.5 | Unable to access base of tree due to dense understory vegetation. Dense ivy <i>Hedera helix</i> established on main stem and first order branches, which obscures tree features and potential defects, though upper portion of crown appears of fair vitality and vigour with no indication of major physiological dysfunction. | F | F | B2 | No works recommended |

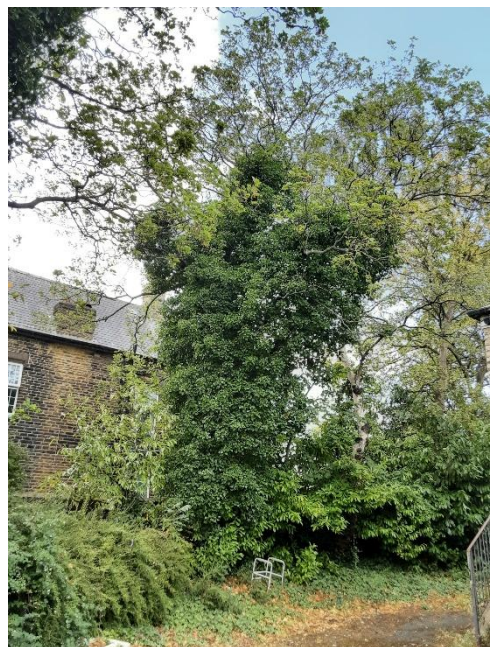
***Plate 16: T016***

| Tree Ref: | Species | Age | SULE | Ht. | DBH | CS | | | | CC | Comments | PC | SC | BS 5837: 2012 Category | Recommendations |
|---|---|---|---|---|---|---|---|---|---|---|---|---|---|---|---|
| T016 | Sycamore<br>( <i>Acer pseudoplatanus</i> ) | EM | 40-80 | 15 | 460 | 5 | 6 | 3 | 6# | 4.5 | Dense ivy <i>Hedera helix</i> established on main stem and first order branches, which obscures tree features and potential defects, though upper portion of crown appears of fair vitality and vigour with no indication of major physiological dysfunction. | F | F | B2 | No works recommended |

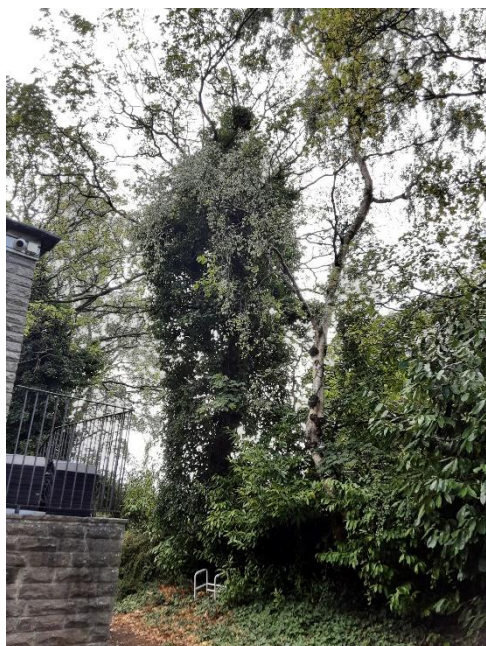
***Plate 17: T016 (left) & T017 (right)***

| Tree Ref: | Species | Age | SULE | Ht. | DBH | CS | | | | CC | Comments | PC | SC | BS 5837: 2012 Category | Recommendations |
|---|---|---|---|---|---|---|---|---|---|---|---|---|---|---|---|
| T017 | Silver birch<br>( <i>Betula pendula</i> ) | EM | 20-40 | 15 | 370 | 3 | 5 | 2 | 5# | 3.5 | Asymmetrical form due to proximity with adjacent trees. Minor deadwood < 100 mm in diameter scattered throughout the crown | F | F | B2 | No works recommended |

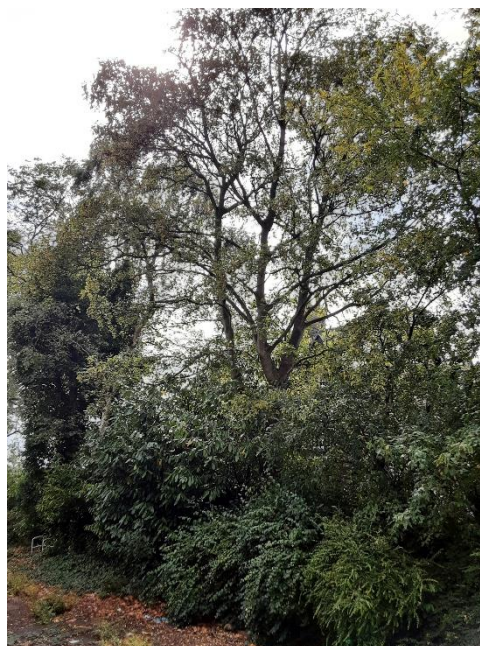
***Plate 18: T018***

| Tree Ref: | Species | Age | SULE | Ht. | DBH | CS | | | | CC | Comments | PC | SC | BS 5837: 2012 Category | Recommendations |
|---|---|---|---|---|---|---|---|---|---|---|---|---|---|---|---|
| T018 | Sycamore<br>( <i>Acer pseudoplatanus</i> ) | EM | 40-80 | 16 | 520 | 5 | 6 | 5 | 6# | 5 | No obvious significant defects, though lacks the necessary qualities for higher BS 5837 categorisation. | F | G | B2 | No works recommended |

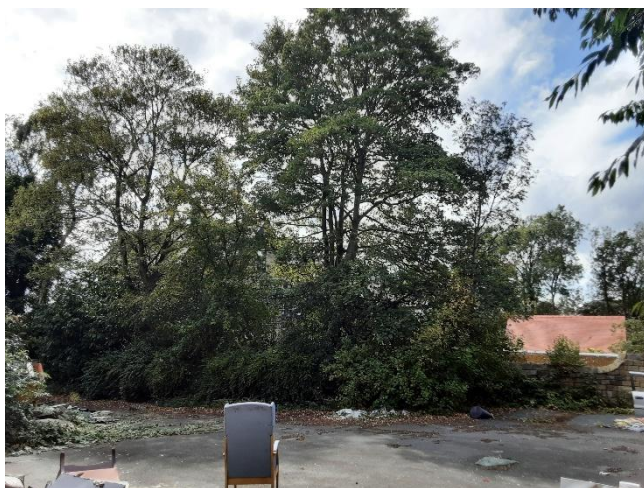
***Plate 19: T018 (left) & T019 (right)***

| Tree Ref: | Species | Age | SULE | Ht. | DBH | CS | | | | CC | Comments | PC | SC | BS 5837: 2012 Category | Recommendations |
|---|---|---|---|---|---|---|---|---|---|---|---|---|---|---|---|
| T019 | Sycamore<br>( <i>Acer pseudoplatanus</i> ) | EM | 40-80 | 16 | 380<br>430 | 6 | 5 | 5 | 6# | 3 | Bifurcates between ground level and 1 m into three co-dominant stems; the angles of these branch unions are all < 25°, and therefore, they may contain included bark. | F | F | B2 | No works recommended |

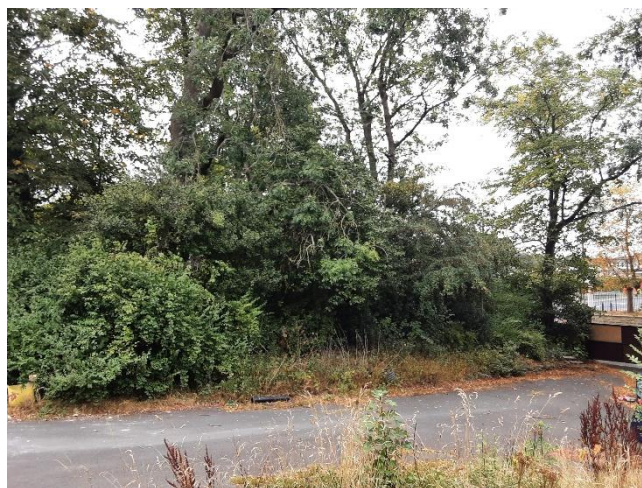
***Plate 20: G001***

| Group Ref: | Species Composition | Age | SULE | Mx. Ht. | Mx. DBH | Approx. No. of Stems | CC | Comments | V | SC | BS 5837:2012 Category | Recommendations |
|---|---|---|---|---|---|---|---|---|---|---|---|---|
| G001 | Common ash<br>( <i>Fraxinus excelsior</i> )<br>Common holly<br>( <i>Ilex aquifolium</i> )<br>Common laburnum<br>( <i>Laburnum anagyroides</i> )<br>Wych elm<br>( <i>Ulmus glabra</i> ) | Y<br>SM | 20-40 | 6 | 140 | 100# | 0 | Dense understorey group. No obvious significant defects, though of limited arboricultural merit, and lacks the necessary qualities for higher BS 5837 categorisation. | F | F | C1 | No works recommended |

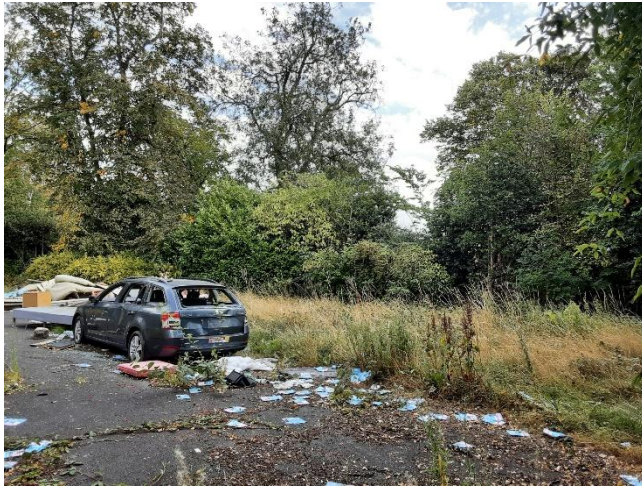
***Plate 21: G002***

| Group Ref: | Species Composition | Age | SULE | Mx. Ht. | Mx. DBH | Approx. No. of Stems | CC | Comments | V | SC | BS 5837:2012 Category | Recommendations |
|---|---|---|---|---|---|---|---|---|---|---|---|---|
| G002 | Himalayan tree-cotoneaster<br>( <i>Cotoneaster frigidus</i> )<br>Common ash<br>( <i>Fraxinus excelsior</i> )<br>Common holly<br>( <i>Ilex aquifolium</i> )<br>Laurel cherry<br>( <i>Prunus laurocerasus</i> )<br>Elder<br>( <i>Sambucus nigra</i> )<br>Wych elm<br>( <i>Ulmus glabra</i> ) | Y<br>SM | 20-40 | 9 | 200 | 200# | 0 | Dense understorey group. No obvious significant defects, though of limited arboricultural merit, and lacks the necessary qualities for higher BS 5837 categorisation. | F | F | C1 | No works recommended |

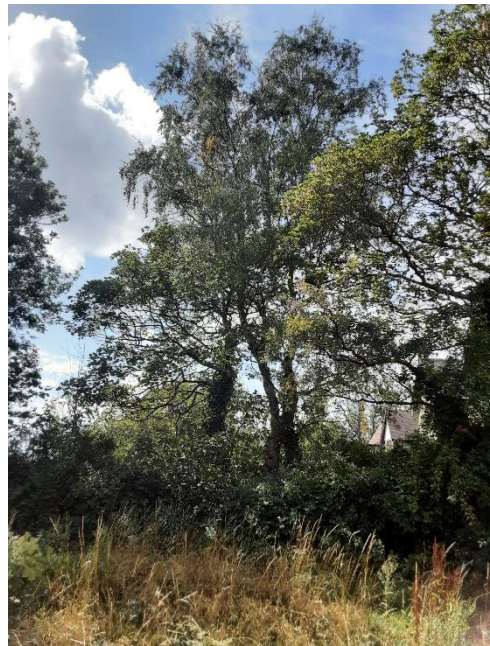
***Plate 22: G003***

| Group Ref: | Species Composition | Age | SULE | Mx. Ht. | Mx. DBH | Approx. No. of Stems | CC | Comments | V | SC | BS 5837:2012 Category | Recommendations |
|---|---|---|---|---|---|---|---|---|---|---|---|---|
| G003 | Silver birch<br>( <i>Betula pendula</i> )<br>Sycamore<br>( <i>Acer pseudoplatanus</i> )<br>Common laburnum<br>( <i>Laburnum anagyroides</i> ) | SM<br>EM | 40-80 | 17 | 500# | 3 | 1.5 | Group containing three trees, some of which are positioned on an adjacent property. Unable to access bases of trees due to dense understory vegetation. | F | F | B2 | No works recommended |

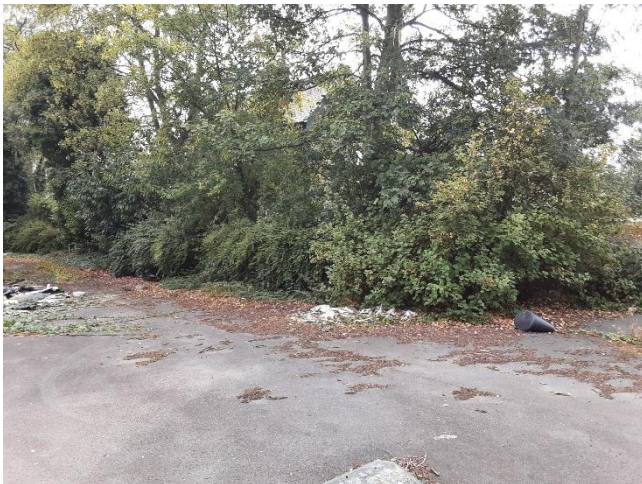
***Plate 23: G004***

| Group Ref: | Species Composition | Age | SULE | Mx. Ht. | Mx. DBH | Approx. No. of Stems | CC | Comments | V | SC | BS 5837:2012 Category | Recommendations |
|---|---|---|---|---|---|---|---|---|---|---|---|---|
| G004 | Sycamore<br>( <i>Acer pseudoplatanus</i> )<br>Common ash<br>( <i>Fraxinus excelsior</i> )<br>Common laburnum<br>( <i>Laburnum anagyroides</i> )<br>Laurel cherry<br>( <i>Prunus laurocerasus</i> ) | Y<br>SM | 20-40 | 8 | 160 | 100# | 0 | Dense linear understorey group. No obvious significant defects, though of limited arboricultural merit, and lacks the necessary qualities for higher BS 5837 categorisation. | F | F | C1 | No works recommended |
