STRUCTURAL DESIGN PHILOSOPHY The George Hotel, Huddersfield

Client: GMI Construction
Project Name: The George Hotel, Huddersfield
Report Title: Block A – Structural Design Philosophy
Report Author: James Hendry
Document ref: 00.24363-ACE-ZZ-ZZ-T-S-0004
Date: April'25

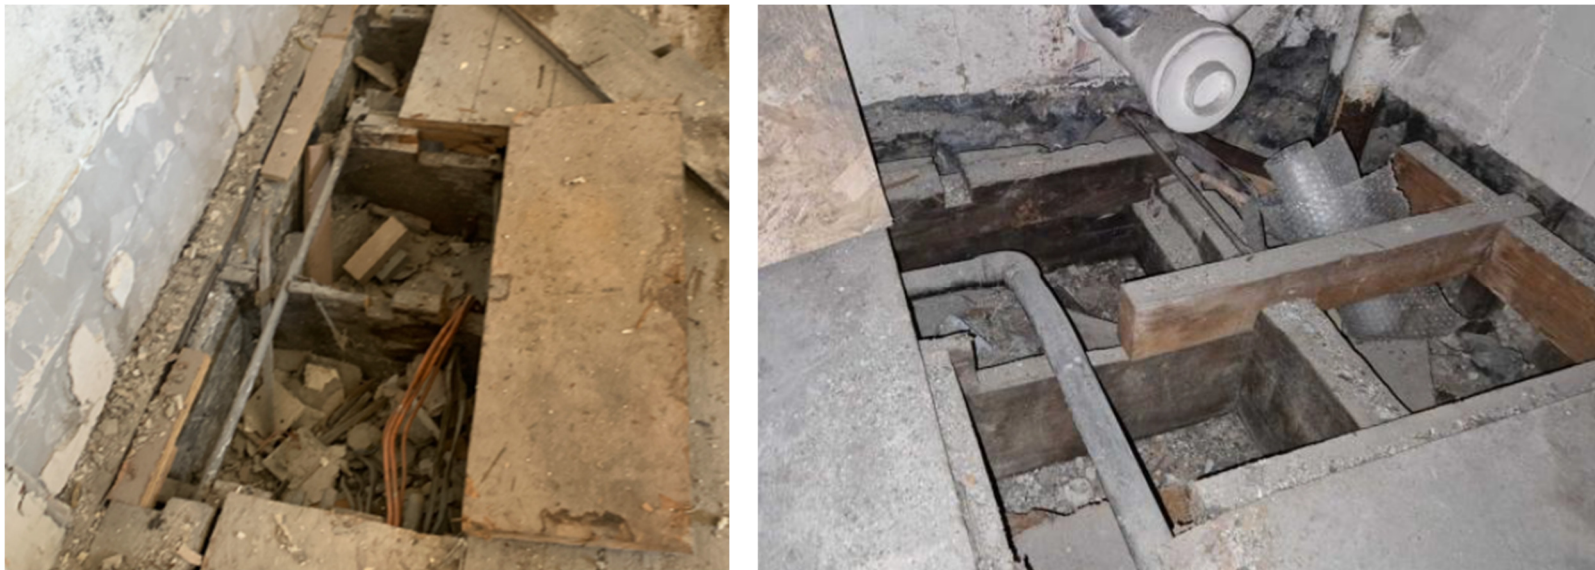
Figure 3 – Heavily Notched Joists (30-40%)

- 3.2.1. A timber survey was undertaken, with a subsequent report produced by Floyd Consulting dated 04/02/2025. The report examined the condition and arrangement of timber elements at all previously exposed points across every floor level.
- 3.2.2. In addition to documenting the condition and geometry of the existing floor joists, the report highlighted a significant number of post-construction service installations (notching of joists). This has inevitably weakened the overall structure, and there are also areas where further investigation is required to confirm sufficient end bearing condition.
- 3.2.3. Refer to Figure 3 below for examples of heavily notched joists.

- 3.2.4. Generally, the timber was found to be dry (unless otherwise noted) and in reasonable condition, notwithstanding the issues identified above. Timber samples were tested and identified as either Red Pine or, more likely, Baltic Pine. The timber was generally slow-grown and, in accordance with BS EN 1912:2024, would achieve a strength grading of C24.

- 3.2.5. Given the proposed increase in dead load, necessary to satisfy updated acoustic and fire performance requirements and in order to preserve the integrity of the existing floor structures, some level of repair and strengthening will be required in specific areas. End bearing conditions, as noted in 3.2.2, will also need to be verified.

Notes	Isometric View
<p><u>Localised Repair Detail at Notch Locations:</u></p> <p>Maximum permitted notch depth is 0.125 x joist depth.</p> <p>Where notching is identified (following removal of ceilings or floorboards), a full depth plywood plate shall be glued and screwed to both sides of the affected joist. The plywood plates should extend a minimum of 300mm beyond the notched area in both directions.</p> <p>Fixings to be staggered and installed in accordance with best practice for timber strengthening.</p>

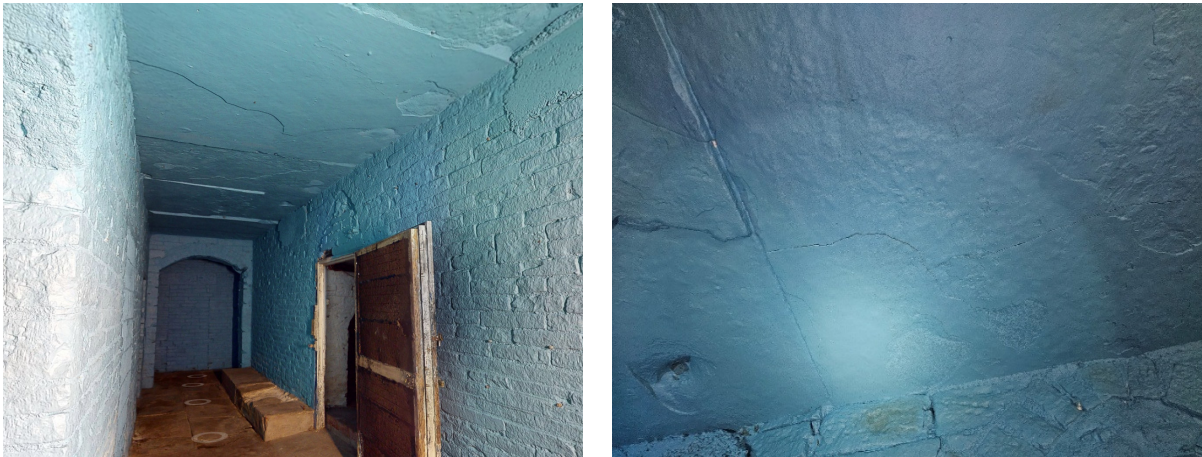
Figure 4 - Photos of Stone Slabs

- 3.3.1. During the condition survey carried out on 27/03/25, stone slabs were observed at both ground and first floor levels, spanning between loadbearing masonry walls.
- 3.3.2. The soffit of the Level 0 stone slabs was visible from the basement. Hairline cracking was noted across several areas, with more pronounced shear cracking evident toward the edges of some units.

- 3.3.3. It is believed that the slabs are formed from sandstone, a material known for variability in quality and strength. Due to this inconsistency, in-situ testing is considered both time consuming and likely ineffective, making it nearly impossible to verify structural capacity through traditional calculation methods.

- 3.3.4. In addition, available literature suggests that sandstone performs poorly under fire conditions and cannot be relied upon to meet modern fire performance standards.

- 3.3.5. Accordingly, we propose installing a grillage of steel beams, likely UC sections or back-to-back equal angles, pocketed into the existing loadbearing walls on padstones at either end. This will provide reliable structural support to the existing stone slabs.

- 3.3.6. The new steelwork will also serve as a suitable fixing point for underdrawn gypsum linings, effectively encapsulating the stone to provide the necessary fire protection.

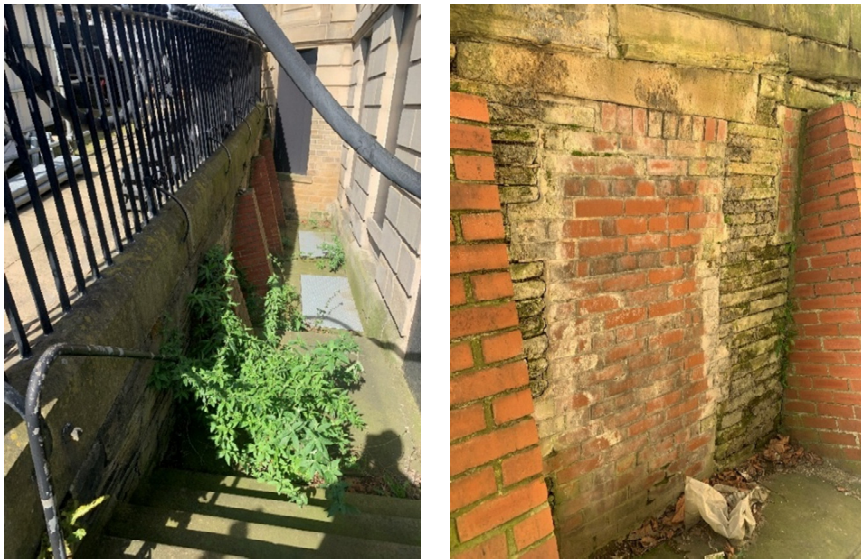
Figure 6 – Photos of Wall

- 3.4.1. During the condition survey carried out on 27/03/25, the existing masonry car park retaining wall, running parallel to Block A and St George's Square, was observed to be leaning significantly towards Block A. It appears that brickwork buttresses have been installed at some point in an attempt to address this issue, however, it is unclear what these are founded on or how effective they have been.
- 3.4.2. The existing iron railings and stone coping are also in poor condition and appear to be detaching from the wall below. The presence of stone lintels and infill brickwork suggests that a historic opening has been bricked up. Further investigation is required to confirm whether any voids exist beneath the adjacent ramp, or if the area has been fully backfilled.

- 3.4.3. Given the deteriorated condition of the retaining structure and its proximity to the listed building, it is recommended that the wall be carefully demolished and replaced with a reinforced concrete retaining wall, designed in accordance with current standards. It is understood that an AIP will be required for this element of the works.
- 3.4.4. To maintain the existing aesthetic, the new wall could be clad in the salvaged stone facing, with the stone coping and iron railings reinstated.
- 3.4.5. Refer to figure 7 below for existing and proposed sections through the Block A external wall.

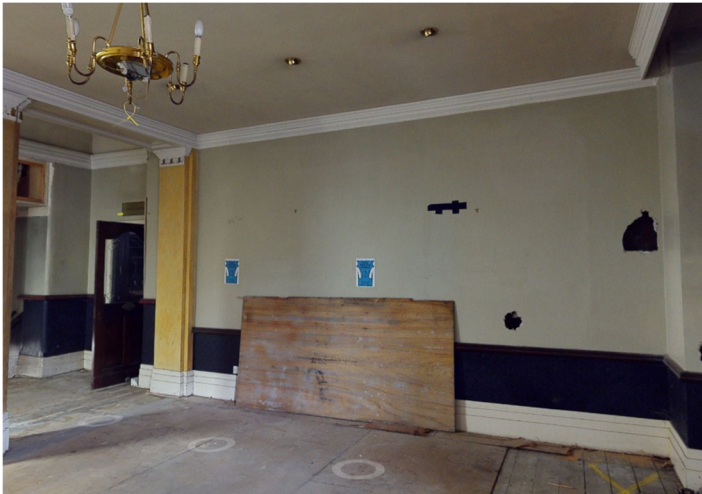
Figure 9 - Photo of Area to be Opened Up

- 3.6.1. The Client's aspiration is to open up the main reception/bar area to make full use of the available space and to create a welcoming, spatially generous first impression for visitors.
- 3.6.2. The existing loadbearing masonry wall, visible in the photograph below, currently extends the full height of the building from the basement up to eaves level. It also supports timber floor structures at multiple levels. As a result, a significant amount of vertical load is being transferred down to the foundations via this wall.

- 3.6.3. Subject to further intrusive investigation and in-situ testing, the current proposal is to introduce a new steel 'picture' frame structure. This will support both vertical loads from the masonry and floors above and provide necessary lateral stability. A prop column has been introduced within the opening to distribute loads more effectively into a bottom spreader beam, which in turn transfers the load into the existing basement walls, without significantly altering the load path.
- 3.6.4. Temporary works will be required to enable the safe removal of the existing structure and installation of the new frame. This will be developed in collaboration with the appointed Temporary Works Engineer at the next stage.
- 3.6.5. Refer to Figure 10 below for the current sketch proposal, which is considered the most pragmatic and buildable approach at this stage.
