# Gynn Lane, Honley

## River Condition Assessment Report

Report Ref. ER-7732-04B

Vivly Living

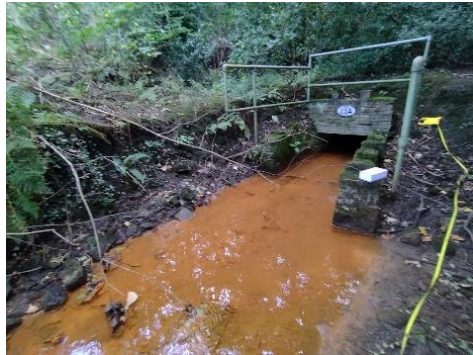
**Figure 3** View of culvert at Module 1.

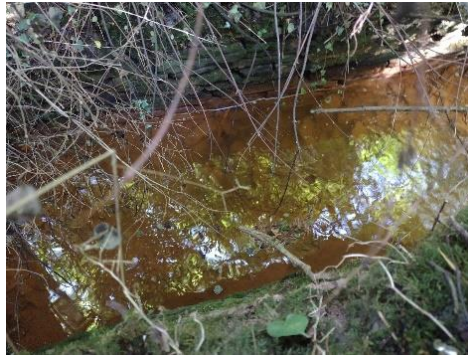
26. The bank faces are comprised of earth sediment where visible, with reinforcement associated with culvert, bridge and pipe outflow being of cemented laid brick. Vegetation comprises mosses, grasses, short and creeping herbs and scrub, with some small trees.
27. Trace amounts of the Non-Native Invasive Plant (NNIP) Himalayan balsam were observed on the left bank top in modules 4 and 5.

**Figure 4** View of channel with brick reinforcement at Module 2.

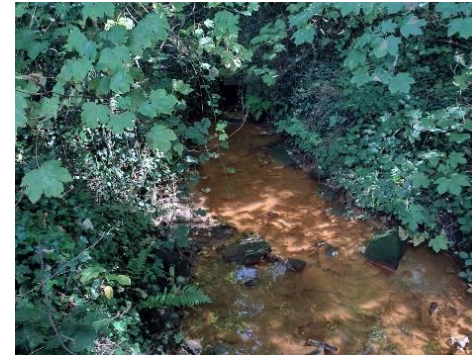
**Figure 5** View from end of module 3, facing upstream.

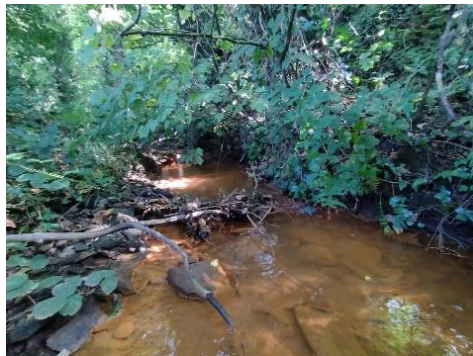
23. The dike has an average MoRPh river width of 1.8m (2.5 to 1.5m). The bed is generally shallow, averaging 0.08cm in depth, being shallower (0.05) upstream where the river is wider, and deeper (0.1) downstream, and comprises mainly unvegetated gravel and pebble, with occasional boulders thought to be artificially introduced. There are frequent accumulations of organic material within the channel.

**Figure 6** View of organic matter within channel bed.

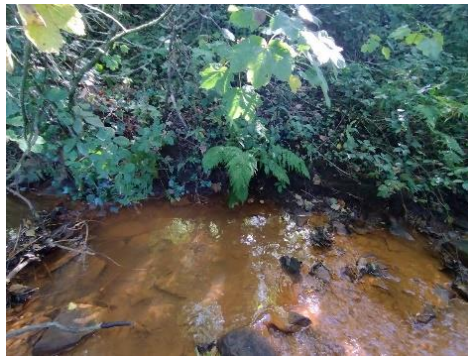
**Figure 7** Typical view of channel, bank face and bank top.

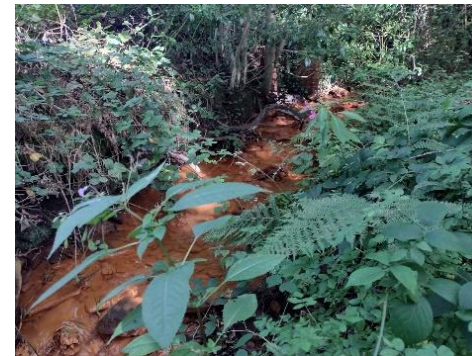
**Figure 8** Himalayan Balsam in module 4.

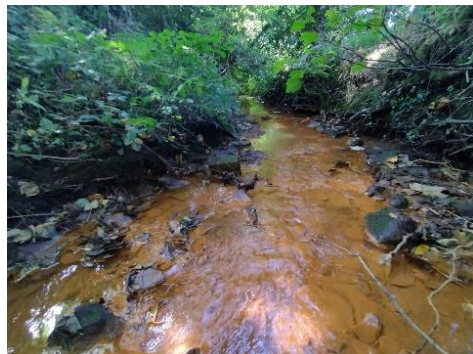
**Figure 9** View of module 5 facing downstream.

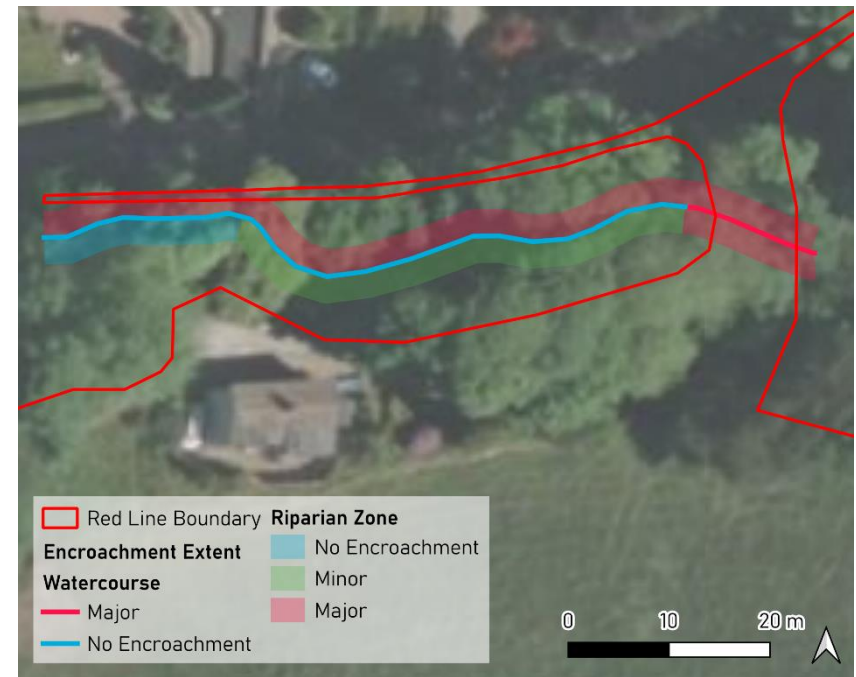
**Figure 10** Encroachment assessment of Ludhill Dike.

Length	Encroachment extents		
	Watercourse	Riparian Zone (N)	Riparian Zone (S)
13m	Major	Major	Major
48m	No encroachment	Major	Minor
20m	No encroachment	Major	No encroachment

- 32. The watercourse encroachment has been assessed based on the presence of reinforcement to the bank faces from the bridge and facilitating the pipe outflow.
- 33. The riparian zone encroachments have been assessed based on the presence of Gynn Lane running along the full length of the northern bank, and the access track to the Site running along the majority length of the southern bank.

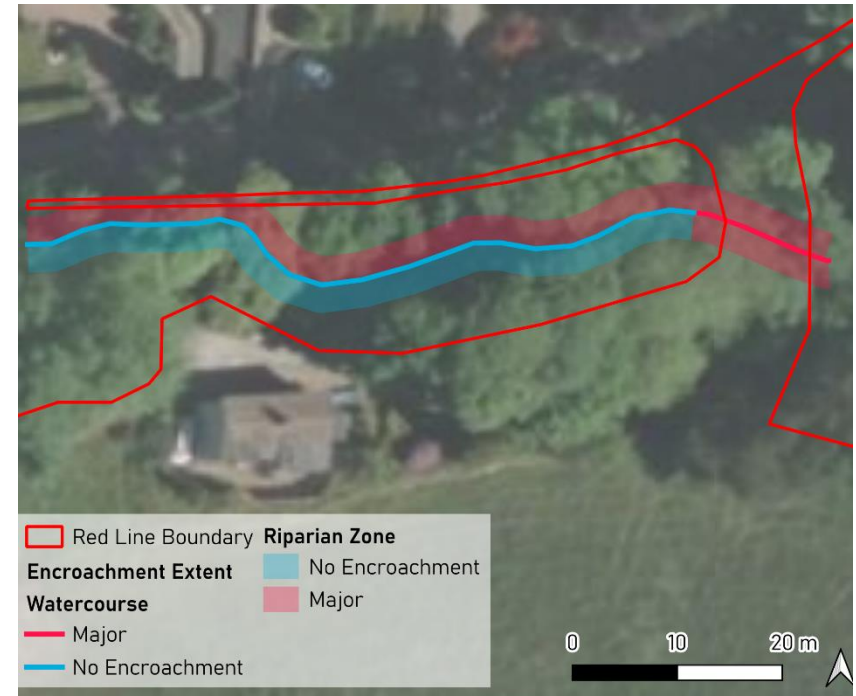
**Figure 11** Post-development encroachment assessment of Ludhill Dike.

39. Changes to the riparian zones have resulted in a reduction in the extent of riparian zone encroachment to the middle 41m of the watercourse. The watercourse encroachment has been retained.
40. This has been assessed based on the change from access track and vegetated garden to an area of POS to the south of the river.
41. The most upstream 14m, and most downstream 26m have retained their baseline encroachment extents.

Length	Encroachment extents		
	Watercourse	Riparian Zone (N)	Riparian Zone (S)
13m	Major	Major	Major
48m	No encroachment	Major	No encroachment
20m	No encroachment	Major	No encroachment
