**ARBORICULTURAL REPORT
AND
ARBORICULTURAL IMPACT ASSESSMENT
to BS 5837:2012
at
Highmoor Lane
Cleckheaton
West Yorkshire
BD19 6LW**

Client:
Morris & Spottiswood

JCA Ref:
22114c/LW

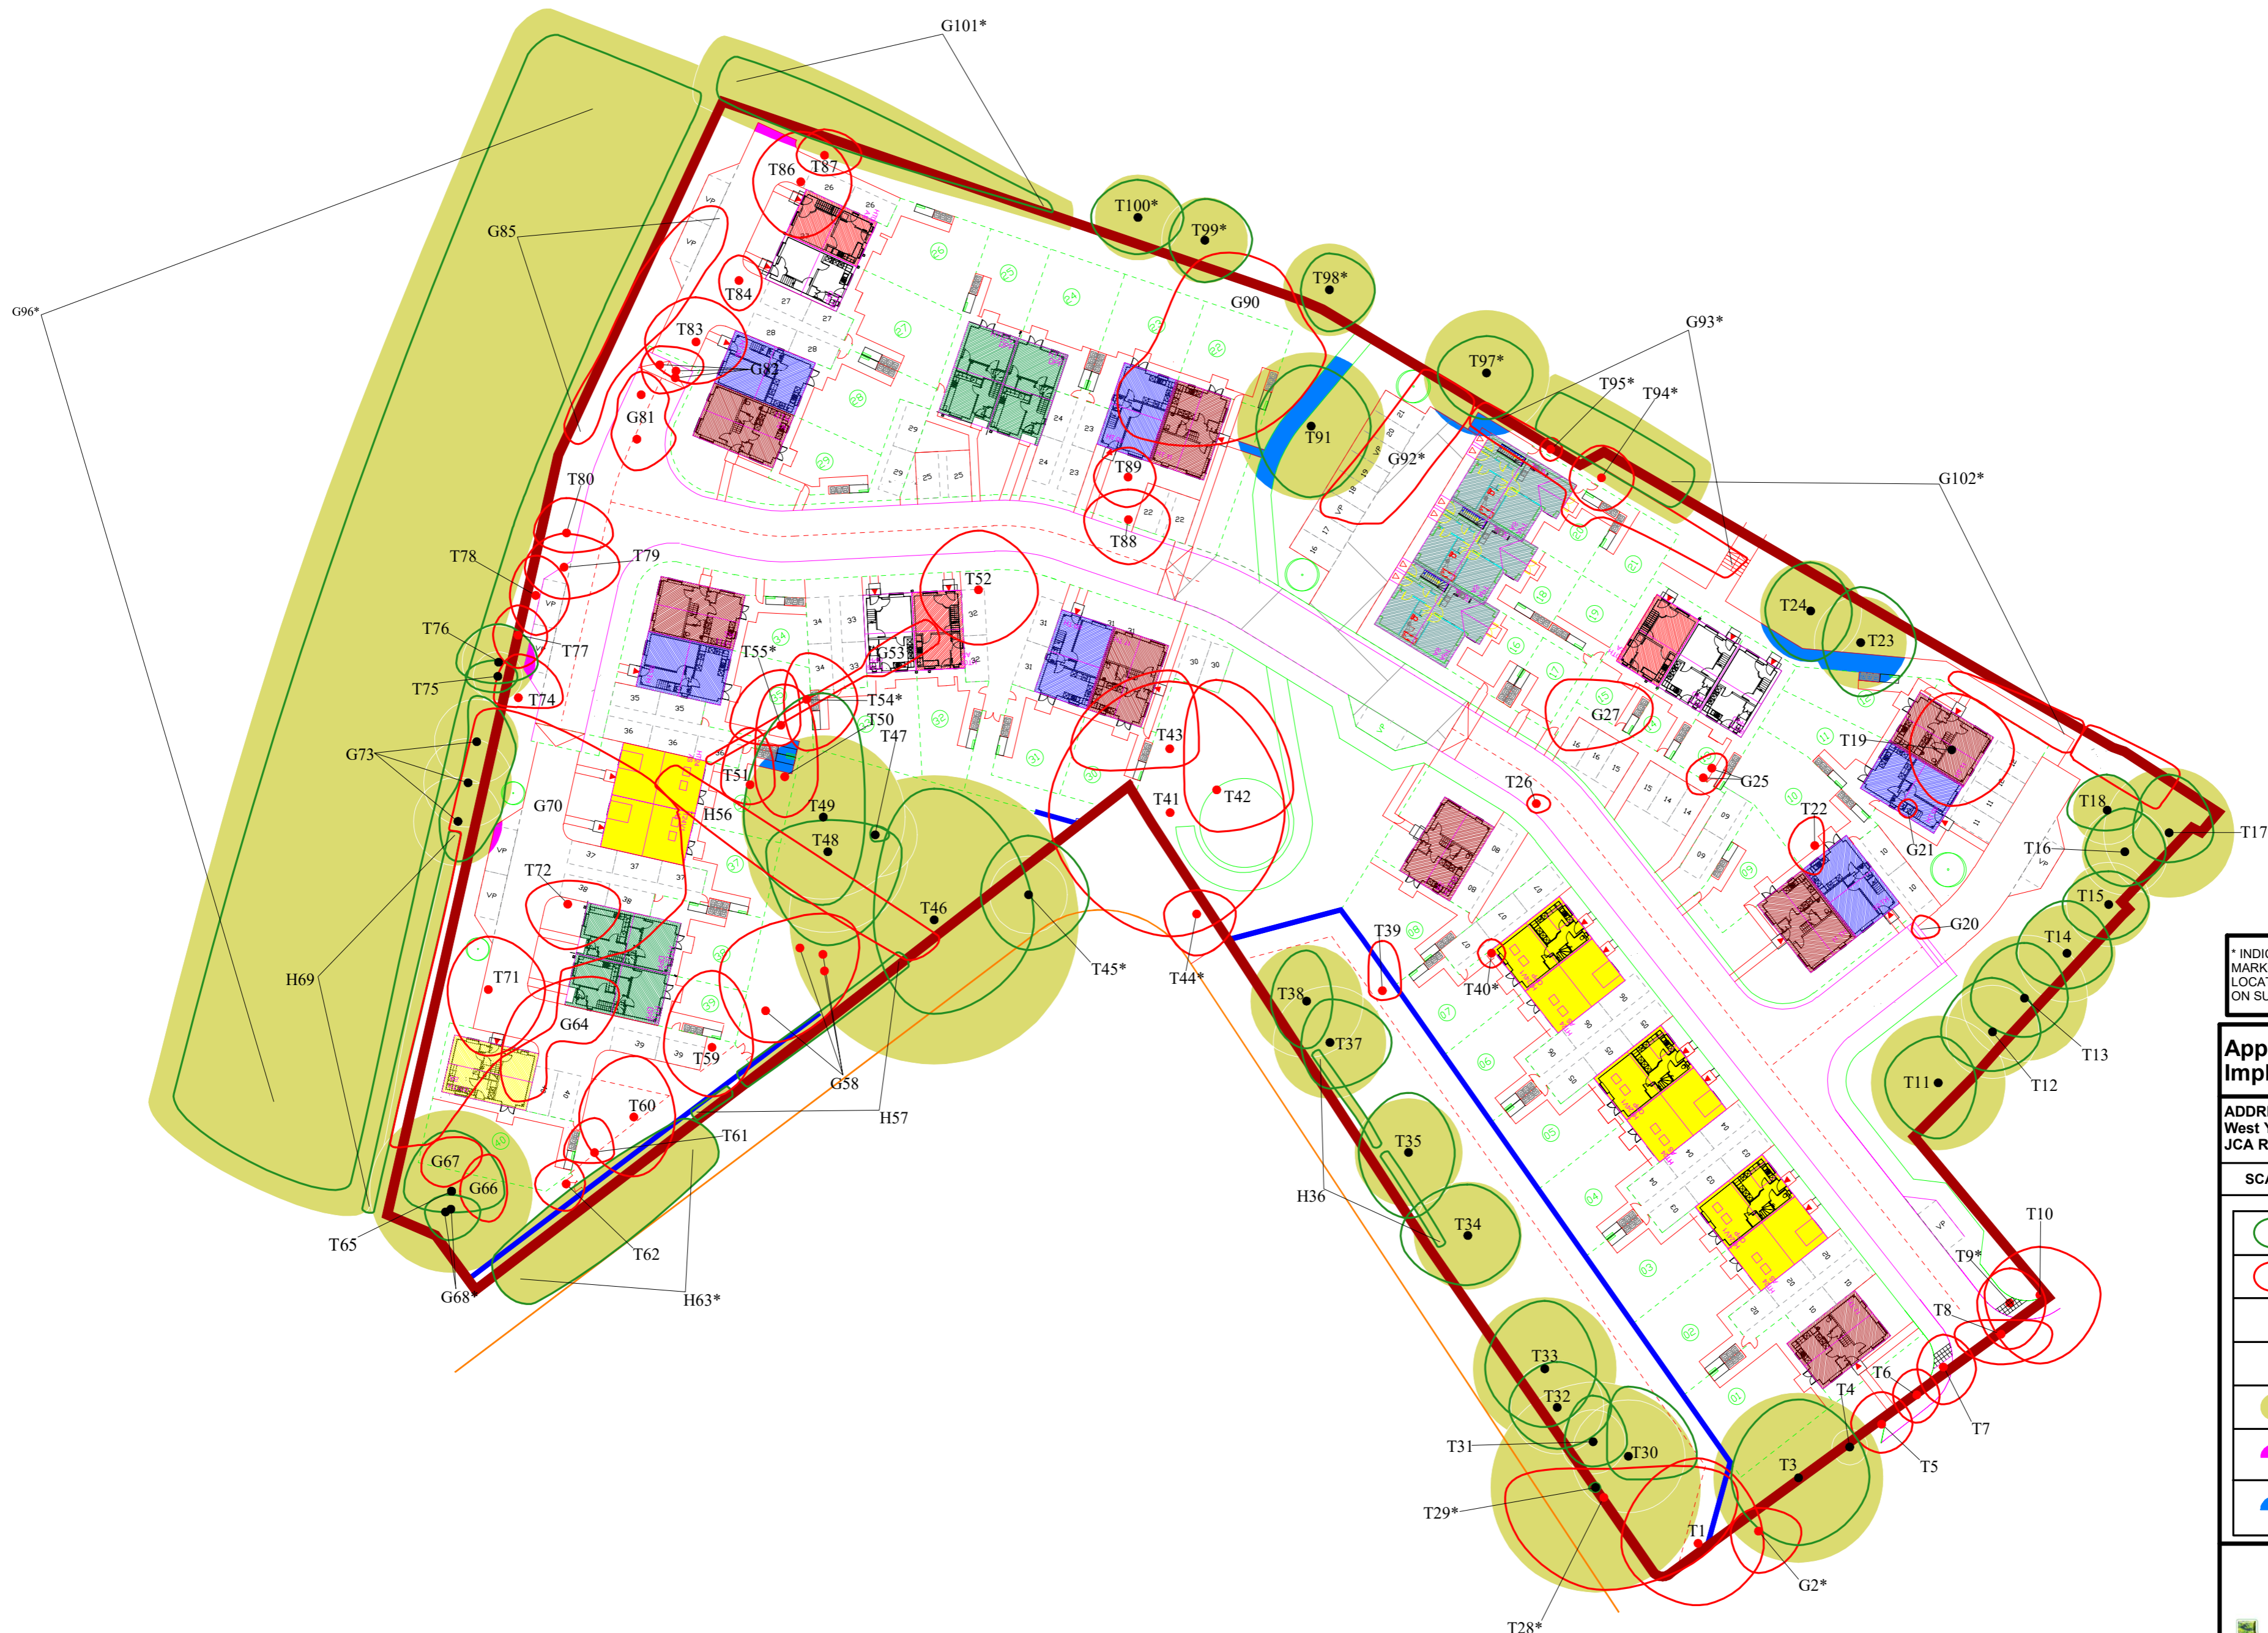
Appendix 6: Arboricultural Implications Plan

- 4.5.3.1 The proposed development entails the construction of hard surfacing within the RPAs of **T23, T24, G73, T76, T91** and **T97**. This takes the form of pedestrian footpaths. In order to prevent foreseeable damage to tree roots, a 'no-dig' method of construction will be utilised.

- 4.5.3.3 Design principles must be confirmed by an appropriately qualified engineer and should be included in an Arboricultural Method Statement.
- 4.5.3.4 Proposed hard surfacing is located within the RPAs of **T65, G73** and **G101**. Due to the minimal nature of the incursion, it is not considered necessary to install specialised surfaces. Instead, root pruning will be undertaken under the supervision of an appointed arboriculturist to minimise potential damage to tree roots and prevent 'ripping' damage, which is commonly associated with mechanical excavation.

- 4.5.2.1 It is proposed to remove existing hard surfaces within the RPA of **T91**. This operation will require the supervision of an arboriculturalist.
- 4.5.2.2 For this method, the existing hard surface will first be broken by mechanical means. Care will be taken to only break the existing hard surface and not to disturb the underlying soil (where the tree roots are located). Once the surfacing has been broken into manageable sizes, it will be carefully removed from the area.
- 4.5.2.3 Once all the rubble has been removed from the area, it will be re-instated with topsoil.

- 4.5.3.2 The chosen system must be fit for purpose and of suitable construction to dissipate compaction damage to tree roots, allow gaseous diffusion to/from the soil and the percolation of water to the soil surface. This may require the use of specialist materials and sensitive edging systems to prevent damage to tree roots. It is recommended that this surfacing be constructed as a final phase of construction, in order to afford the maximum protection throughout development.
