**ARBORICULTURAL REPORT
AND
ARBORICULTURAL IMPACT ASSESSMENT
to BS 5837:2012
at
Highmoor Lane
Cleckheaton
West Yorkshire
BD19 6LW**

Client:
Thirteen Group

JCA Ref:
22114c-Rev2/LW

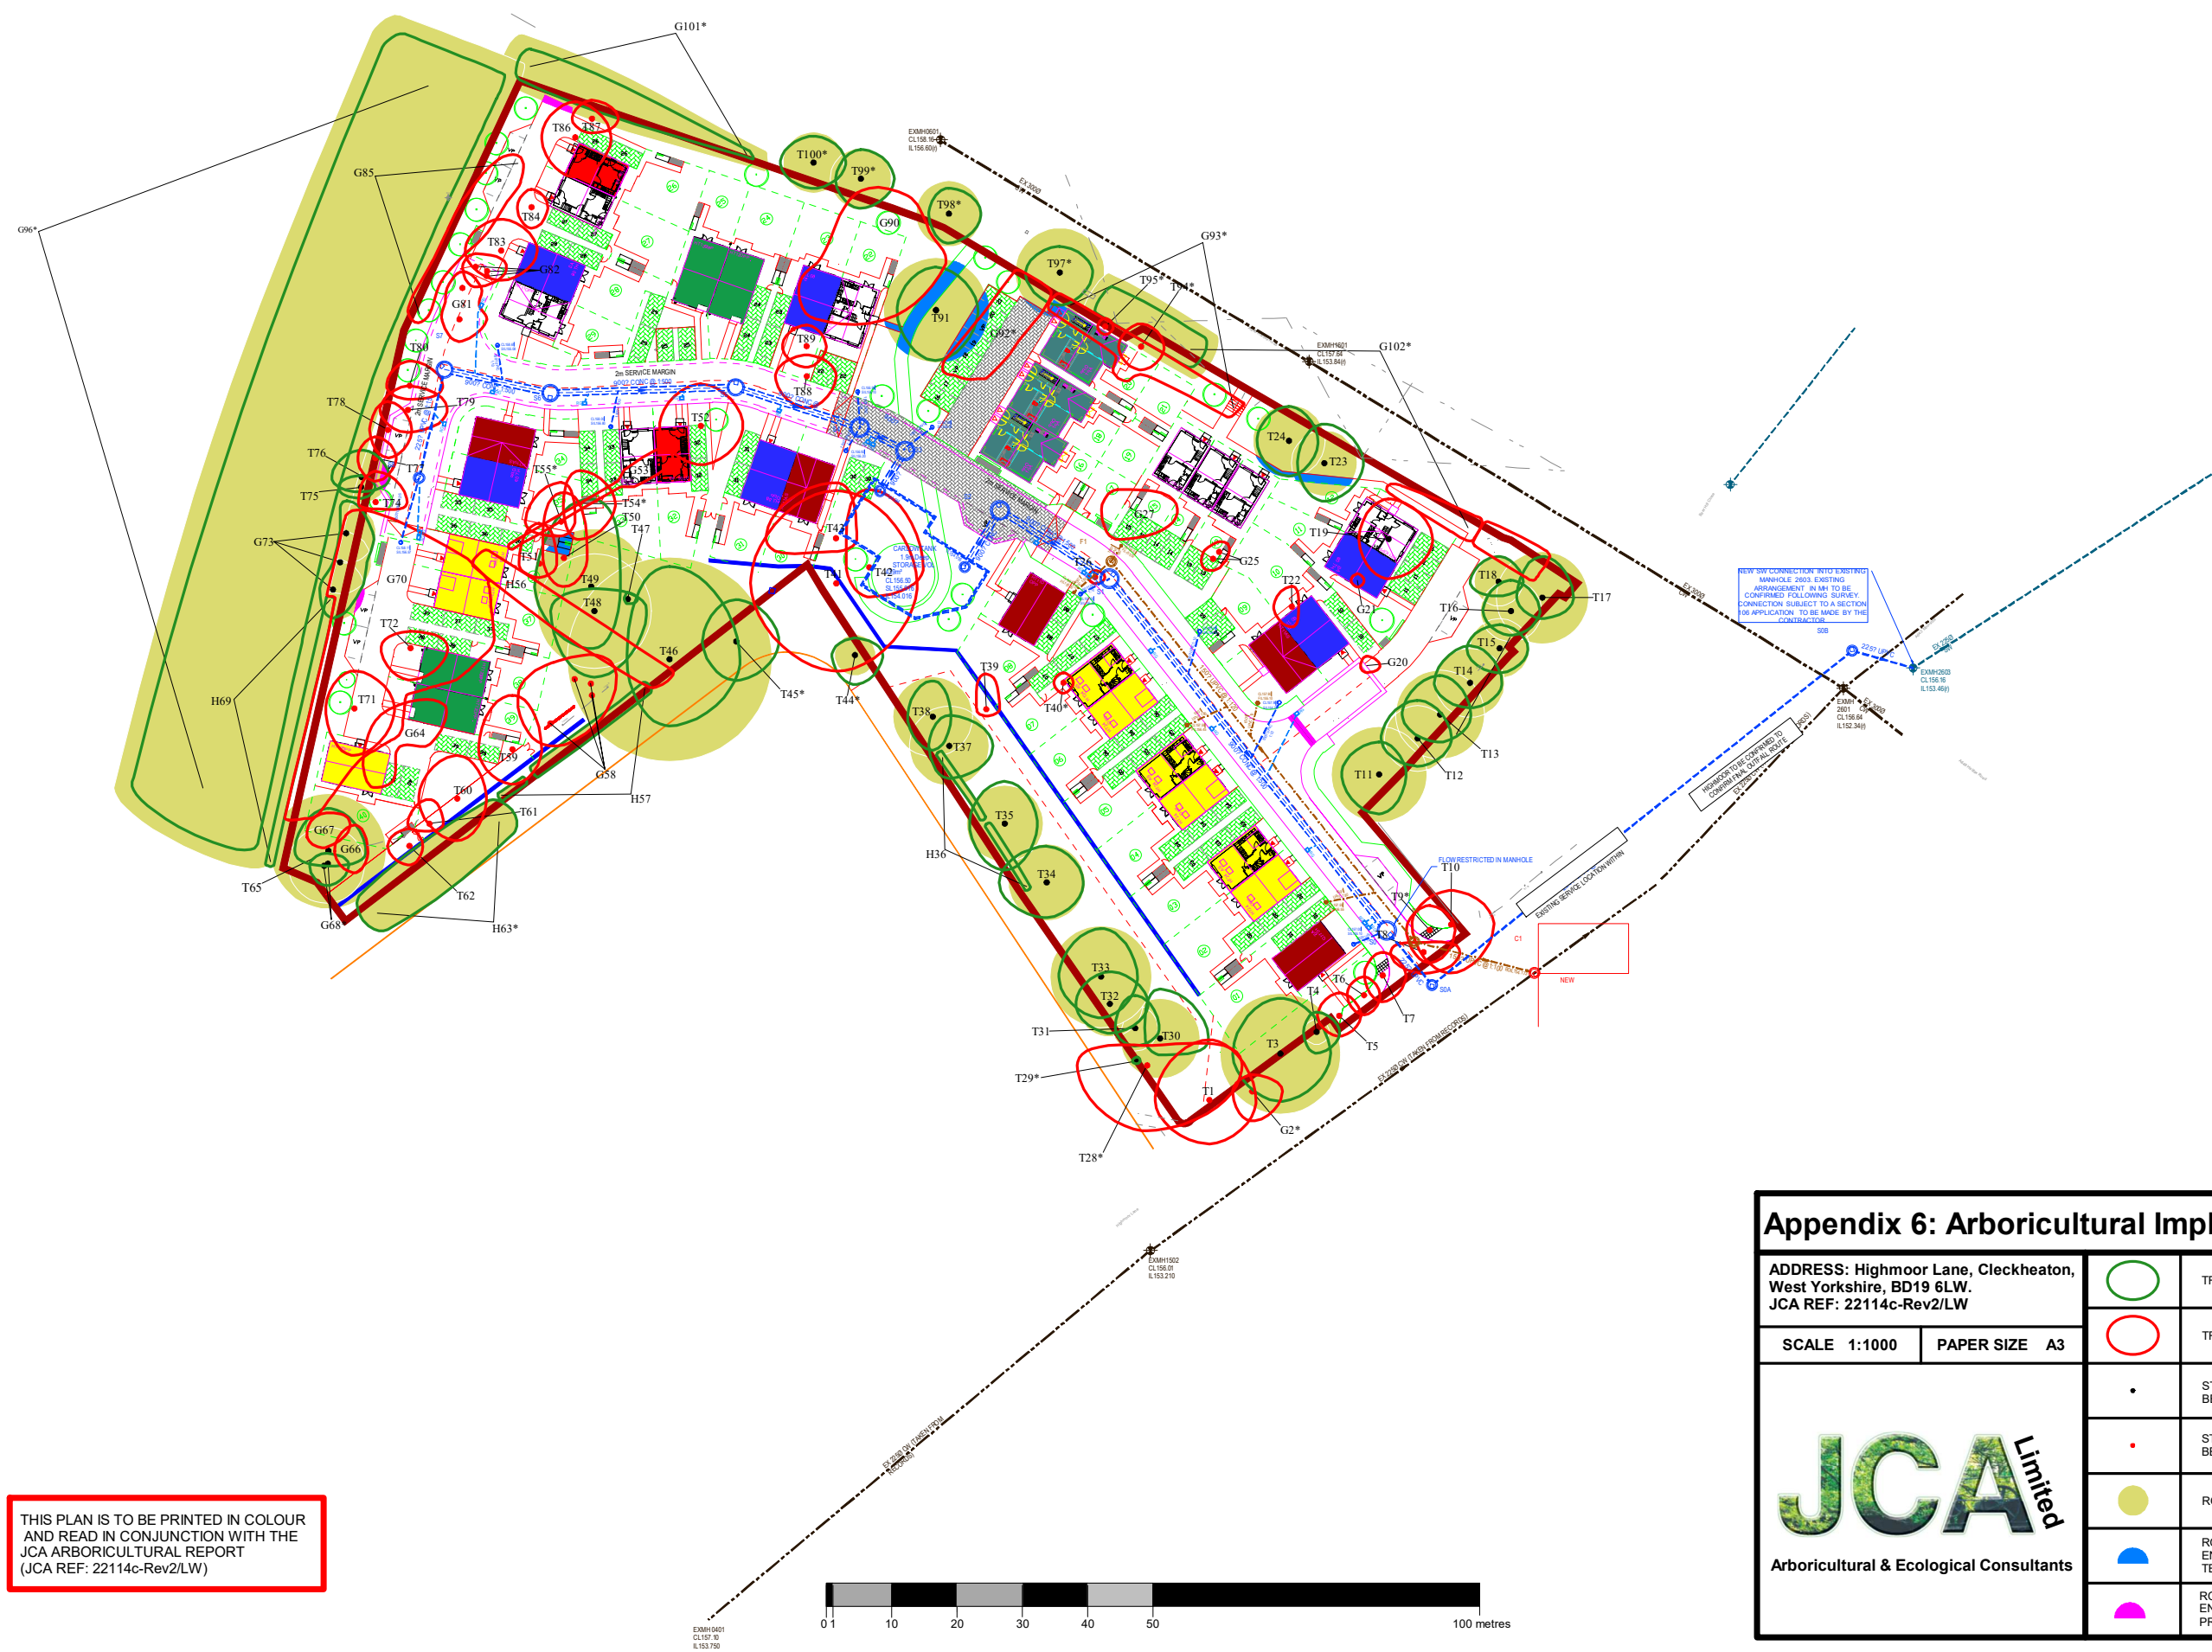
Appendix 6: Arboricultural Implications Plan

4.5.3.1 The proposed development entails the construction of hard surfacing within the RPAs of **T23**, **T24**, **T91** and **T97**. This takes the form of pedestrian footpaths. In order to prevent foreseeable damage to tree roots, a 'no-dig' method of construction will be utilised.

4.5.3.4 Proposed hard surfacing is located within the RPAs of **G73**, **T76** and **G101**. Due to the minimal nature of the incursion, it is not considered necessary to install specialised surfaces. Instead, root pruning will be undertaken under the supervision of an appointed arboriculturist to minimise potential damage to tree roots and prevent 'ripping' damage, which is commonly associated with mechanical excavation.

4.3.2 Where the footprint of proposed hard surfacing pass within the RPA of retained trees, root pruning will be required, under the supervision of an appointed arboriculturist. Root pruning will accommodate the proposed roads whilst preventing any 'ripping' damage, a problem commonly associated with mechanical excavations. Root pruning is relevant to **G73, T76** and **G101**.
