Desk study and
preliminary risk
assessment report for
amended design

Wood Lane, Mirfield

Client: South Pennine Boat Club

REFERENCE:	SPBC-DSAD	VERSION:	1	ISSUE DATE:	19 April 2025
-------------------	-----------	-----------------	---	--------------------	---------------

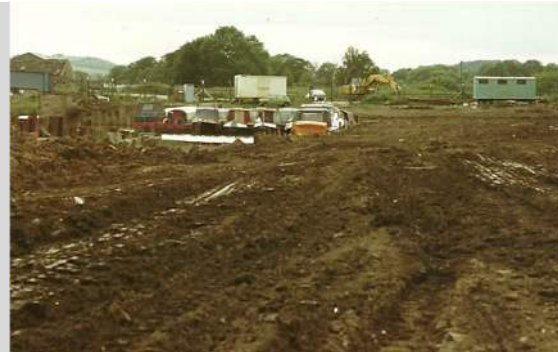
12. Arisings used to infill drainage ditch and lagoon to rear of dry dock, after new culvert installed

The large excavation undertaken to create the mooring basin (photos 7 to 12) reportedly did not encounter any unexpected or unusual ground conditions, and the arisings were used to infill the ditch and lagoon to the rear of the dry dock, after installation of a culvert leading directly from the sluice to the River Calder.

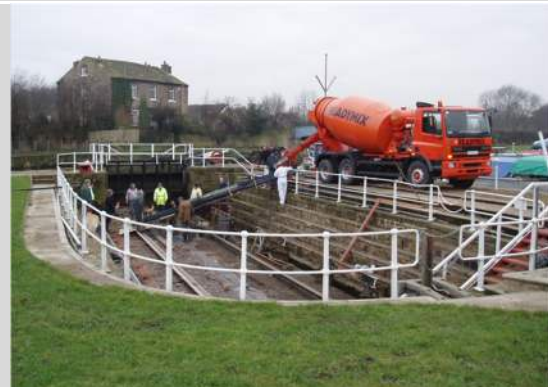
16. Reinforced concrete laid over original stonework at base of dry dock. Railings and paving slabs installed around perimeter.

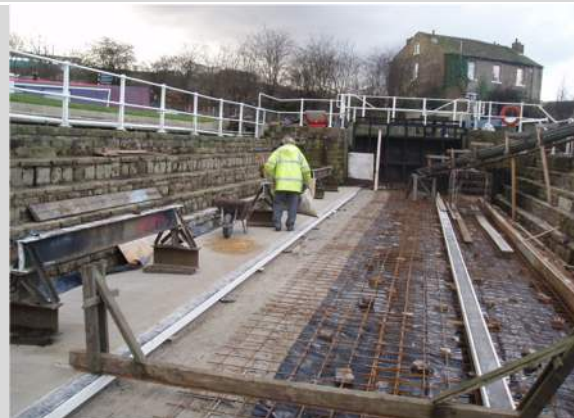
17. Reinforced concrete laid over original stonework at base of dry dock.

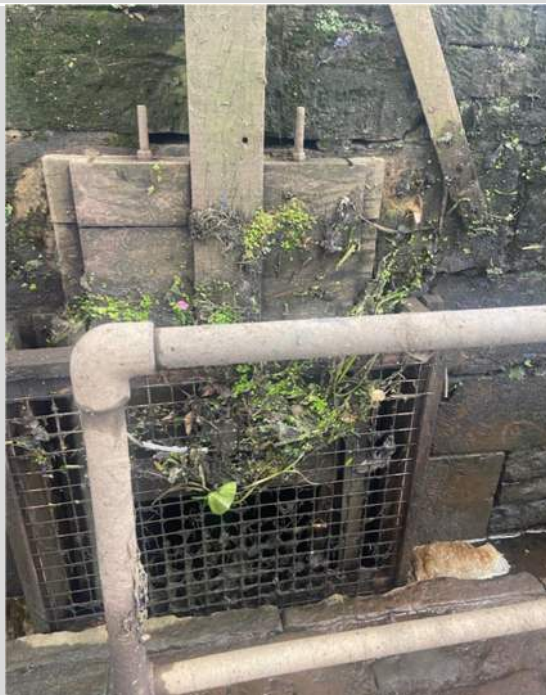
11. Sluice gate at northeast end of dry dock. The drainage ditch and lagoon have been replaced with a culvert that feeds directly into the River Calder.

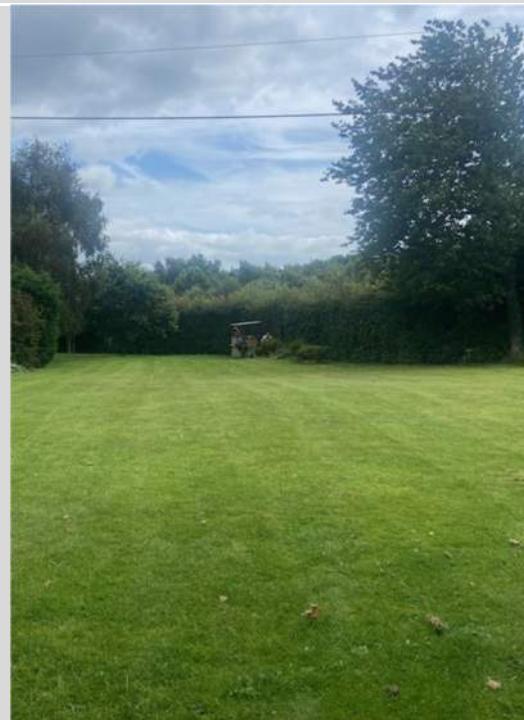
12. Boat club grounds, well maintained, no evidence of grass die-back.

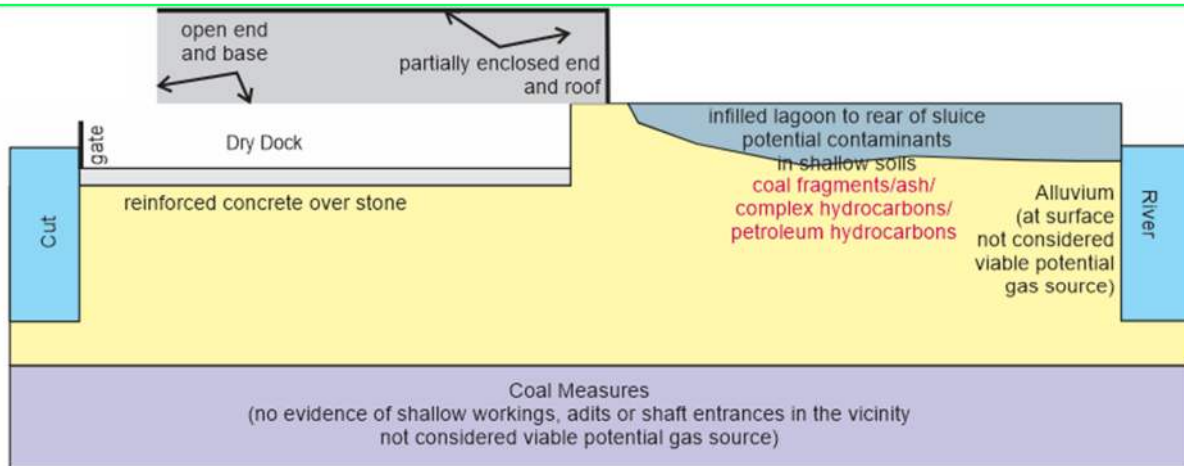
Figure 4: Simplistic ground model

Potential sources: contaminants in shallow soils from historic usage as boatbuilding yard
 Potential receptors: end users, construction workers
 Potential pathways: direct contact, ingestion, inhalation of vapours

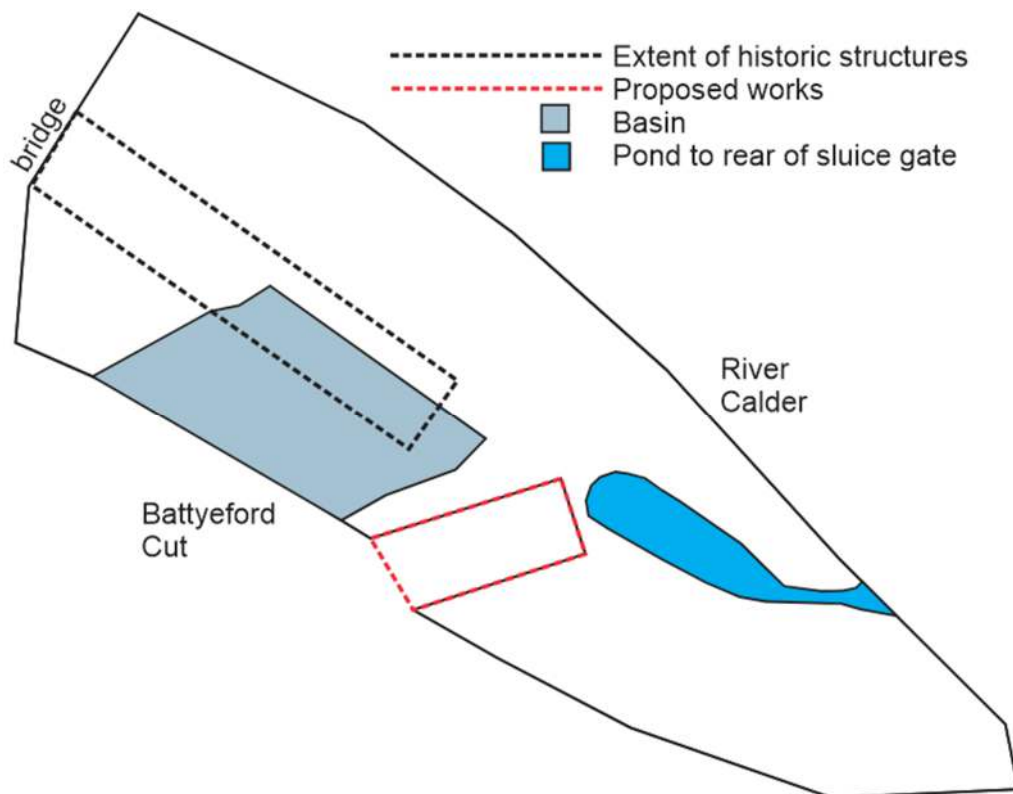
Figure 5: Schematic of larger site

The extent of buildings shown on historic maps (Table 1) can be seen to end some distance to the northwest of the proposed works, and the location of actual barge construction (Figure 3) took place within the area of the new mooring basin. It is known that arisings from the excavation of the mooring basin were used to infill the historic lagoon to the rear of the sluice. The perimeter of the dry dock comprises concrete steps, paving slabs and pillars which were constructed/placed at various times after completion of the basin excavation. It can be seen in photographs that during re-building of the dry dock walls, the soil to the rear of the original stonework remained largely undisturbed, and as such it can be assumed that none of the basin arisings were placed directly around the perimeter.
