**Project:** 25\_5837\_11\_49  
**Site:** 11 Cumberland Ave, Huddersfield HD2 2JJ  
**Client:** Mannan Iqbal

| Report Type: | Tree Survey, Arboricultural Impact Assessment & Method Statement |

# Arboricultural impact assessment

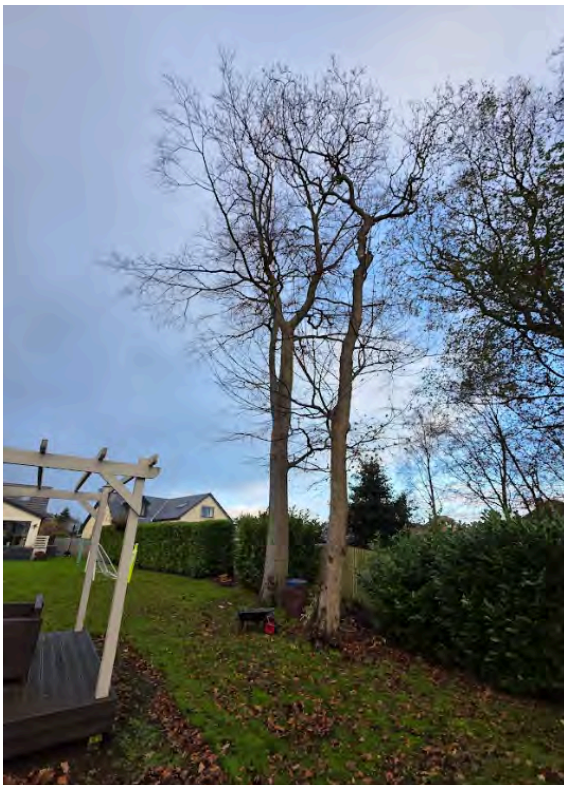
*Photographic plate showing T1 & T2. (ROAVR, 2025)*

| Tree Number | Species | Age Class | DBH | Height (crown height) | N | E | S | W | Condition | Life Expectancy | Physical Description | Comments | Managment Recommendations | RPA offset from stem. | Category Rating |
|---|---|---|---|---|---|---|---|---|---|---|---|---|---|---|---|
| T1 | <i>Fagus sylvatica</i> (Beech) | M | 701 | 22(4) | 4 | 7 | 4 | 5 | Good | 40+ | Small cavity at base on South West side between buttresses with 2 young fresh unidentified fungal fruiting bodies inside, | None | None | 8.41 | A1 |

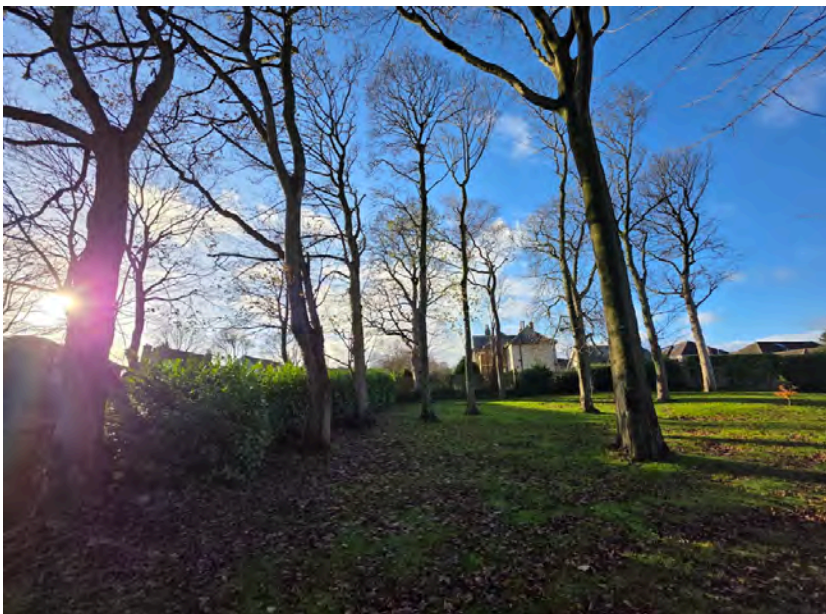
*Photographic plate showing the extent of mature tree cover on site with T6 (front right) and T7 (front left) and T10 to T20 in the background. (ROAVR, 2025)*

The proposed driveway and parking area encroach into the RPAs of T5, T6, T7, and T1.

- **No-Dig Methodology:** To ensure the viability of these specimens, no excavation is permissible within these areas; the surfaces must be constructed using a no-dig, three-dimensional cellular confinement system.
- **Installation Standards:** The system must be laid directly onto the existing ground level to ensure the continued water permeability and gaseous exchange required for root function.

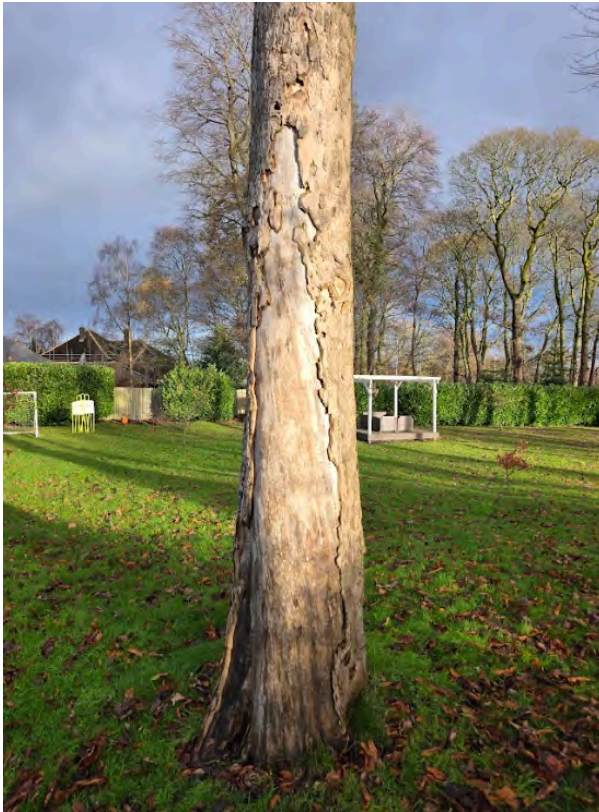
*Photographic plate showing major bark wounding at the base to roughly two metres above ground level on the west side of T16. (ROAVR, 2025)*

| T16 | <i>Acer pseudoplatanus</i><br>(Sycamore) | M | 606 | 20(6) | 4 | 3 | 3 | 6 | Fair | 10+ | Cavity at ground level on the south east side 70mm length 20 mm width and roughly 45mm depth. Investigations with a probe and mallet show that the exposed wood inside is very loose with hollow sounding mallet sounds around the cavity at ground level on the south and west side. Major bark wounding on the West side on the stem to 2.5 metres above ground level. | None | Further investigation with decay section equipment recommended due to surrounding targets on the dwelling and neighbouring property. | 7.27 | C1 |

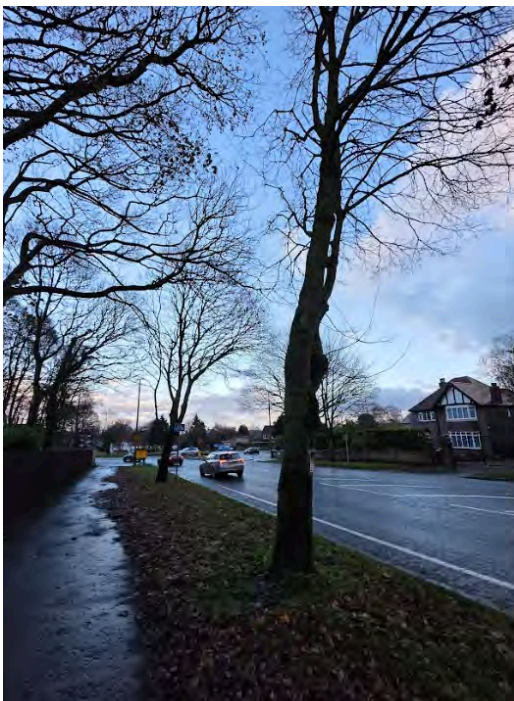
*Photographic plate showing offsite trees T21 & T22 and the proposed dropped kerb and vehicle crossover location. (ROAVR, 2025)*

The proposed dropped kerb is located within the RPA of T21, an off-site Norway Maple situated within a soft landscape strip.

- **Manual Excavation:** Because the majority of T21's roots will be located within this strip, all excavations must be undertaken by hand using hand-held tools.
- **Supervision and Build-up:** All manual work must be conducted under arboricultural supervision, with the new vehicle crossover constructed using a permeable surface build-up to mitigate the impact of the minor level difference from the road.
