**ARBORICULTURAL IMPACT ASSESSMENT  
to BS 5837:2012  
at  
Red House  
281 Oxford Road  
Cleckheaton  
West Yorkshire  
BD19 4JP**

**Client:**  
Kingscrown Developments

**JCA Ref:**  
22627a/ChC

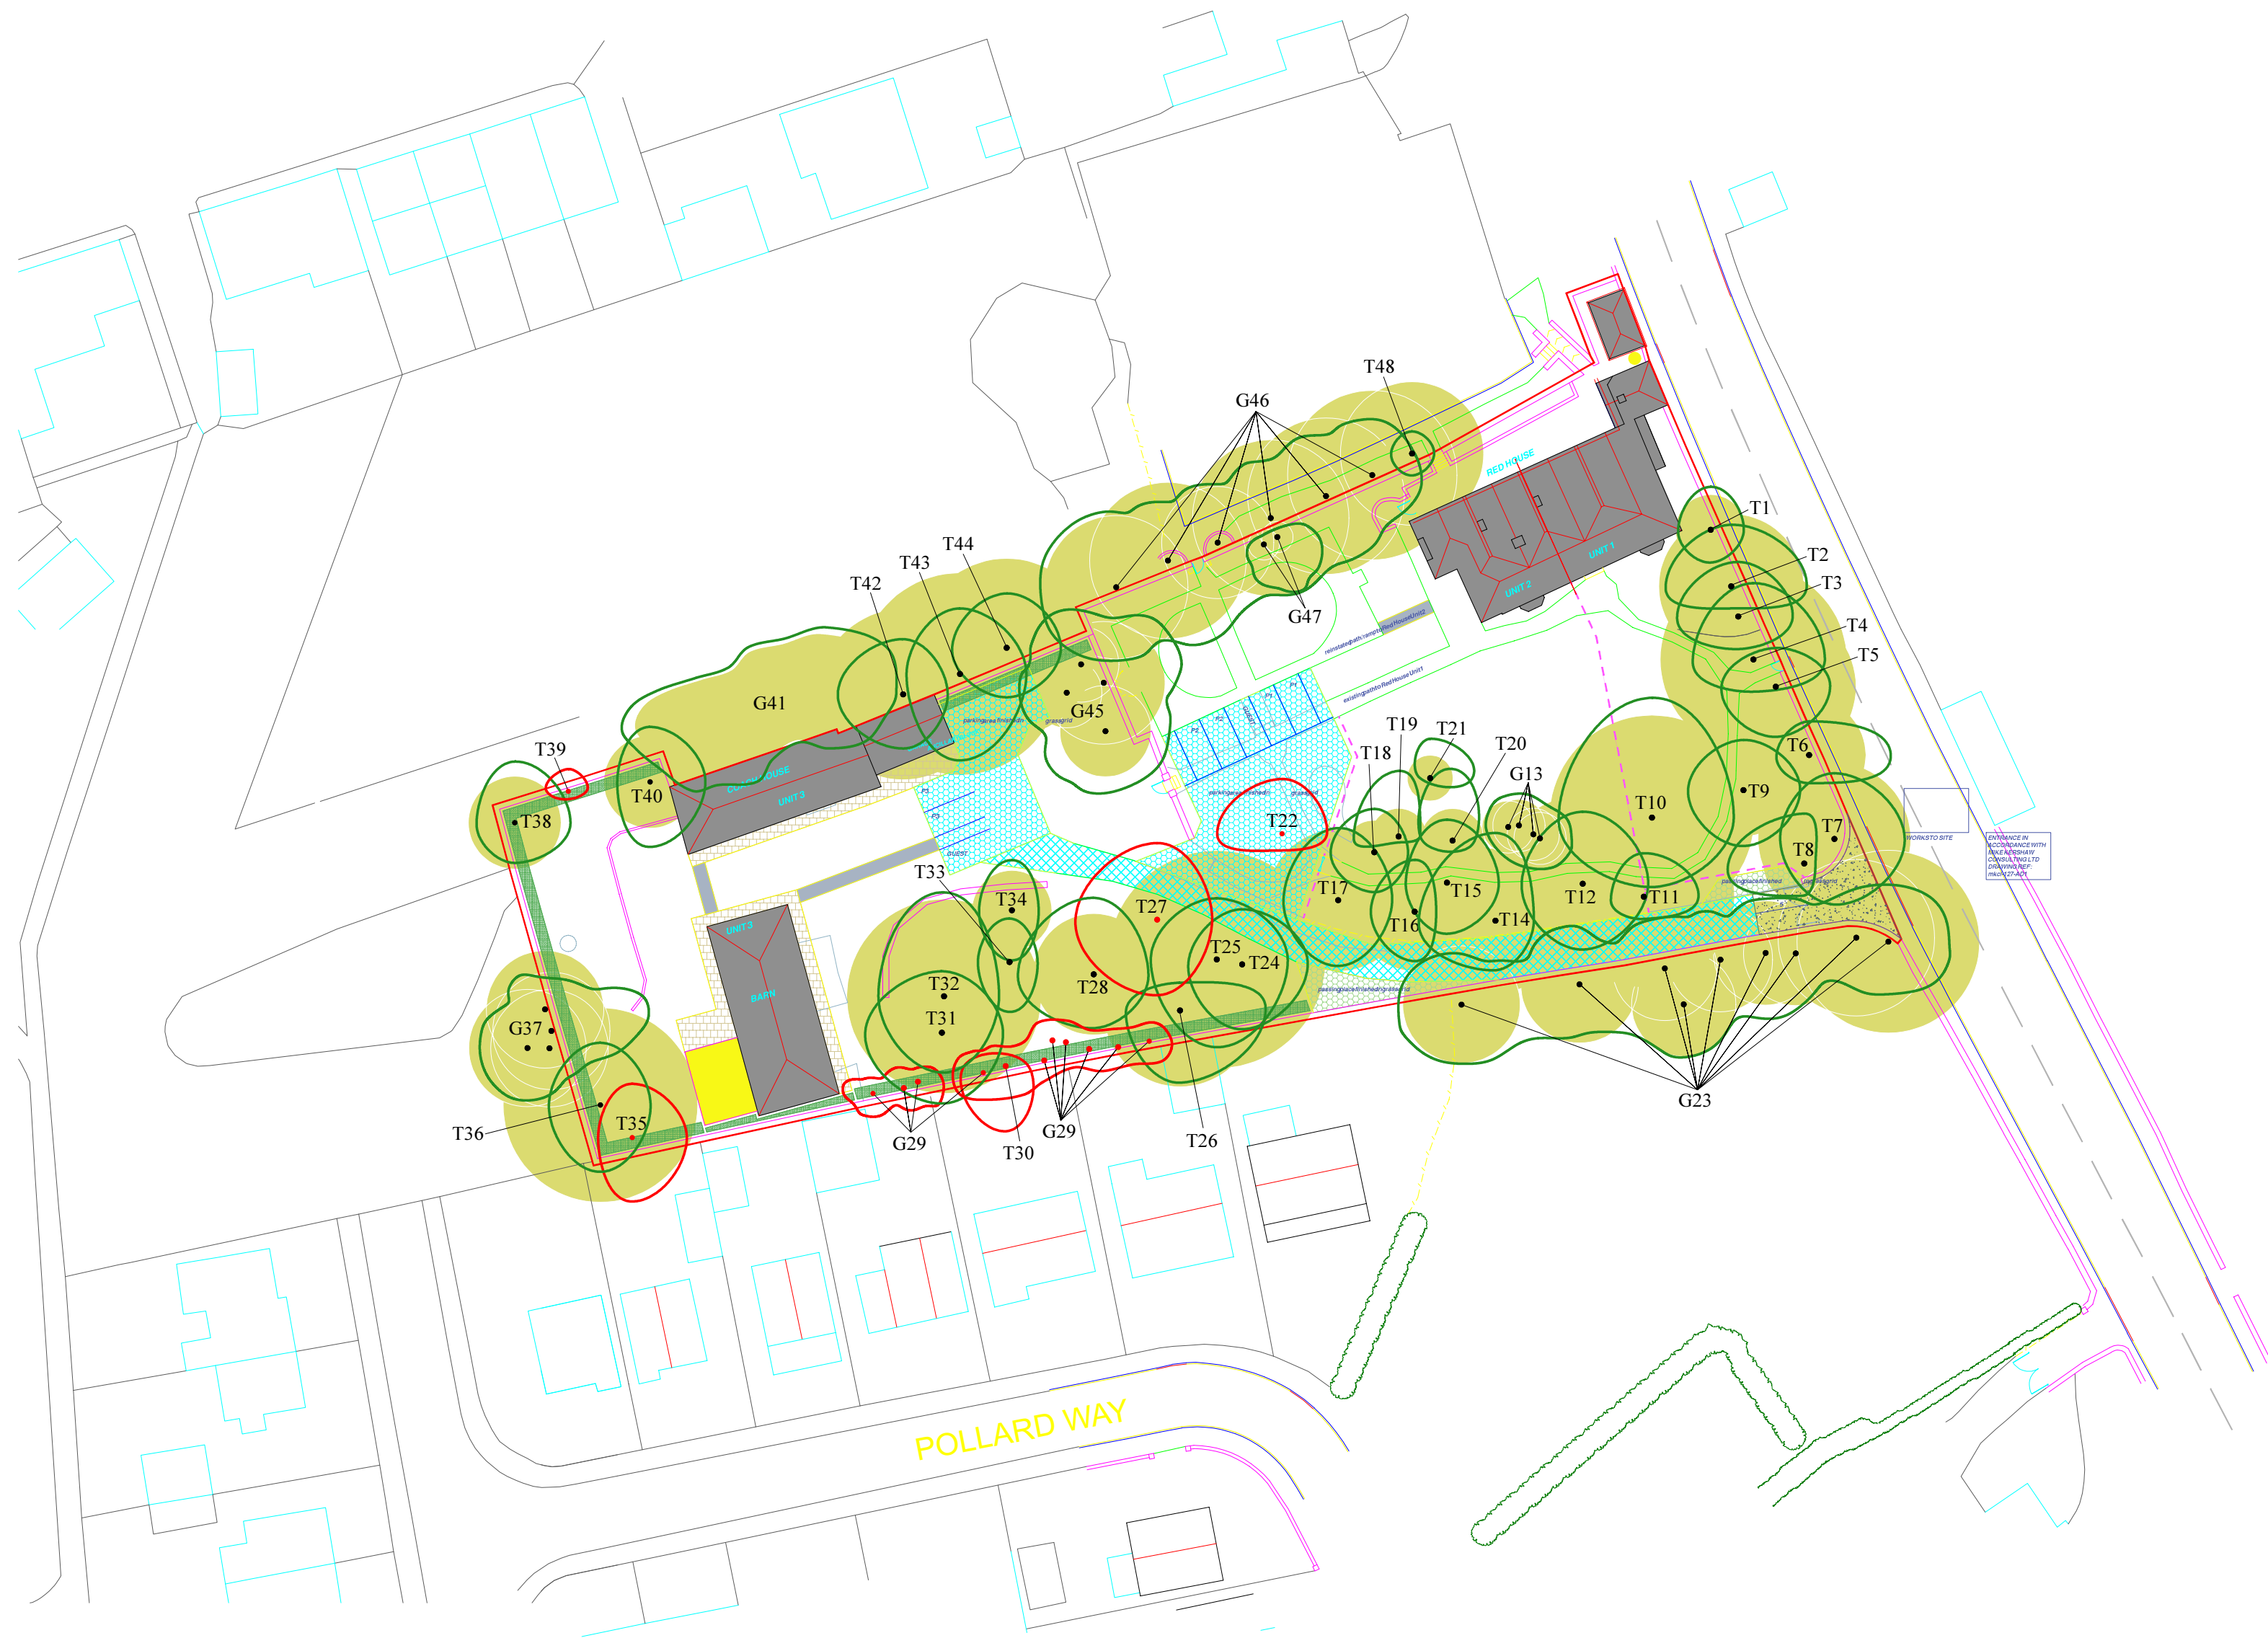
**Appendix 6: Arboricultural Implications Plan**

3.2.1 **T22, T27, G29 and T35** are proposed to be removed to facilitate the proposed scheme. However, **T27** can be retained as a standing monolith at circa 5m in height.

3.3.1 To accommodate the proposed development works, it will be necessary to prune **G23, T24, G37, T40, G41, T42, T43, T44 and G45**.
