**274 Cumberworth Lane**

**Coal Mining Risk Assessment**

**October 2025**

**Project:** 274 Cumberworth Lane Coal Mining Risk Assessment

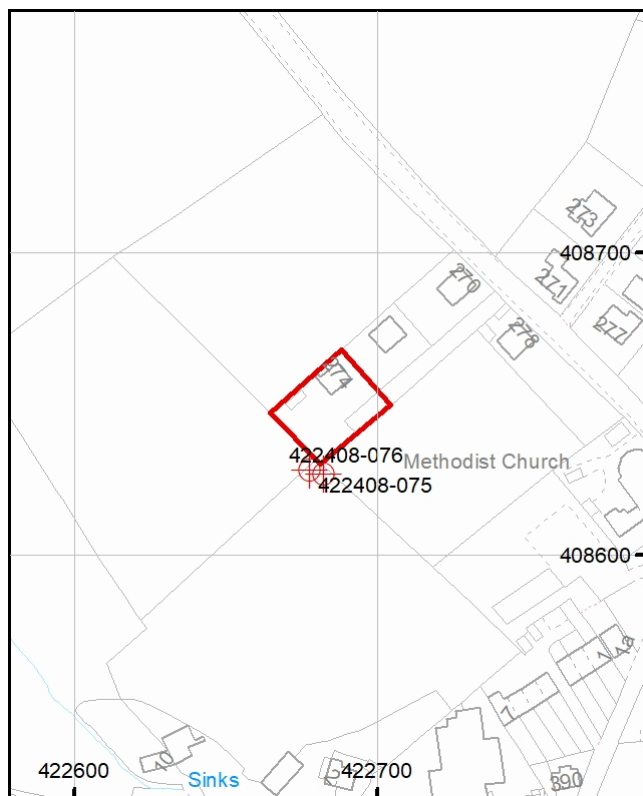
# Enquiry boundary

We can confirm that the location is  
**on the coalfield**

Within, or within 20 metres of, the boundary of the property there are 2 mine entries, the approximate positions of which are shown on the enquiry boundary plot. For reasons of clarity, mine entry symbols may not be drawn to the same scale as the plan.

422408-076. This shaft was fully grouted in 2018 by Sirius Drilling Ltd. Shaft capped with a 3.90x3.90x0.50m reinforced concrete slab at a depth of 1.0m bgl (rockhead), designed by CoDa Structures and approved by Coal Authority in Feb 2020.

422408-075. This shaft was fully grouted in 2018 by Sirius Drilling Ltd. Shaft capped with a 3.90x3.90x0.40m reinforced concrete slab at a depth of 1.0m bgl (rockhead), designed by CoDa Structures and approved by Coal Authority in Feb 2020.

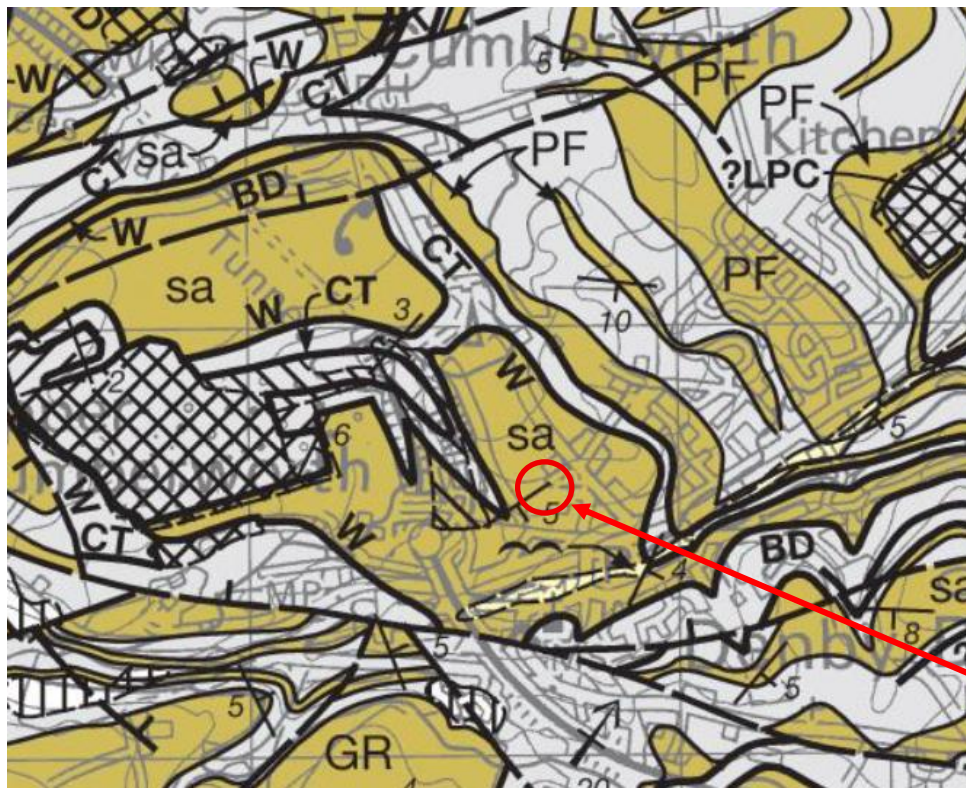
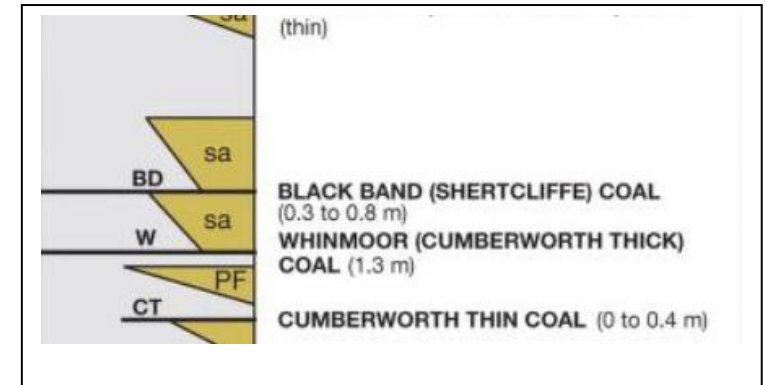
## **APPENDIX B – GEOLOGICAL MAP EXTRACT**

The site is mapped as being underlain by bedrock of the Pennine Lower Coal Measures, Mudstone, Siltstone and Sandstone.

The Whinmoor (Cumberworth Thick) coal seam is mapped approximately 110m to the West of the site and the Cumberworth Thin coal seam 220m to the West of the site, with relative thicknesses of 1.3m and 0 to 0.4m.

The site is situated within an area of probable shallow mine workings and in a development high risk area. Upon inspecting geological maps, it is evident that two coal seams are situated nearby (within 250m, and all are known to have been worked for various uses.

- 3 Rotary Open Hole Boreholes to 25m depth to allow for assessment of underlying strata and to identify whether unrecorded mine workings exist;

- Full intrusive investigation report summarising the findings of the investigation.
