Project: Land at East Field Shepley, Huddersfield
Title: Building Inspection
Job No: 2157.01
Date: 26 February 2026
Author: Isabel Syddall – Senior Ecologist
Reviewer: Kelly Clark – Associate Director

Technical Advice Note: Bat Building Inspection and Roost Assessment

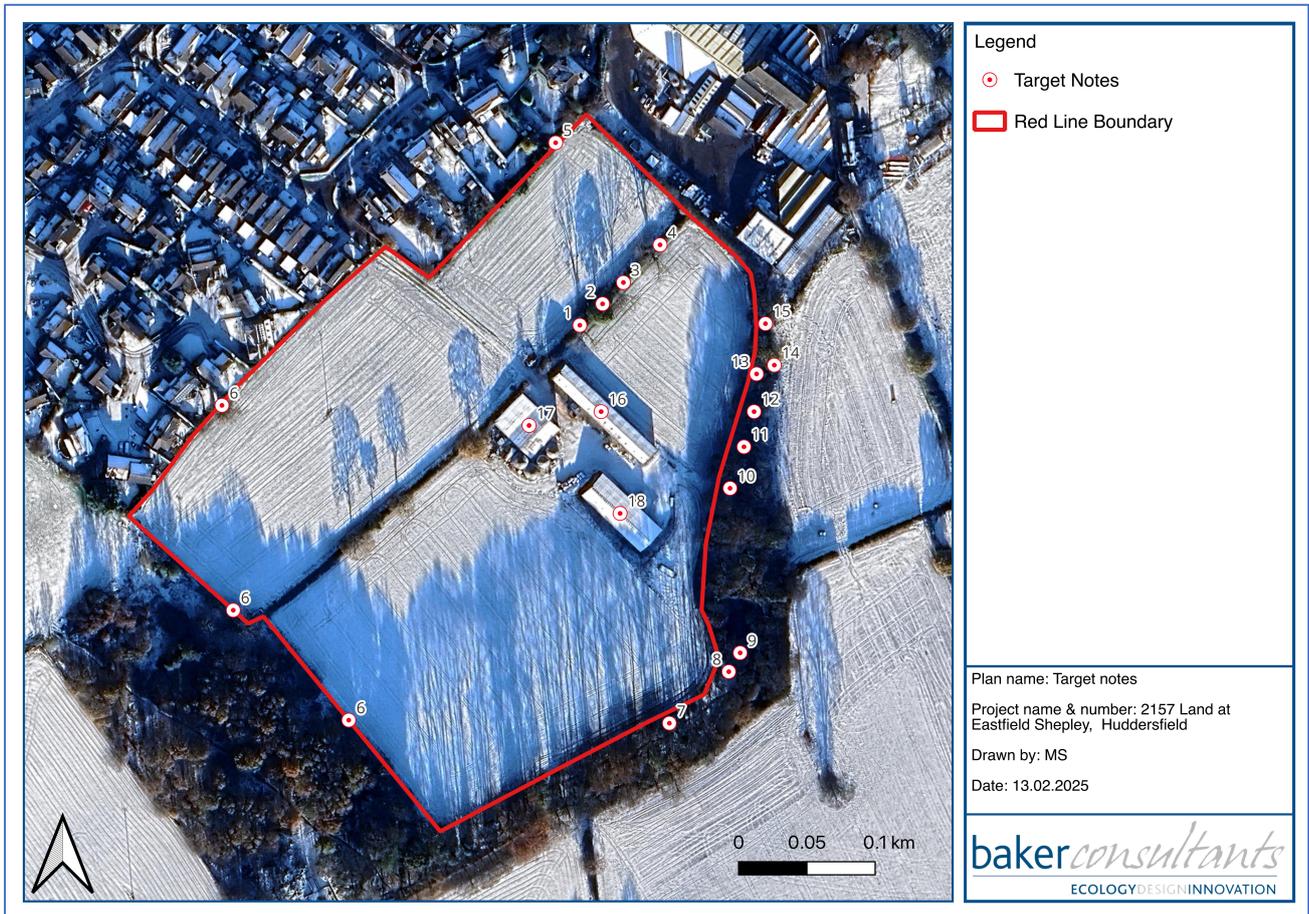
Figure I. Site Plan

The location of buildings within the site is shown below in Figure 1.

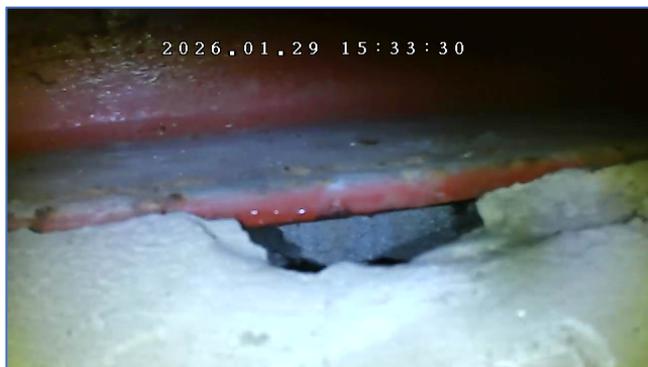
On the southern elevation, particularly to the west, there are gaps under a red metal joist which sits atop the breeze block wall, these gaps lead directly into cavity features which extend down into the wall (Figure 1). These gaps can be accessed internally along the entire southern wall and inspection with the endoscope found no evidence of bats and presence of cobwebs within the cavity features, however some were relatively free of cobwebs.

Due to the presence of the breezeblock feature on the southern elevation, it is not possible to rule out the low roosting opportunities for bats. The building remains assessed as have Low BRP.

Figure 1. Cavity feature in breezeblock southern elevation

Inspection of building TN17 has one feature of low suitability for roosting bats within the wall cavity on the southern elevation. This feature could be fully accessed and searched with an endoscope. Given that the rest of the building is unsuitable for roosting bats it is recommended that a Precautionary Method of Works (PMoW) be implemented to facilitate demolition of this building. A Suitability Qualified Ecologist (SQE) could thoroughly inspect the feature prior to demolition and supervise the demolition works in this area.

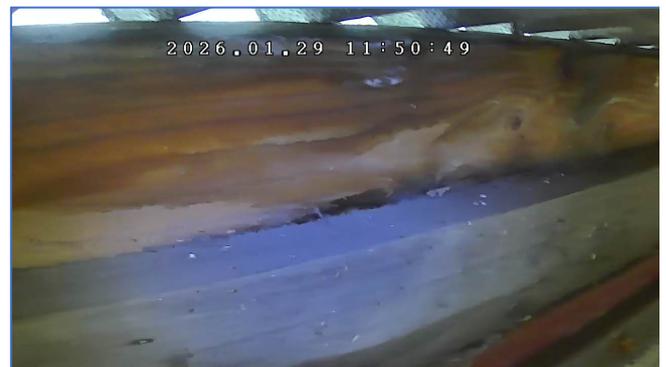
There are wooden joists at the eaves of the eastern elevation with small gaps present between the two, with potential access provided by gaps between the corrugated roof at the eaves behind the gutter. However, the joists appear wet as they are exposed to weather and this feature is shallow (Figure 2).

Figure 2. Gaps between wooden joist on eastern elevation

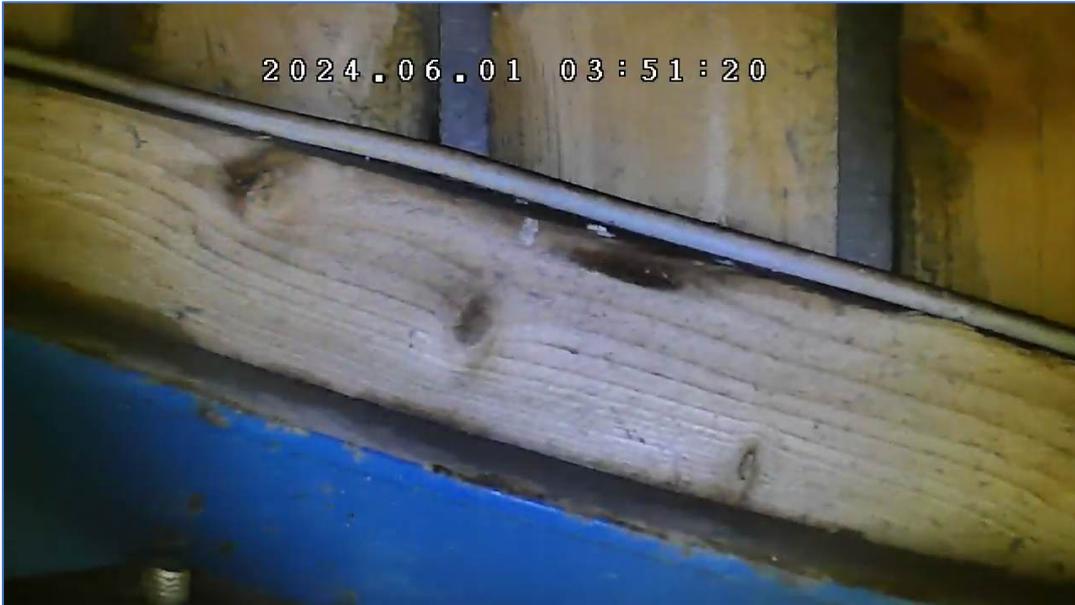
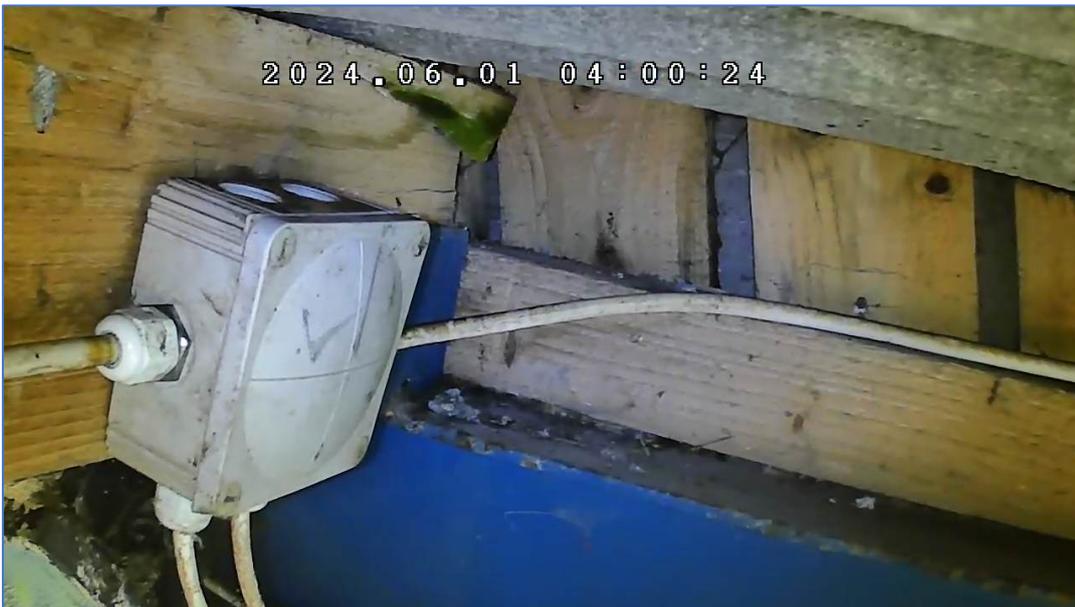
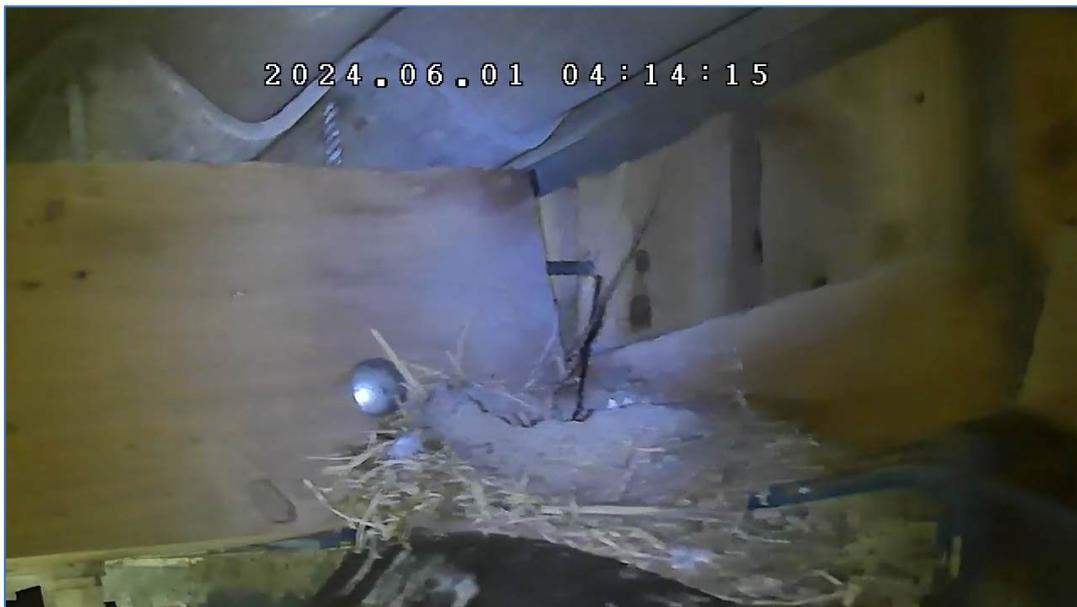
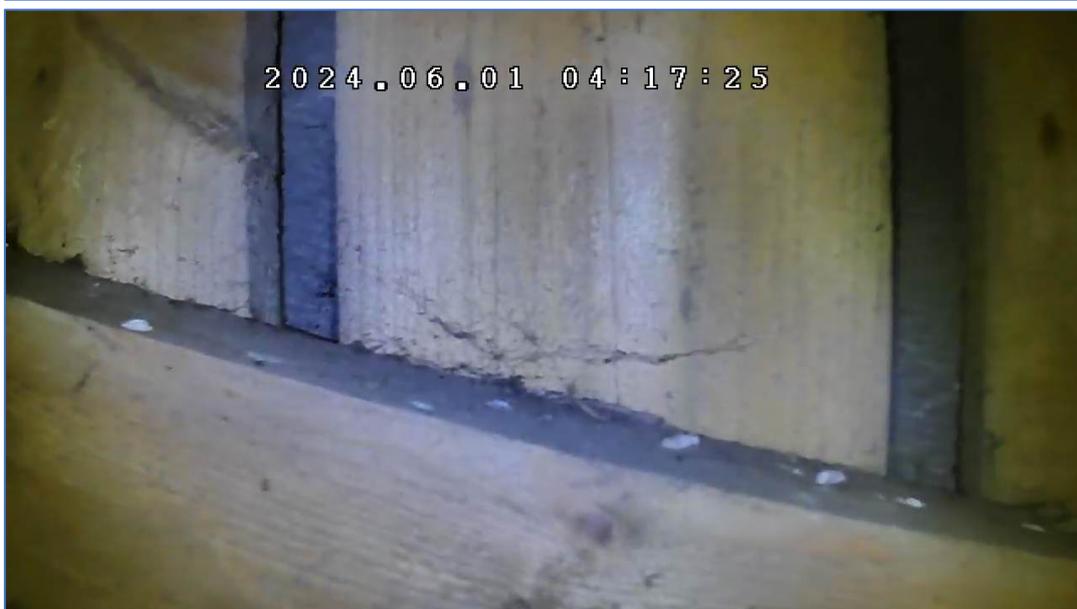
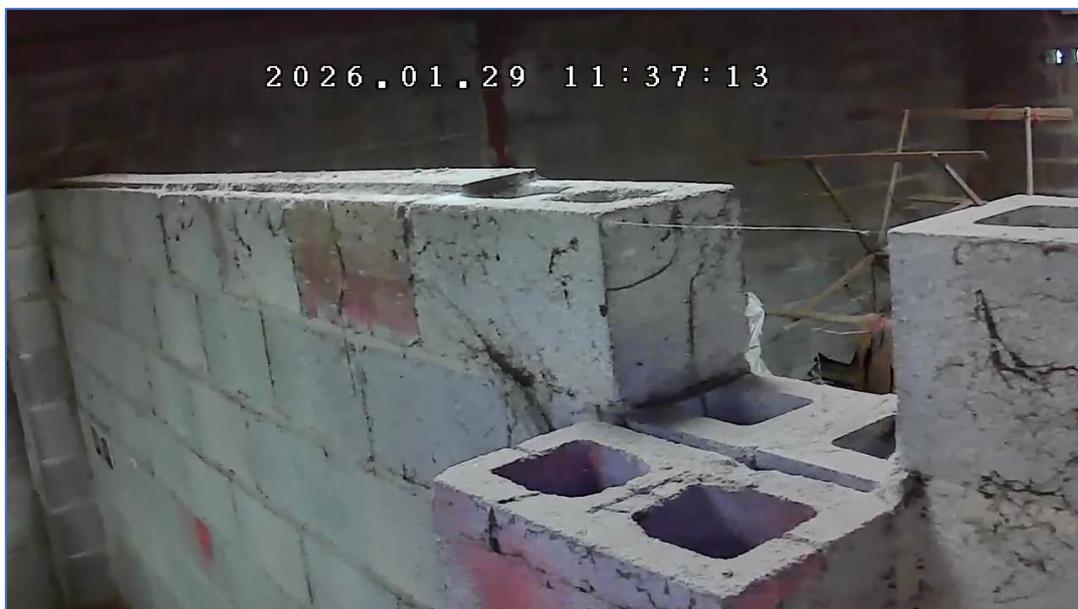
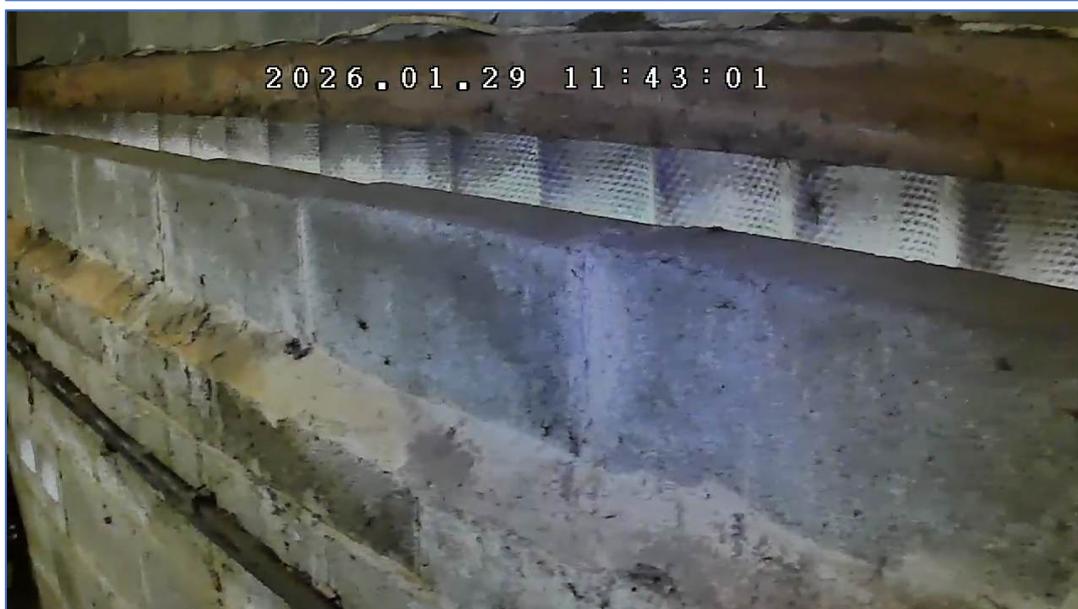
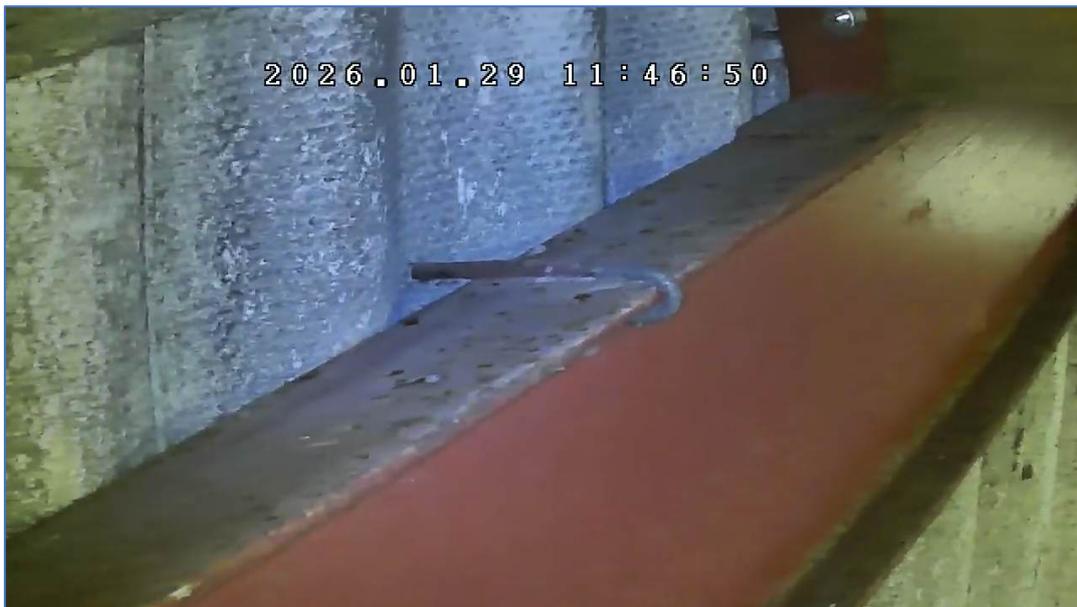
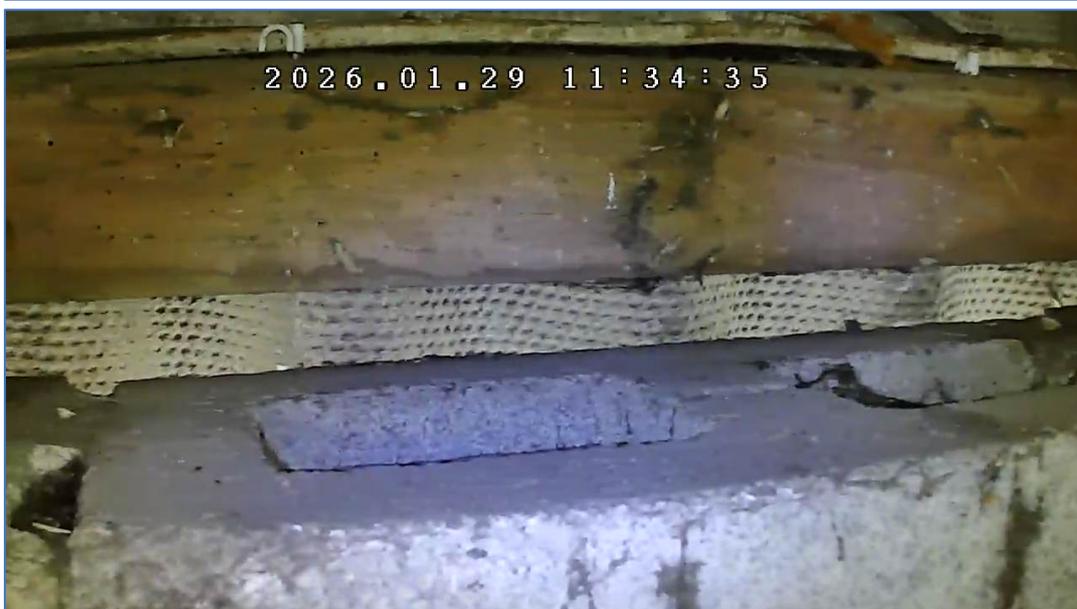
Building TN16

Following this updated inspection the corrugated sheeting at both gable ends has been identified as unsuitable. Detailed inspection at height facilitated by the use of the pole mounted camera has confirmed that the overlap is just 10cm in length and the external gaps between corrugations and timber lead directly inside the building into an open structure with no suitable roost feature present. Whilst internal access was limited by the presence of stacked straw, this feature is consistent along both gable ends and therefore there are no suitable features present for roosting bats and no evidence of use of the building by bats was found. Surveyors noticed a large amount of bird droppings inside the building at the western gable end and evidence of roosting feral pigeon was prevalent throughout the building. This building is now re-assessed as having Negligible BRP.

Given the extra level of detail provided by the use of specialist equipment two of three buildings (TN16 & 18) can confidentially be re-assessed as having negligible BRP. Further survey of these buildings is not recommended.

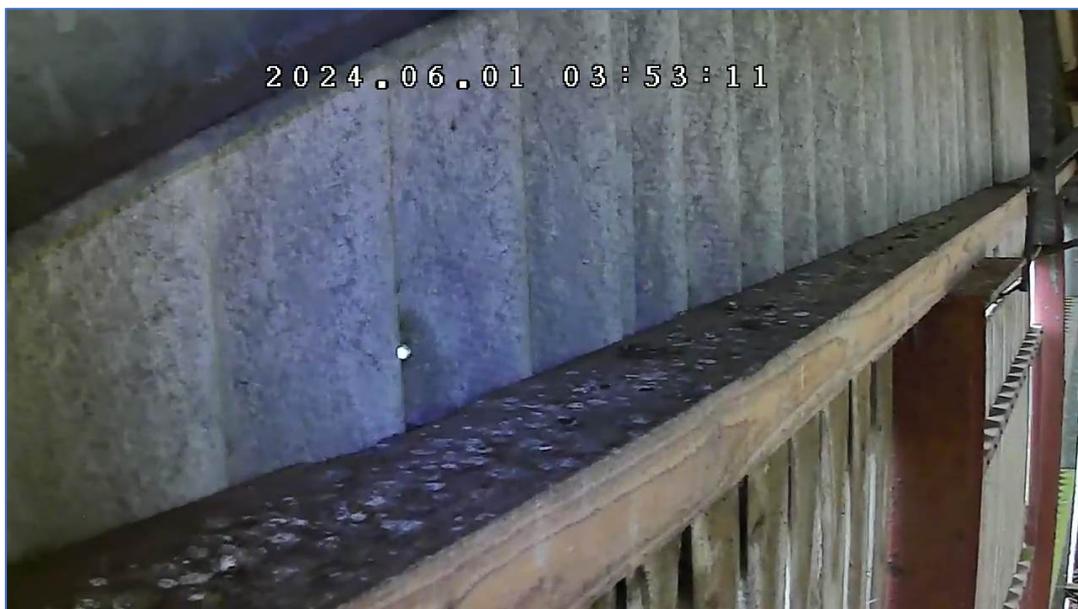
Building TN18

As with building TN16, the roofing material overlaps timber slats on each gable end which was originally thought to provide potential roosting opportunities for bats. However close inspection using the pole mounted camera confirmed that there is no suitable crevice feature for bats to roost.

present throughout the building and no evidence of use of the building by bats was found. This building is now re-assessed as having Negligible BRP.
