6.0. Arboricultural Impact Assessment

This report continues on from the pre-development report, reference: **TSC LTD 007 PDR** dated 15th December 2025.

Site plans have been supplied giving details of the proposed plans for three new self-build detached dwellings. The references for the documents are: **2574-D-20-003 Proposed Site Plan** and **2574 Planning Drawings FINAL**.

The proposed development includes the construction of three detached dwellings within the site, and an access driveway to each of them from a new entrance from Marsh Lane.

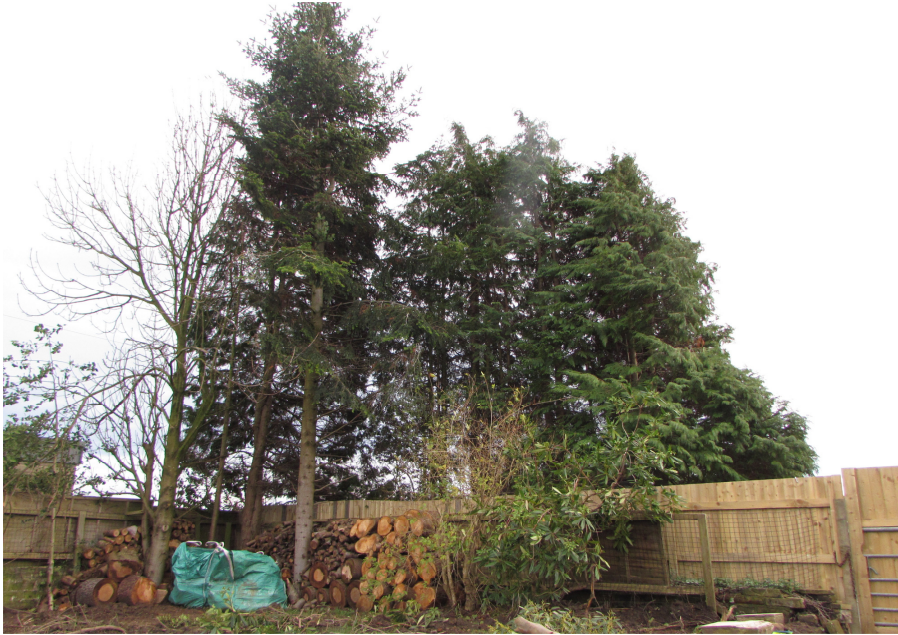
Photo 1 – View of T6, T7, T8 & T9 from within the site, with the adjacent highway trees in the background

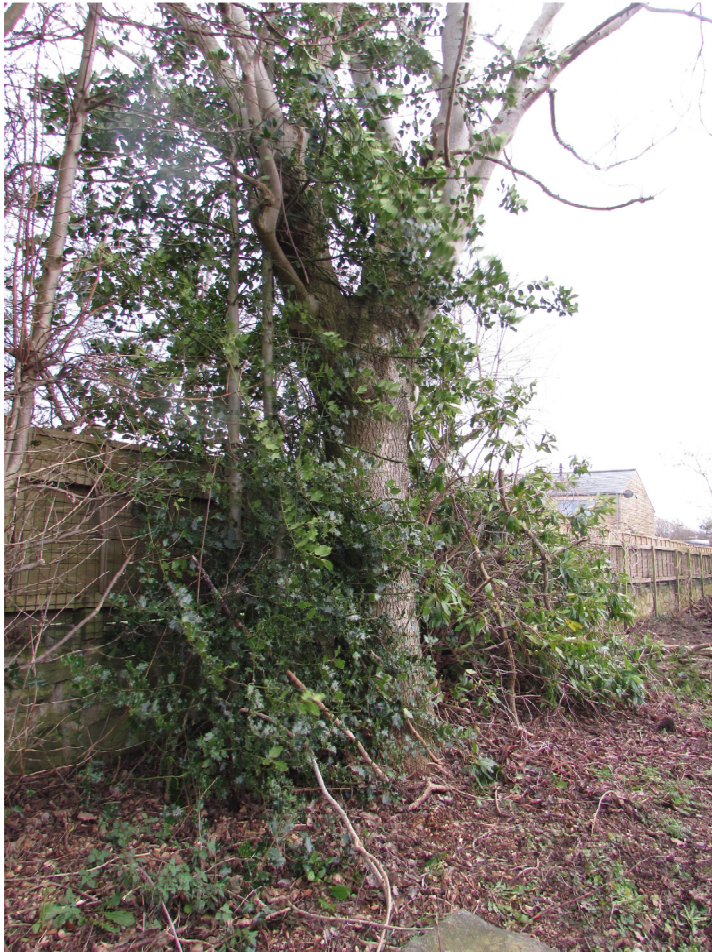
Photo 2 – View of T2, an Ash

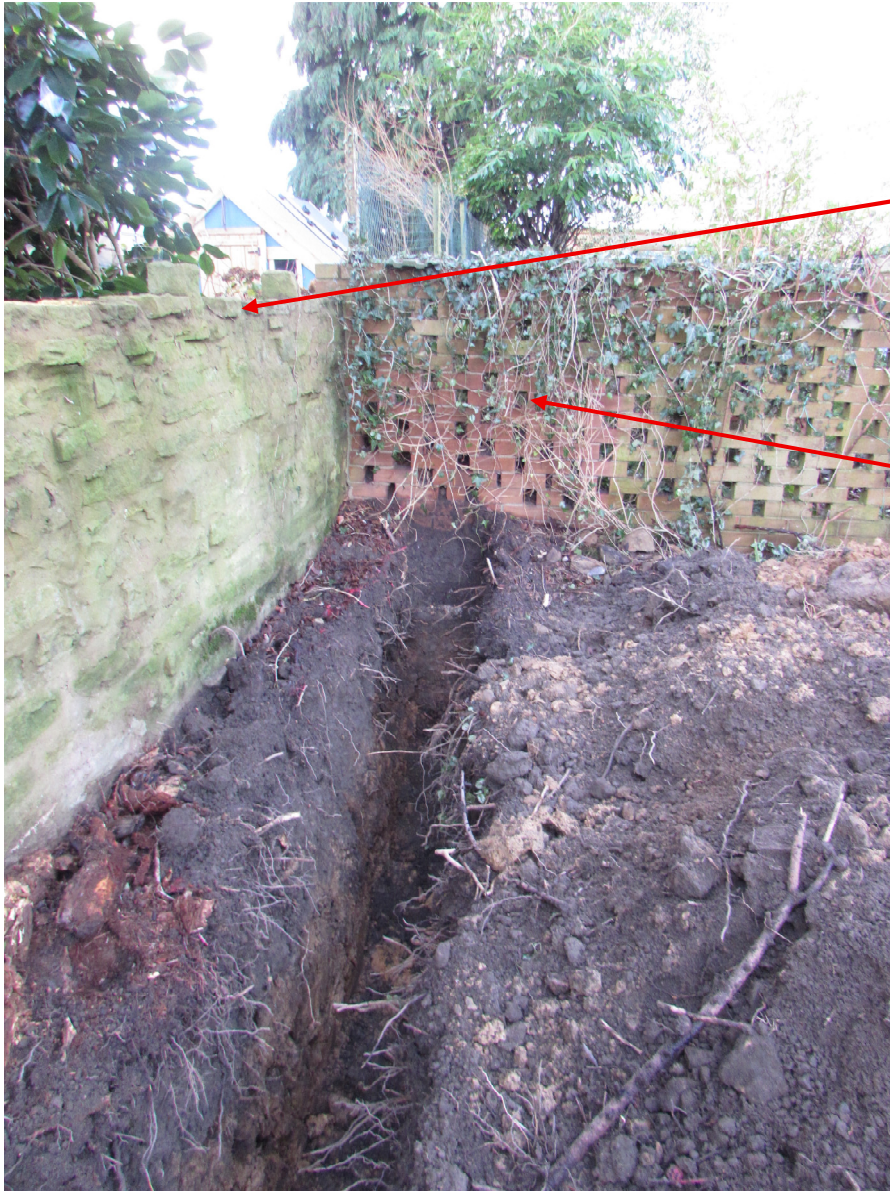
Photo 1 - Trial pit 1.

Showing 2 walls: boundary wall to the left, and light wall running into the site from the boundary.

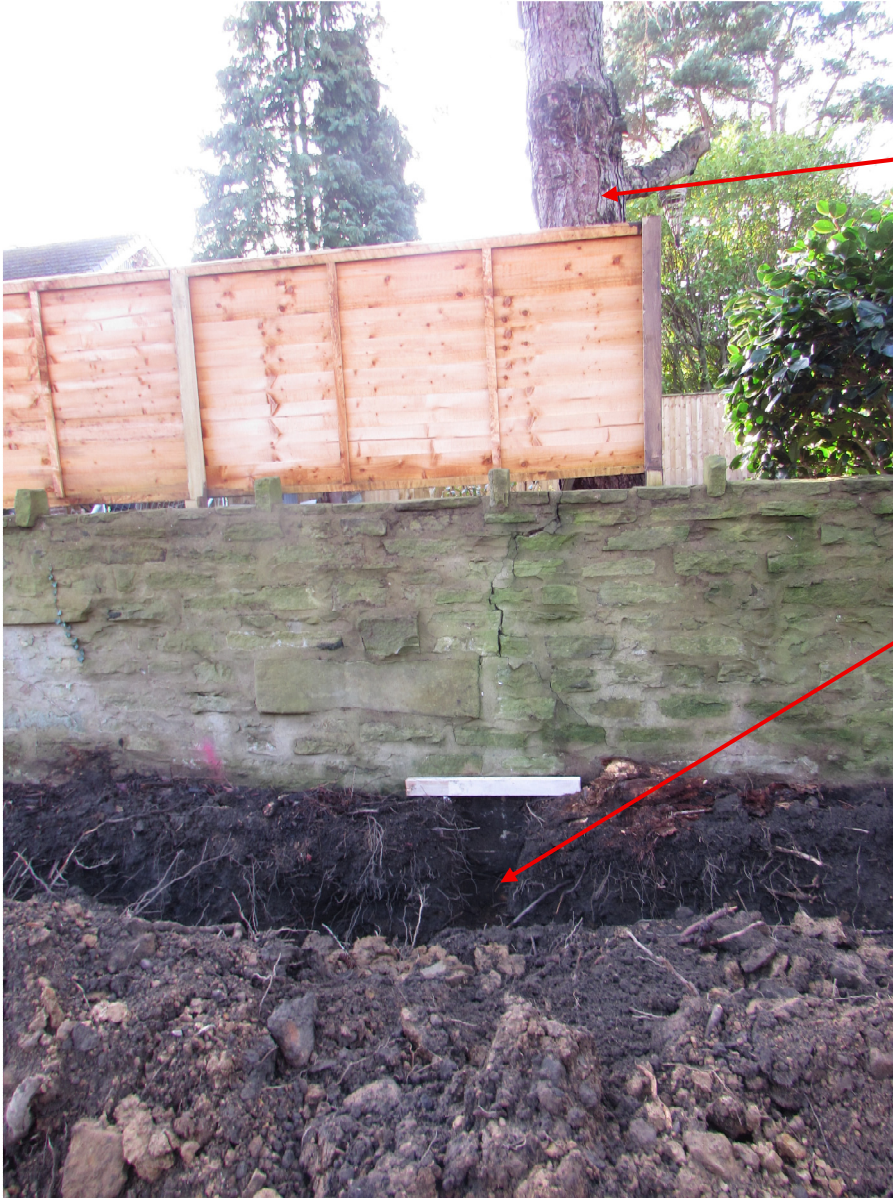
Photo 2 – Trial Pit
1

Tree T5 - Larch

The excavation of the wall is indicated where the white horizontal piece of wood is. The foundations of the wall were exposed to a depth of 0.37 metres.

I could see no roots from **T5** over onto the site.

I followed the course of all present surface roots in the top 0.4 - 0.6 metres and most narrowed in diameter as they travelled towards the wall, indicating that they originated from growth within the site.

In the instances where the diameter stayed constant, it was evident that they were too high in the soil and the wall structure prevented anything from the neighbouring land coming across at this height.

The foundation depth of the boundary wall was exposed to the depth of the change from the organic layer (soil horizon 0) to a sandy sub soil layer which was markedly compacted and root free.

The change in soil was measured at 0.42 metres from the soil surface. The remaining 0.33 metres was from the sandy sub soil to the bottom of the pit.

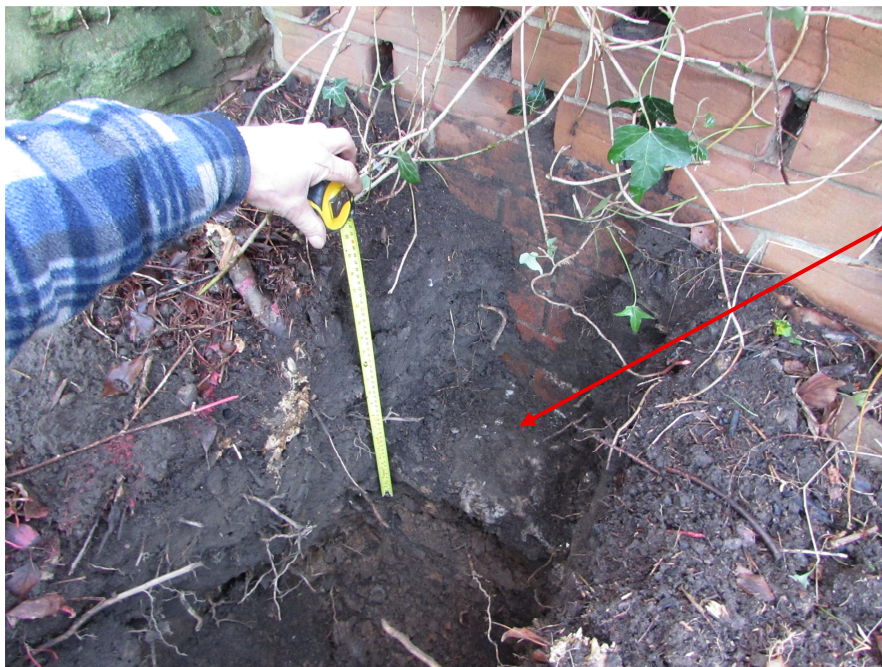
The lighter wall structure had a foundation depth of 0.5 metres.

Photo 3 – Foundation of lighter wall structure, approximately 3.4 metres away from T5.

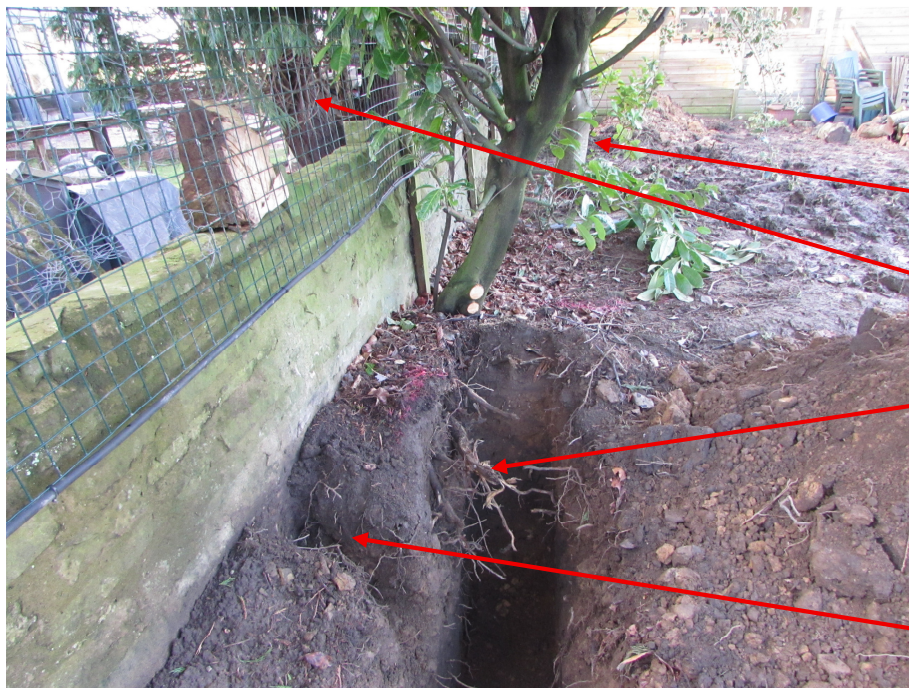
Photo 4 – Trial Pit 2

These roots traced back to Laurel

Foundation wall excavation area

The second pit was 0.3 metres away from the wall, and 0.44 metres wide. The depth was 0.85 metres and the length was 2.27 metres.

Again, the soil changed at around 0.4 metres deep, to a yellow substrate layer which was more compacted. Generally less roots were observed in the entire area of the pit. Only those from the Laurel were prominent.

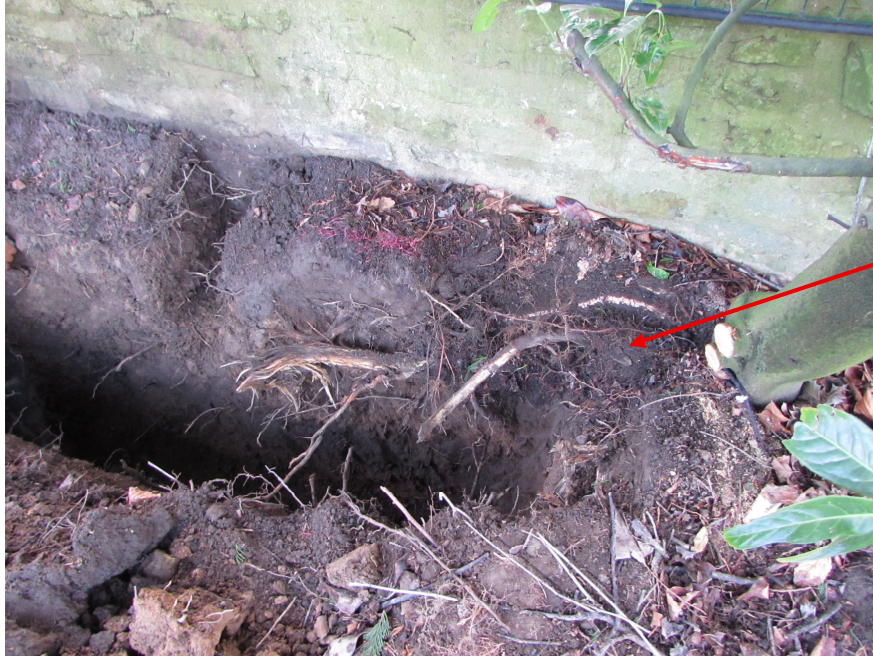
Photo 5 – Trial Pit 2
Showing the roots
going to the Laurel.

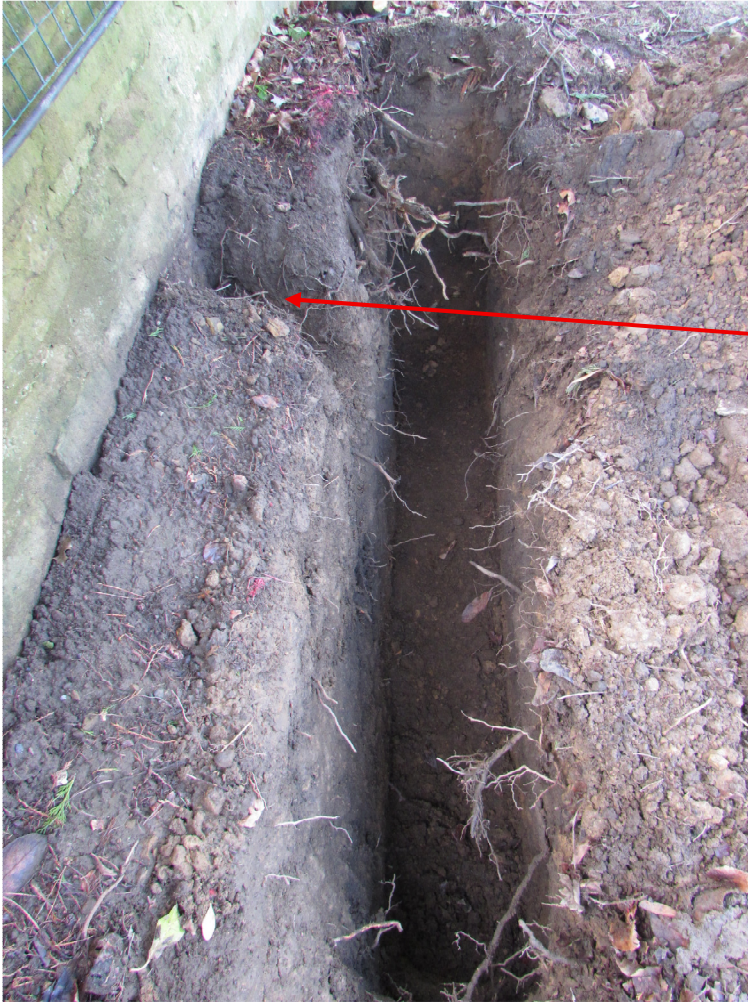
Photo 6 – Trial Pit 2 – Extent of roots in the trial pit

Very few roots visible in the pit

Excavation of wall footings

I conclude that no roots from tree **T4** had got through or around the wall, that I could observe.

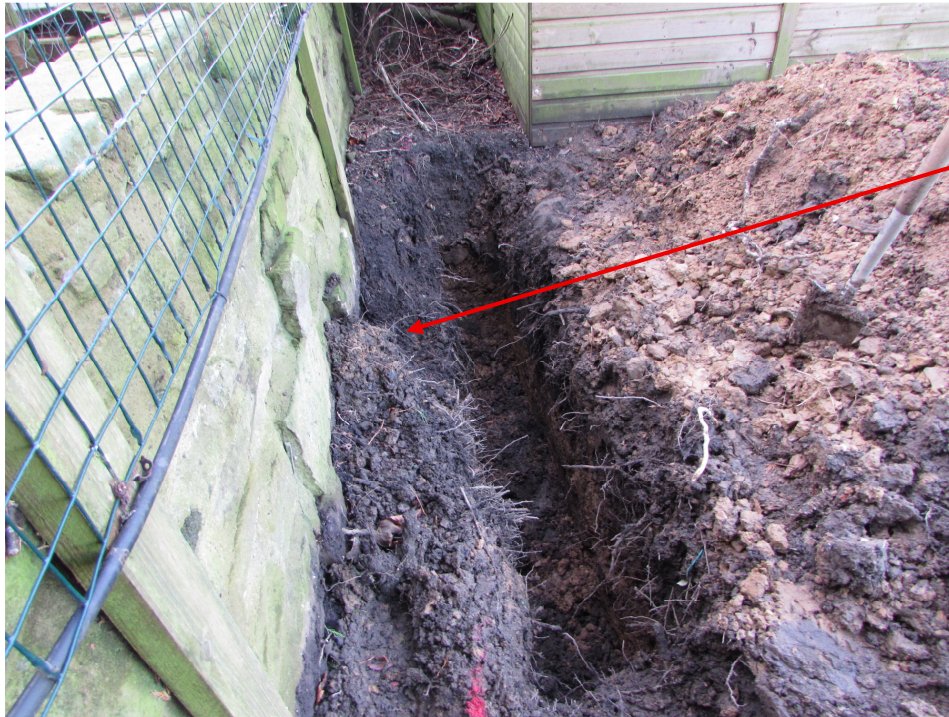
Photo 7 – Trial pit 3

The location of the excavation of the wall foundations

As can be seen in the photo, there were a reasonable number of roots traversing the pit of similar size. All within the upper soil profile where the foundations would have contained them. There were none where the more compacted soil profile was present.

I conclude that no roots from tree **T4** had got through or around the wall, that I could observe.
