Netherwood Farm, Marsden

Bat Survey Report

15th April 2026

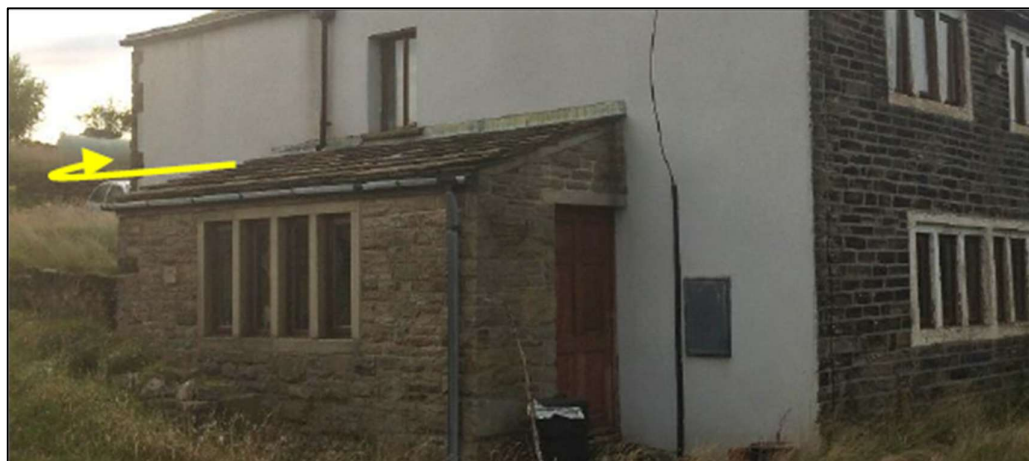
Plate 3. Extract from the 2017 Middleton Ecological Consultancy Report showing the flight path of one emerging bat on 22nd August 2017

5.1.2 The closest records related to the common pipistrelle roost within the farmhouse, and in-flight records of a *Myotis* bat species and a noctule recorded by Middleton Ecology Consultants in 2017. The roost was located in the western verge of the porch roof at the south of the farmhouse (as shown in Plate 3 below).

5.2.7 No bats or signs of bats were present within the interior of the building. The common pipistrelle roost recorded in 2017 (Plate 3) remained viable, but no bats were identified during the endoscope inspection of the roost.

- 6.2.2 The original report recommended the retention of the known roost as well as gaps between stone slates (MEC, 2017). The extent of any additional mitigation required would need to be determined on completion of the nocturnal surveys.

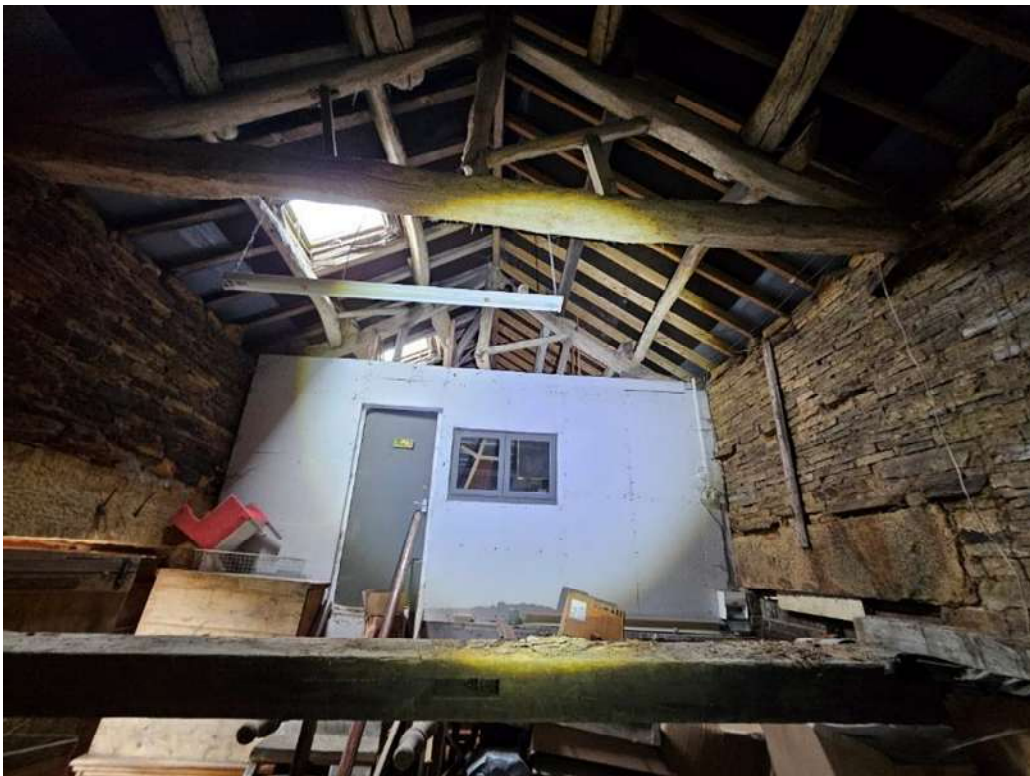
Plate 7. Interior of the larger barn section

5.2.4 Within the barn, traditional bitumen-coated roofing felt (Type 1F) was present beneath the stone slates (Plate 7). In the smallest section at the northern end, the roof had been lined with a breathable membrane, likely Proctor Roofshield (Plate 8). The client

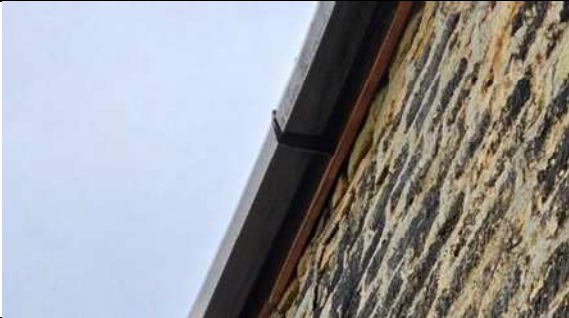
Gaps behind the fascia board.
C

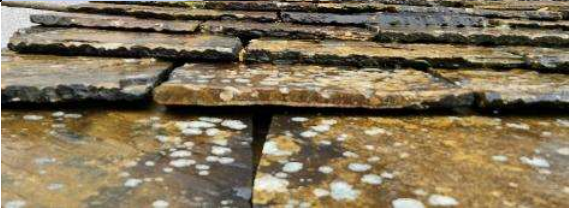
Gaps between stone slates.
D

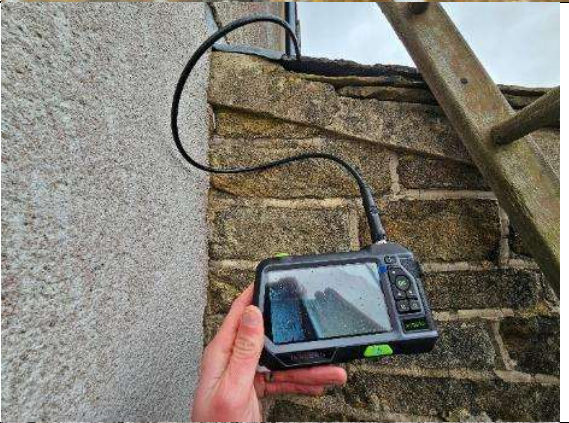
Gaps below lead flashing /between slates on the roof verge.
E

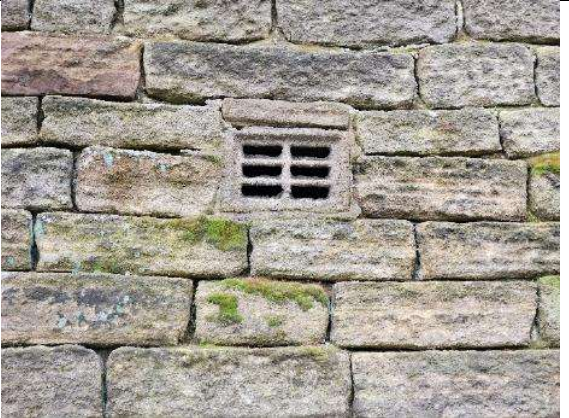
Ventilation bricks.
F

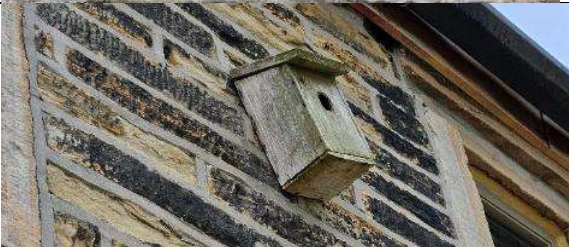
Bird box.

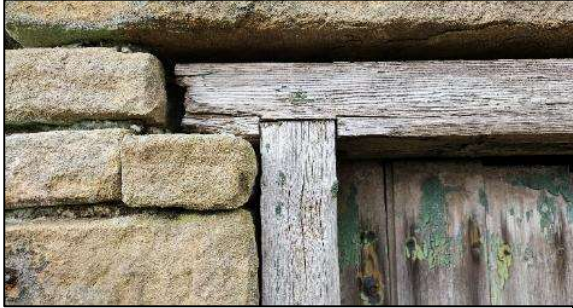
Gaps around the door frame.

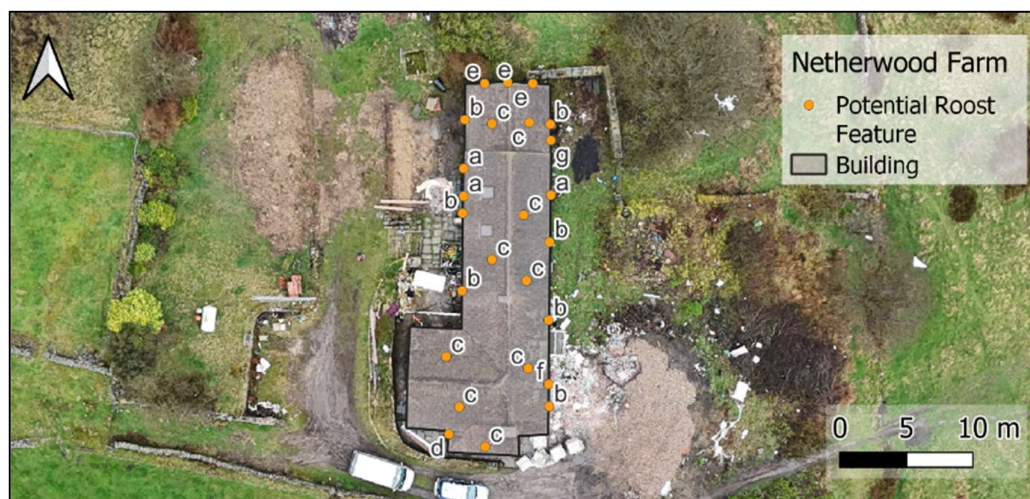
Figure 3. Potential roost feature locations

- 5.2.5 Potential bat roost features associated with the walls comprised gaps in masonry, gaps behind fascia boards, ventilation bricks, and a wooden bird box. In addition, gaps associated with the roof were also present comprising gaps between stone slates, including at the verge (and the previously recorded roost location). Potential roost features are shown in Table 3, and their locations shown on Figure 3.

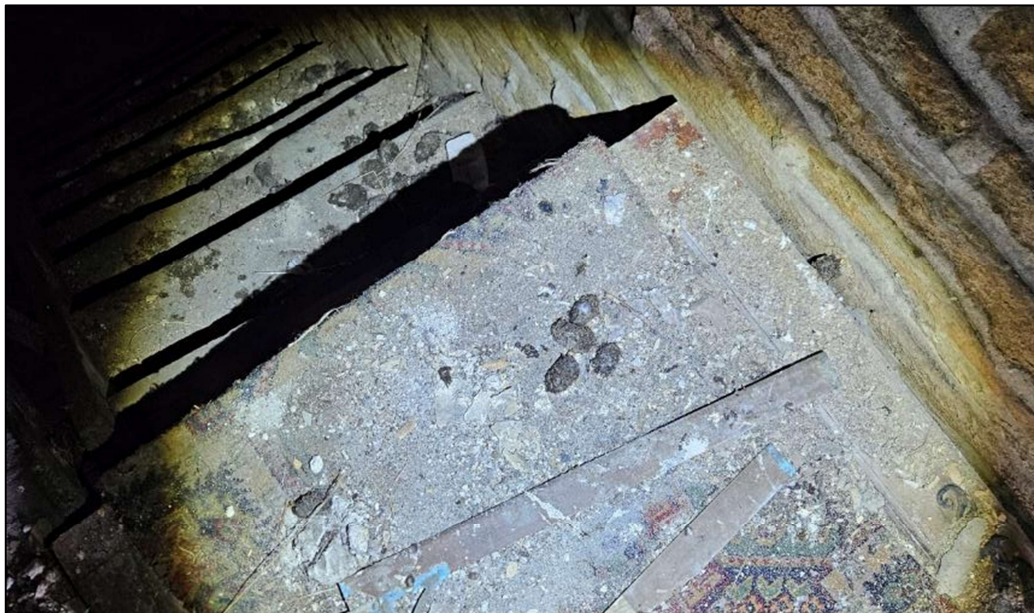
5.2.8 Swallow nests were recorded within the smaller section of the barn (Plate 9). In addition, approximately 15 barn owl pellets were recorded in the smaller section of barn at the northern end of the building (Plate 10).

Plate 10. Barn owl pellets within the northern section of the barn

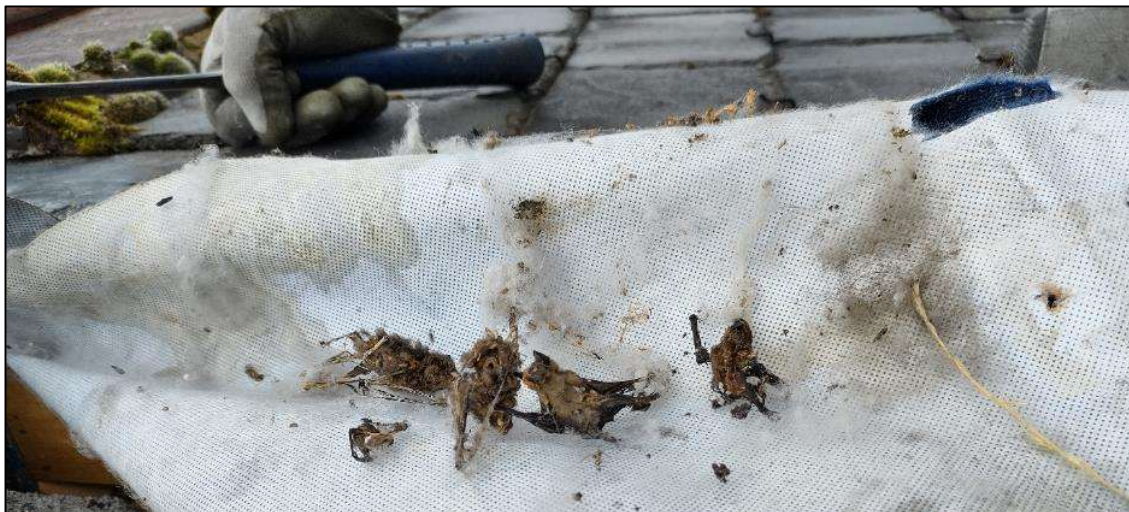
One example we have encountered comprised a pipistrelle roost which formed in a building extension constructed in 2009. Over the course of just 13 years the roofing felt degraded to the extent that it trapped and killed more than 10 bats. Fortunately, the problem in this roost was identified and remedial work was undertaken to replace the roofing membrane in 2022.

Plate A2.1. Four dead pipistrelles tangled in breathable roofing membrane
