**ARBORICULTURAL IMPACT ASSESSMENT  
to BS5837:2012  
at  
Fieldhead  
Snelsins Road  
Cleckheaton  
BD19 3UE**

**JCA Ref:**  
22667e/LW/CC – Rev 1

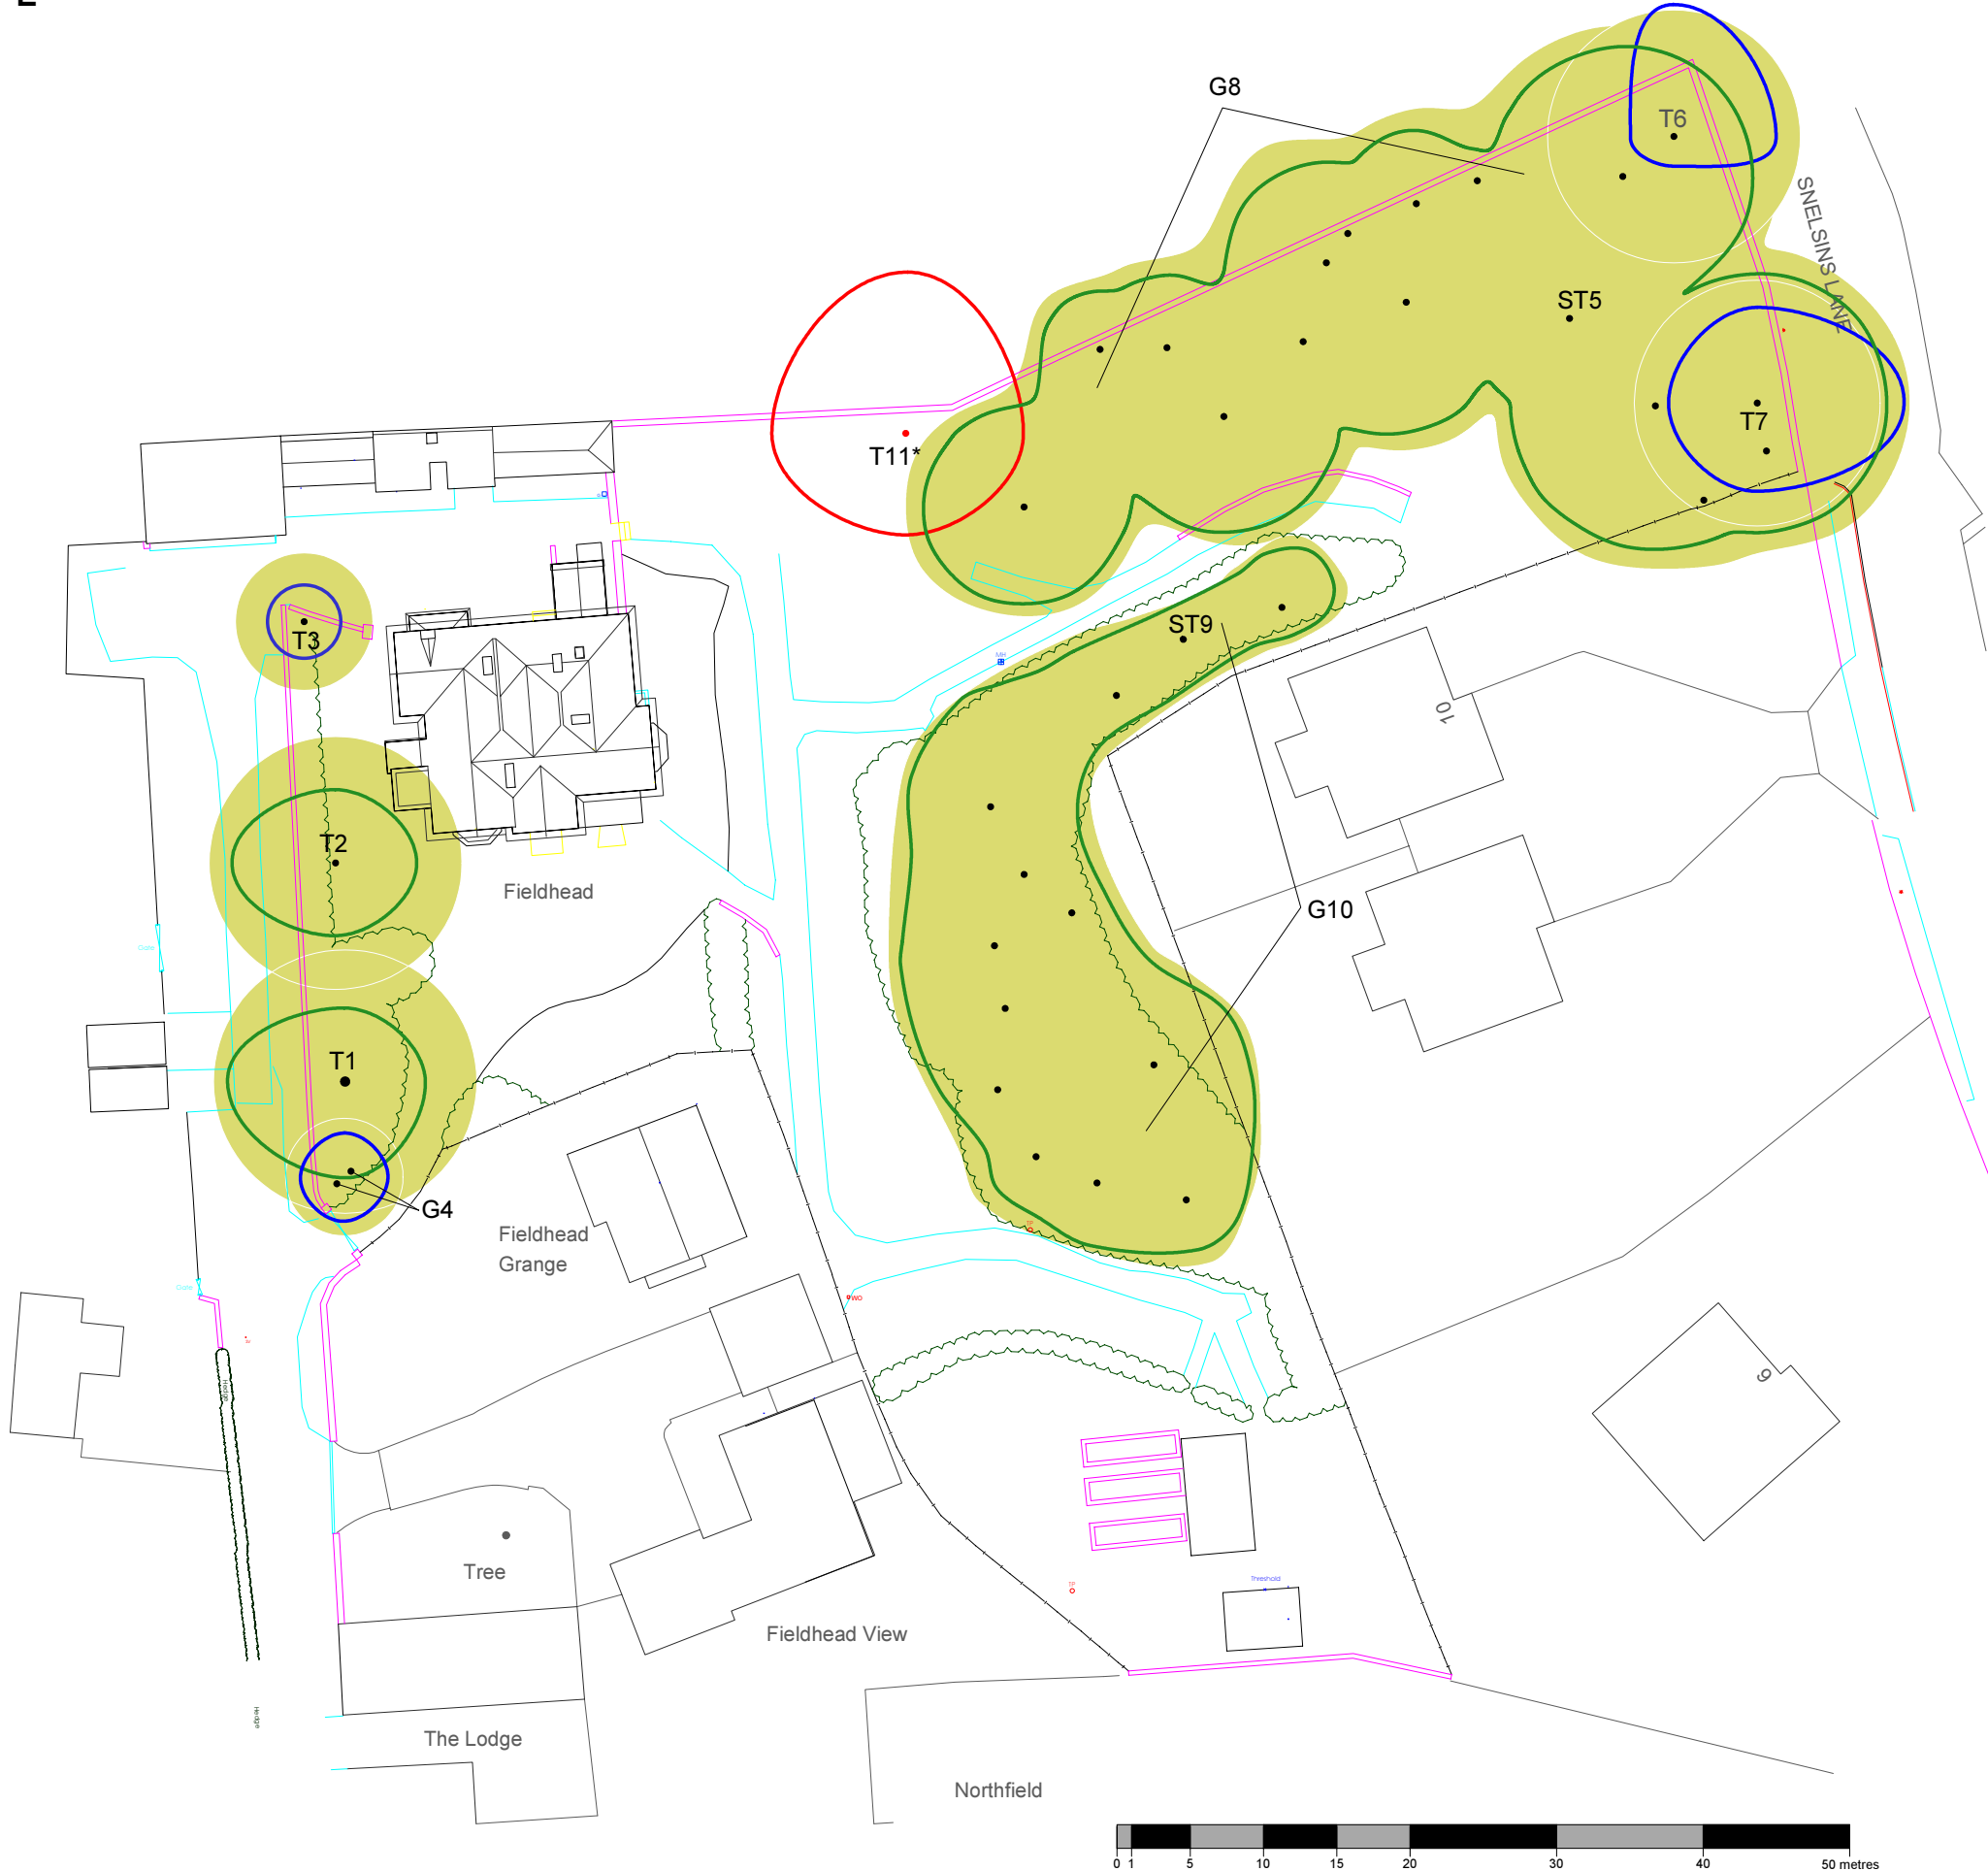
### Appendix 5: Tree Constraints Plan

THE ROOT PROTECTION AREA SHOULD IDEALLY REMAIN UNDISTURBED IF THE TREE IS TO BE RETAINED.

THE DEVELOPMENT PROPOSALS SHOULD THEREFORE BE DESIGNED TO AVOID THE RPA OF ANY TREE WHICH IS TO BE RETAINED.

IF IT IS NECESSARY FOR THE DEVELOPMENT TO ENCROACH INTO THE RPA OF A TREE WHICH IS TO BE RETAINED THEN SPECIALIST CONSTRUCTION TECHNIQUES AND MATERIALS MUST BE CONSIDERED.

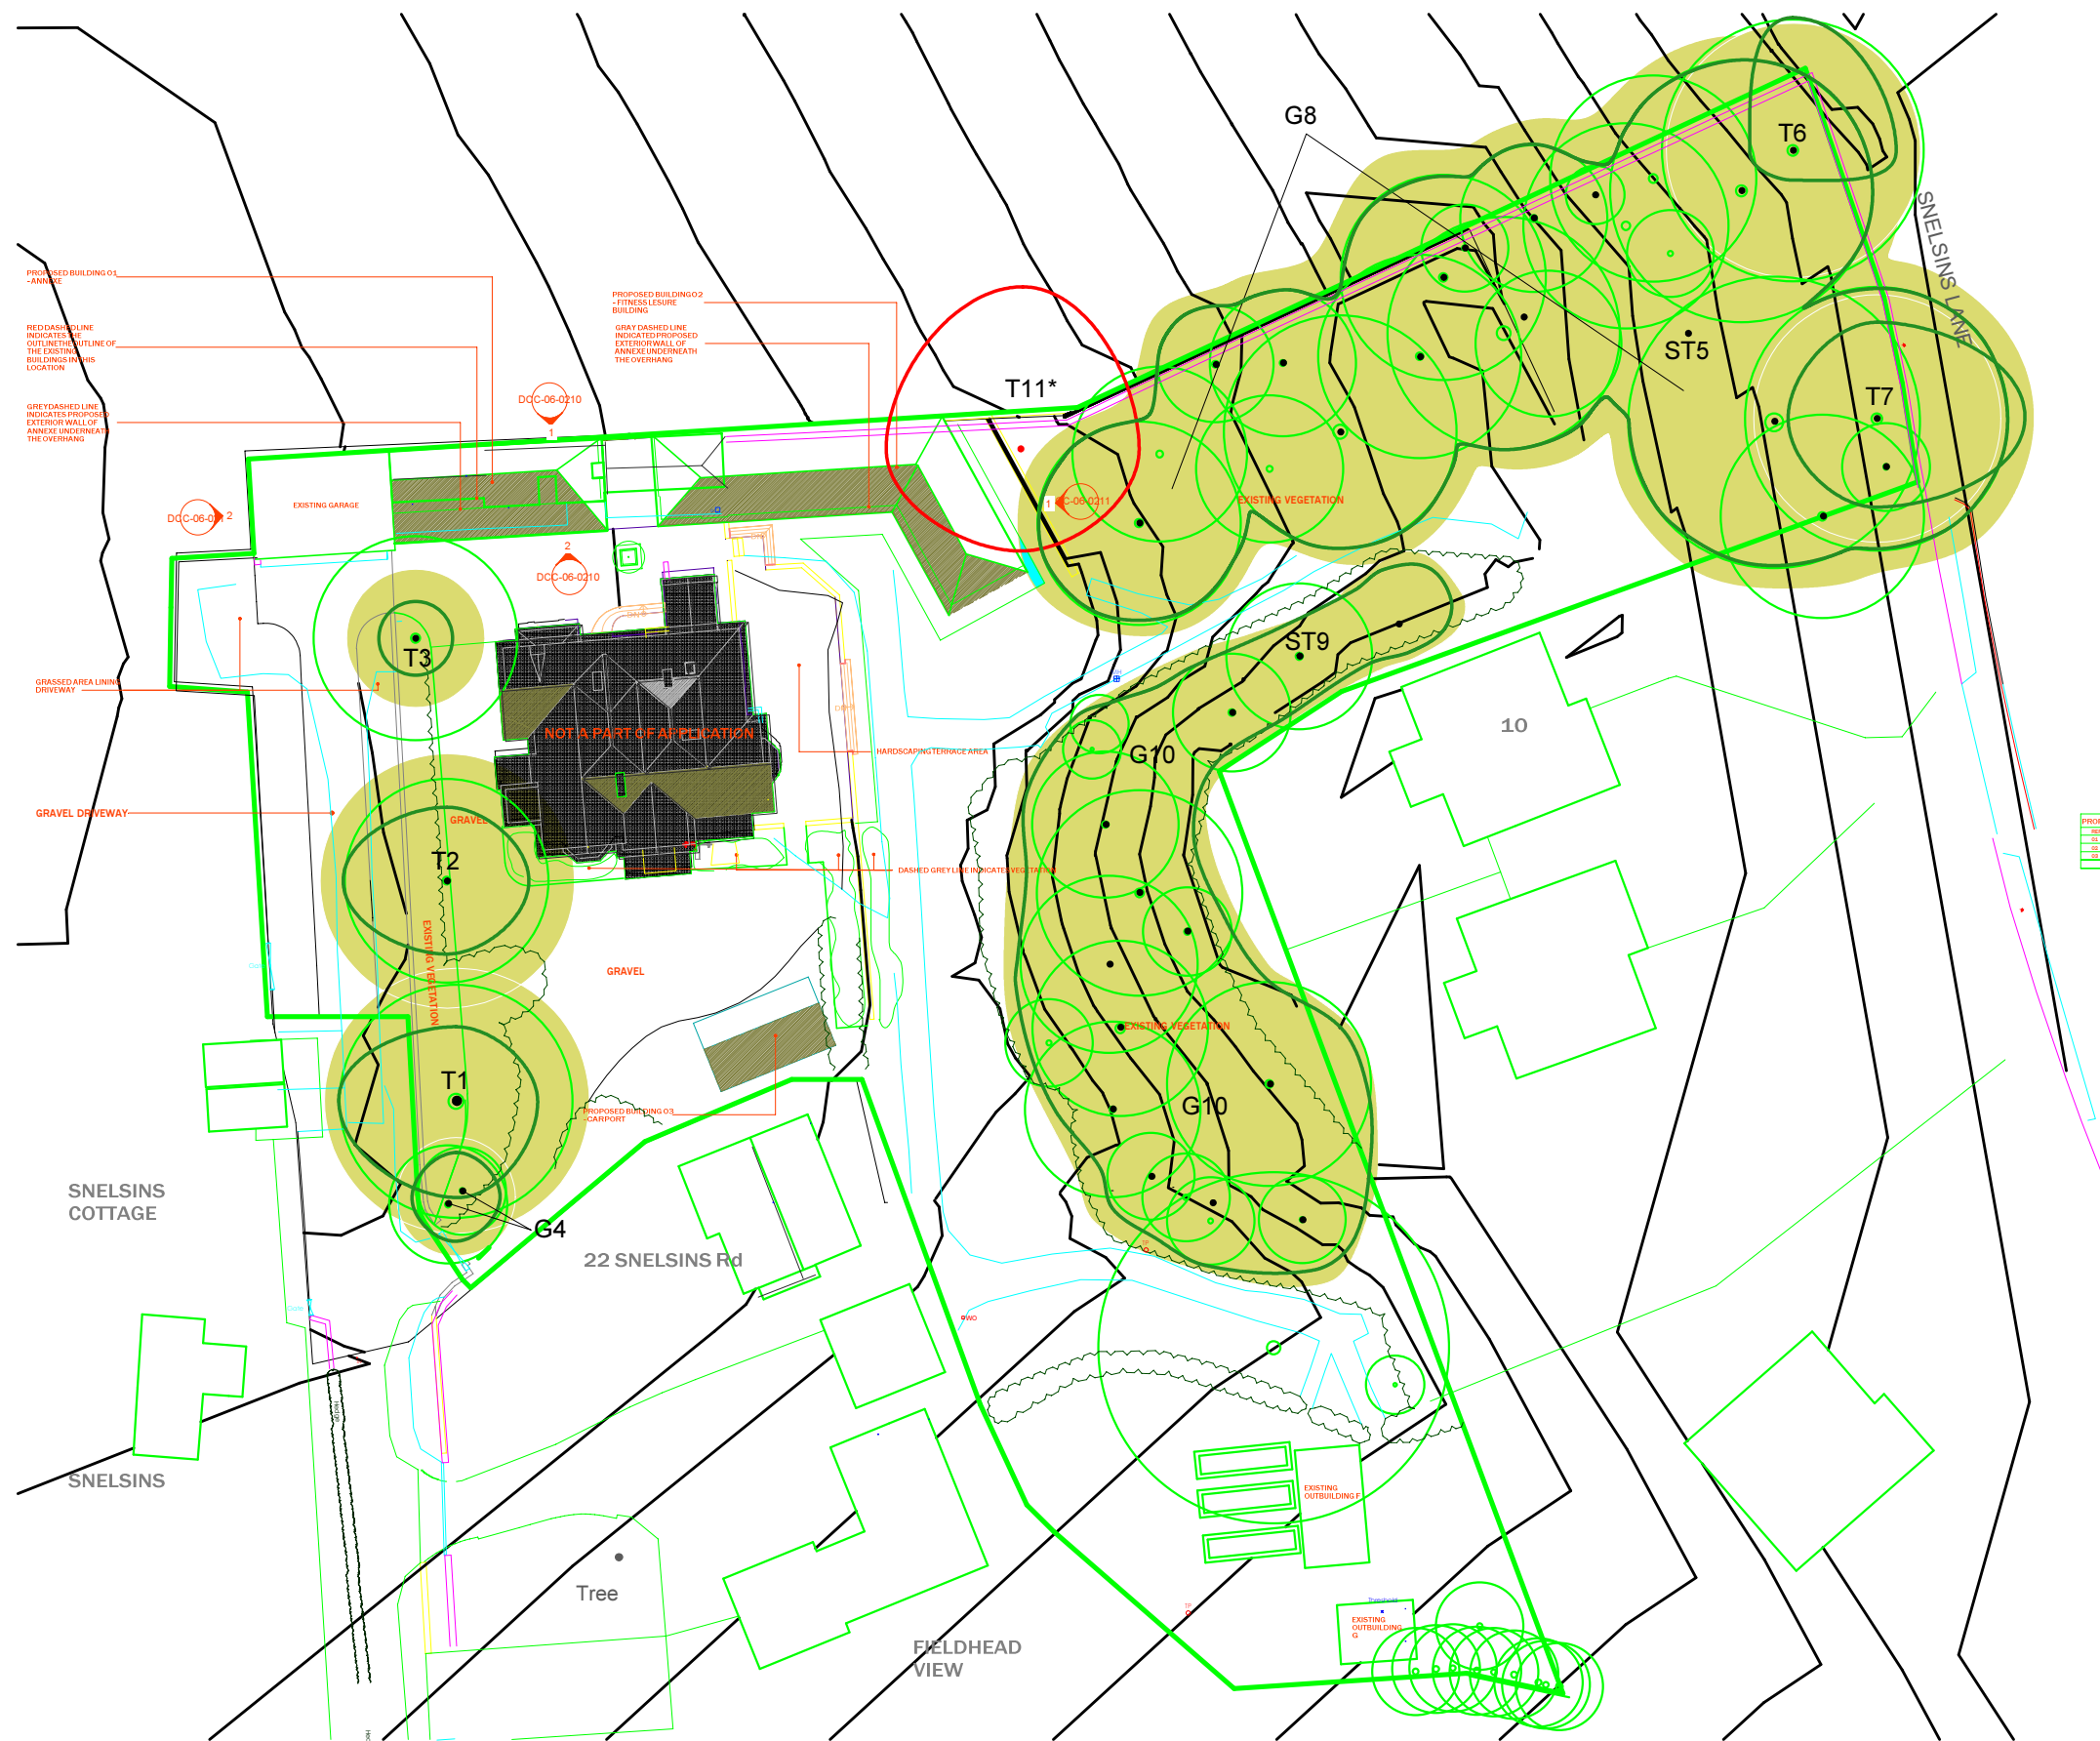
## Appendix 6: Arboricultural Implications Plan

- 3.5.3.1 As **T11** now requires removal for Arboricultural reasons, due to its decline in health, the footprint of the proposed annexe outbuilding does not incur the RPA of trees to be retained trees. As such no specialist construction or foundation methods are considered necessary for the sole purpose of preventing damage to trees.
- 3.5.3.2 Despite this, specialist foundation designs may still be required for other reasons, and advice should always be sought from a suitably qualified structural expert. The water demand of trees can be an important consideration when determining the appropriate foundation design. Because of this, water demands for the trees identified on this site are included at **Appendix 1**, in accordance with **NHBC Standards**, for use by the appointed structural expert.

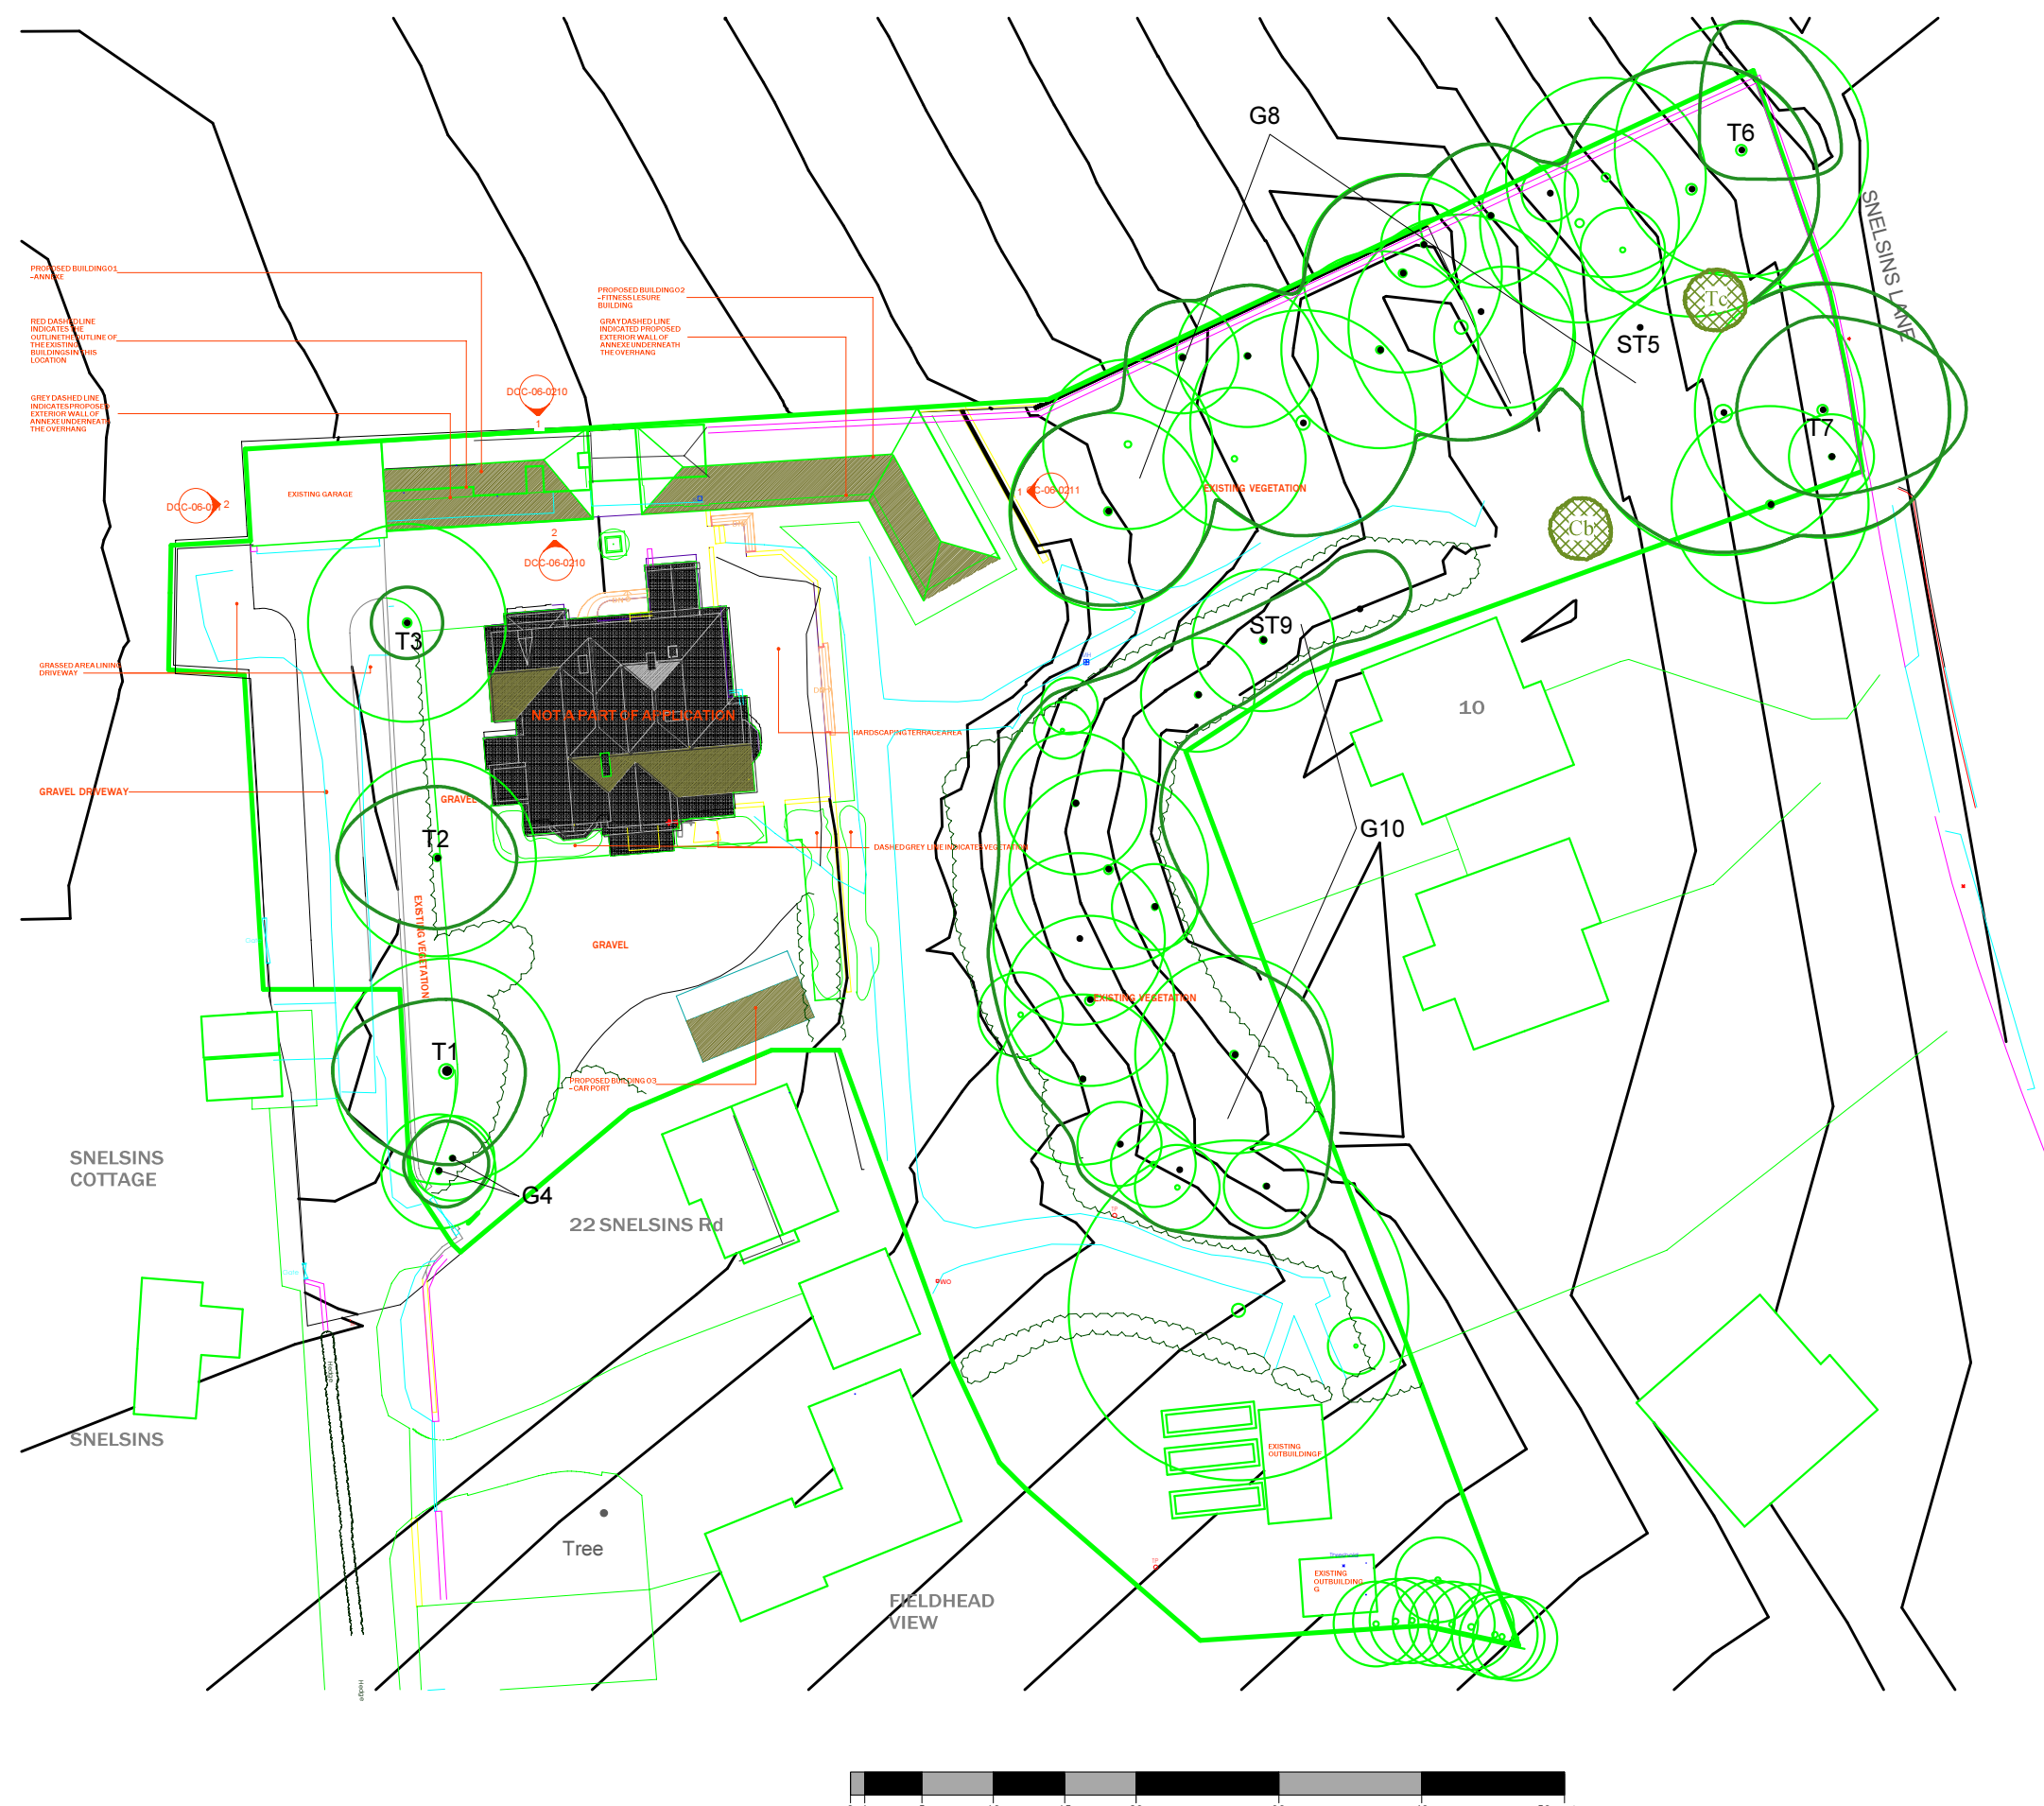
- 4.5 To mitigate the loss of **T11** (an over-mature Ash tree in decline) it is proposed to re-plant two native trees (x1 Small-leaved Lime and x1 Hornbeam) within the rear garden. An indicative Replacement Planting Scheme Plan has been prepared by JCA, which can be viewed at **Appendix 7**.

Double-staking method to be used to set young seedlings in the soil. Flexible tree is labeled in the center.

Ballfill with organic free draining granules

Water thoroughly twice within the first 48 hours
