Contaminated Land Phase One Desk
Study and Coal Risk Assessment for
proposed residential development
at
Land Adjacent
52 Ingham Road,
Thornhill Lees,
Dewsbury,
Kirklees,
WF12 0AQ.

August 2023

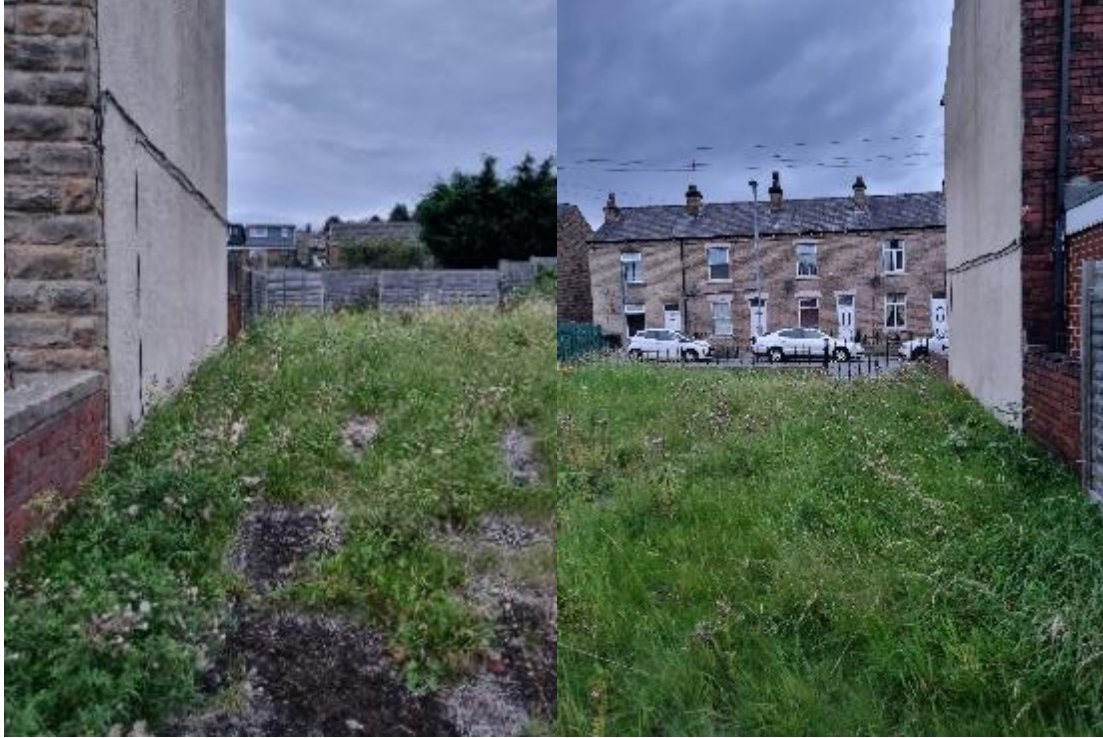
Northern boundary with adjacent property looking east and west

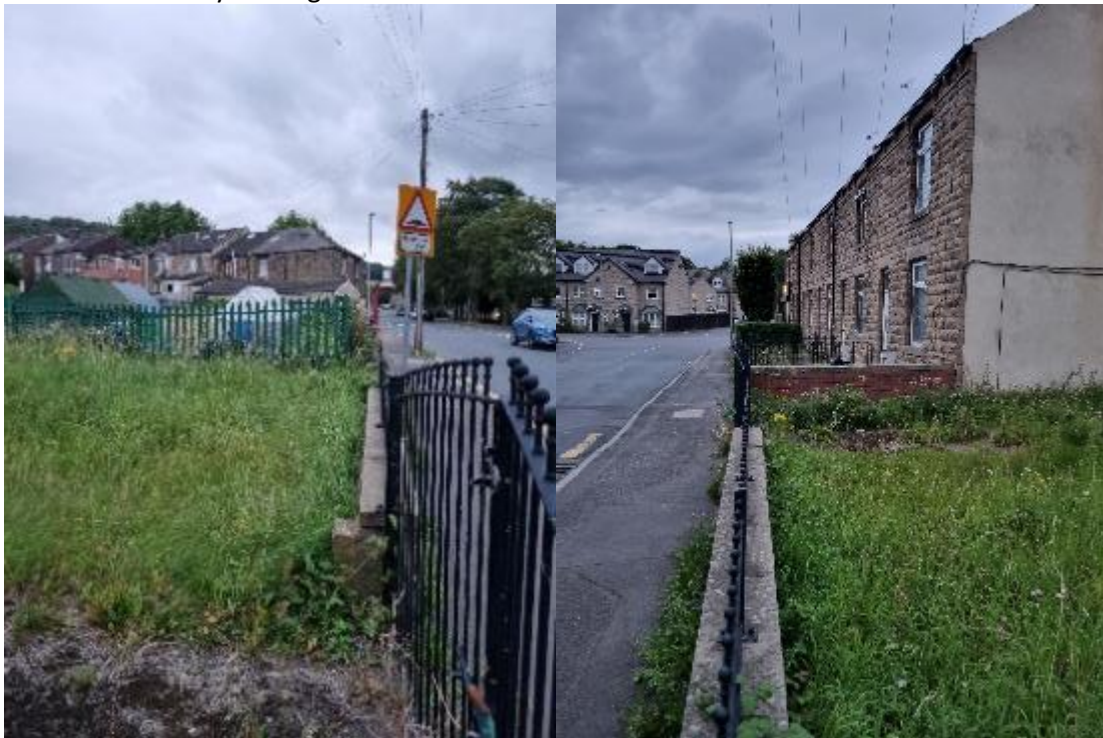
Western boundary looking south and north

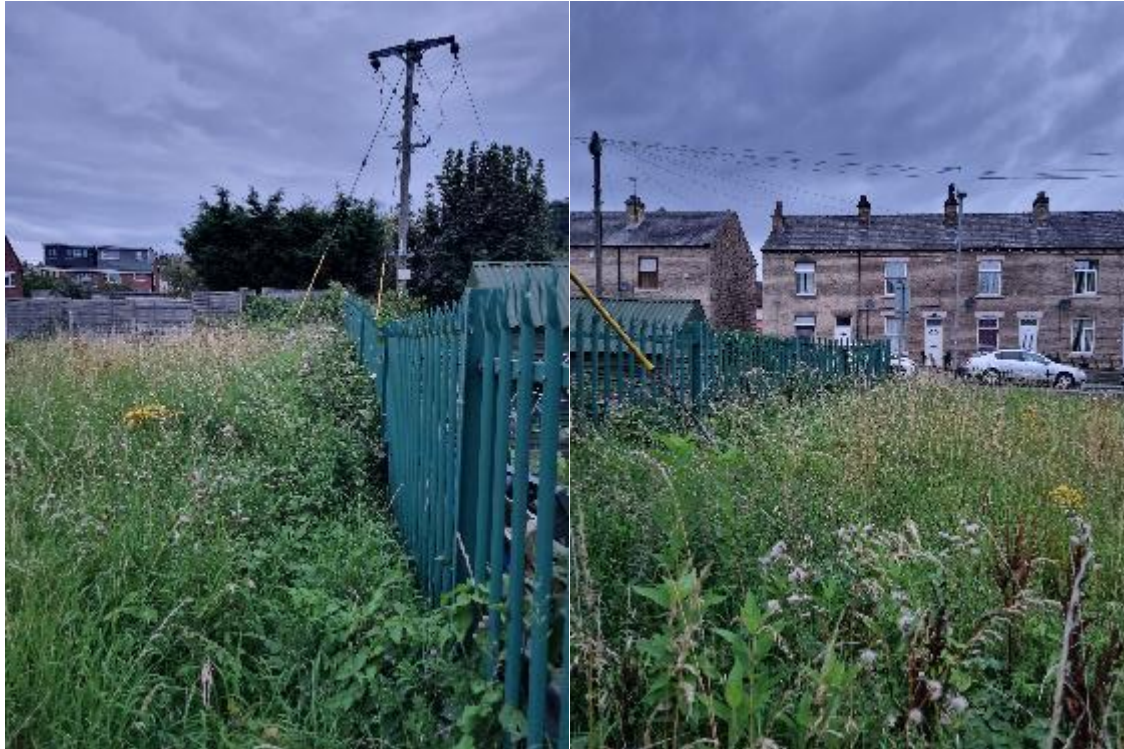
Southern boundary looking east and west

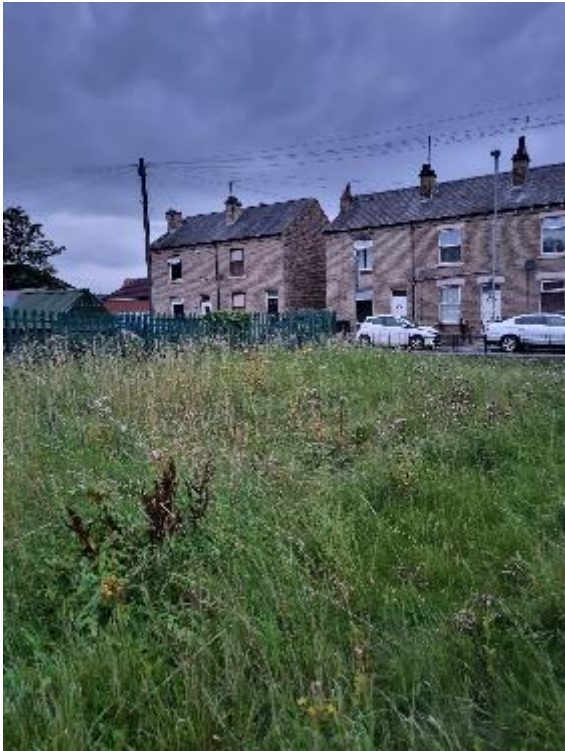
Looking across the site northeast to south west

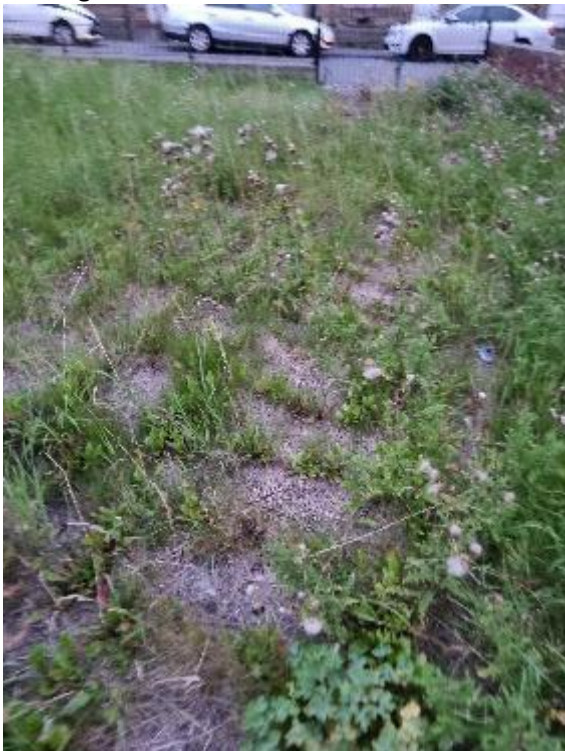
Parking area

The site is approximately rectangular in shape, fairly level and grassed over. Evidence of a drive/parking area can be seen to the northwest corner of the site.

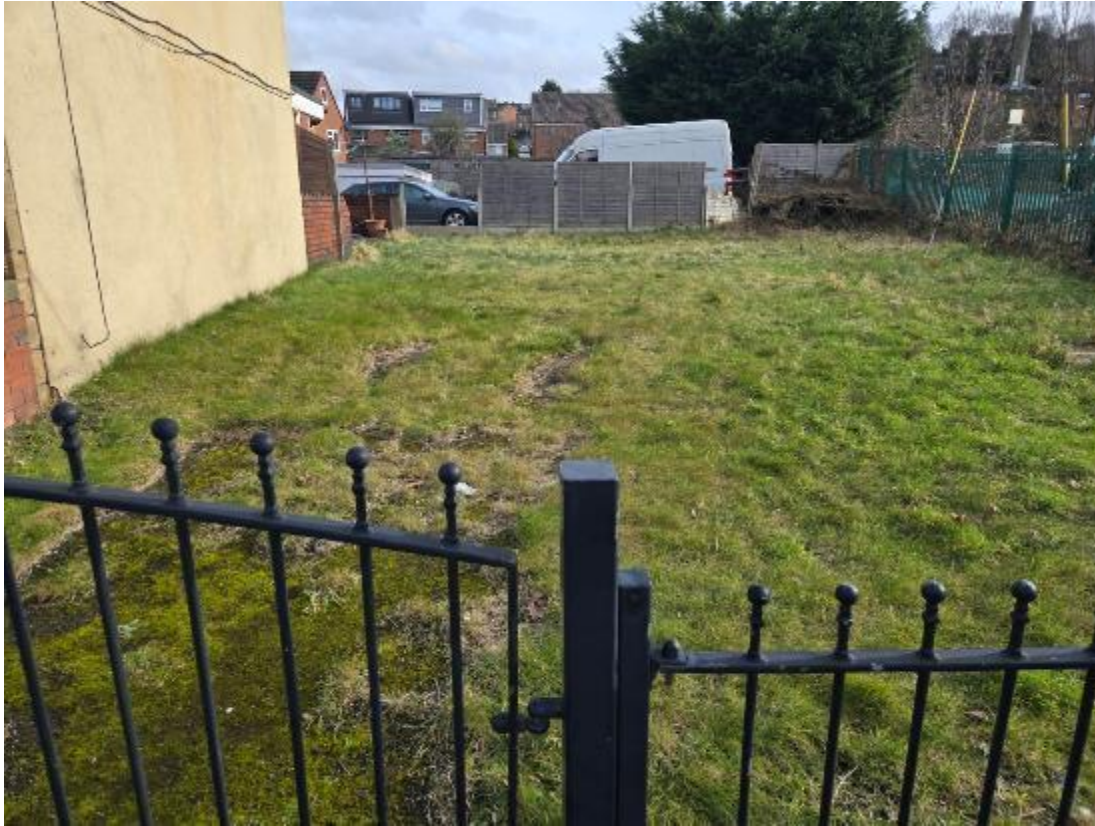
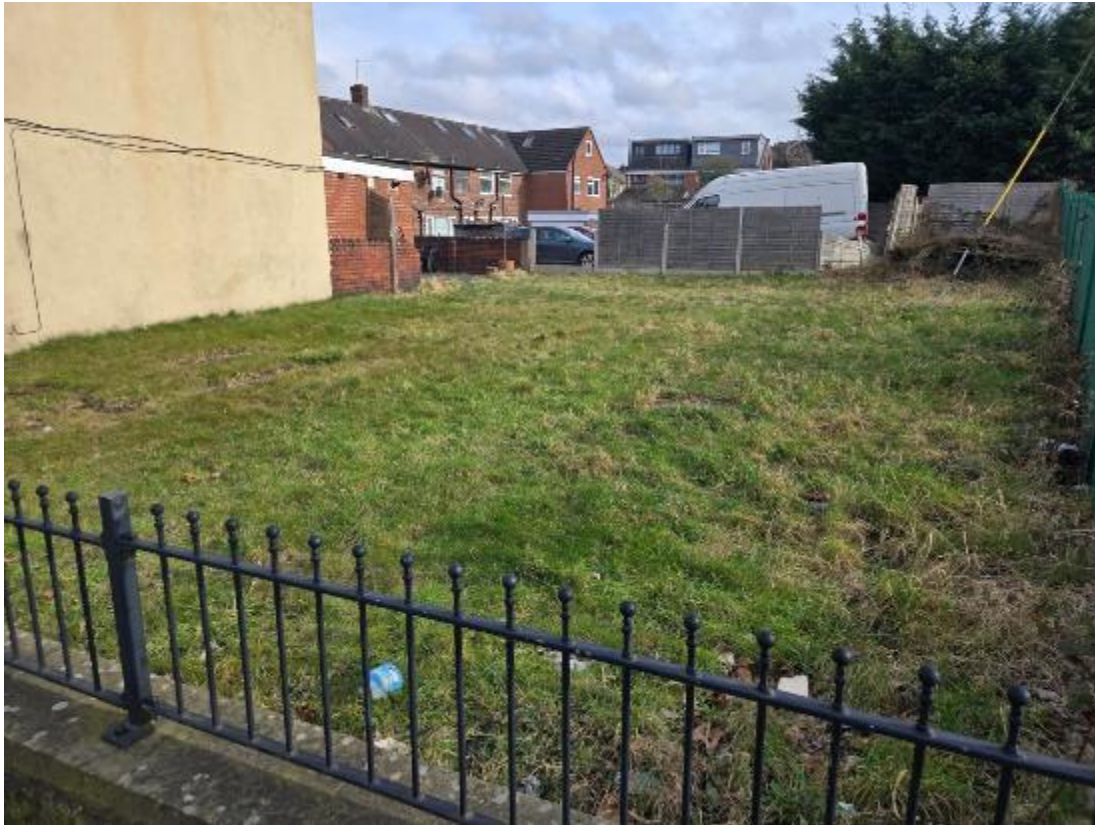
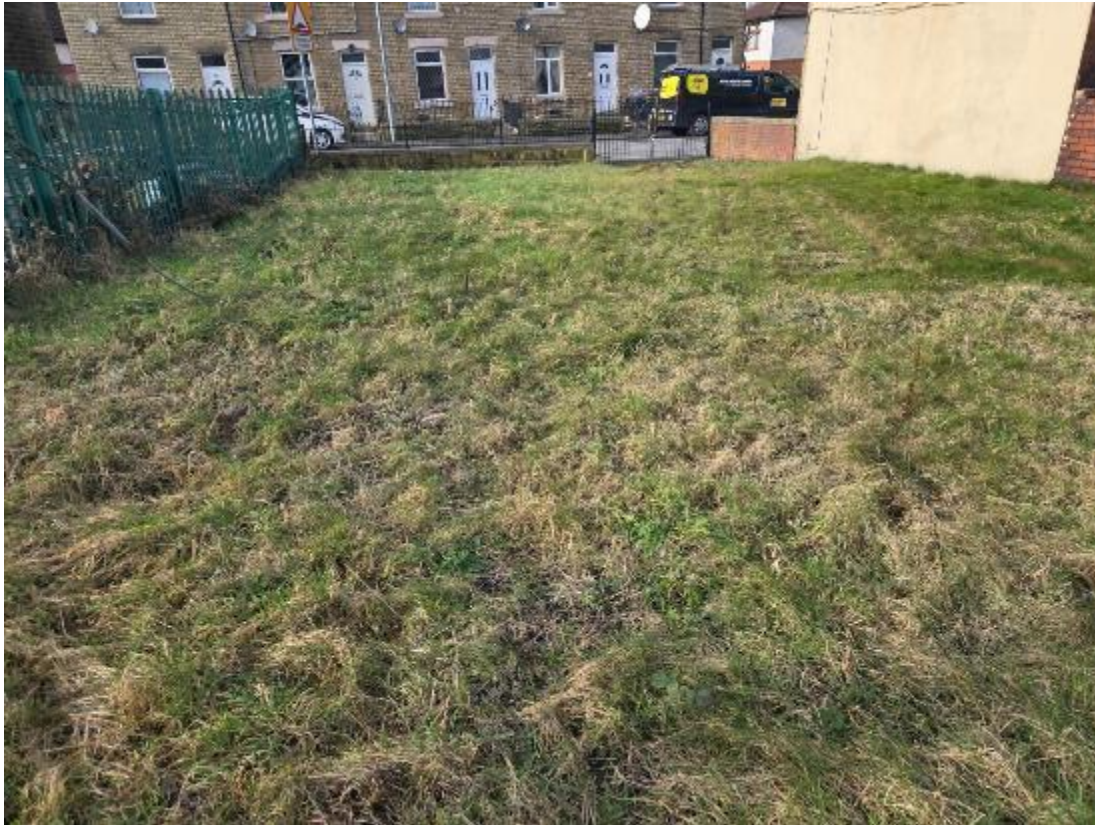
The site is overgrown across its entirety. There is some evidence of the former building still on site with some rubble in places. In addition, some rubbish/litter and waste wood were seen across the site.

Looking across the site from west to east and west to east

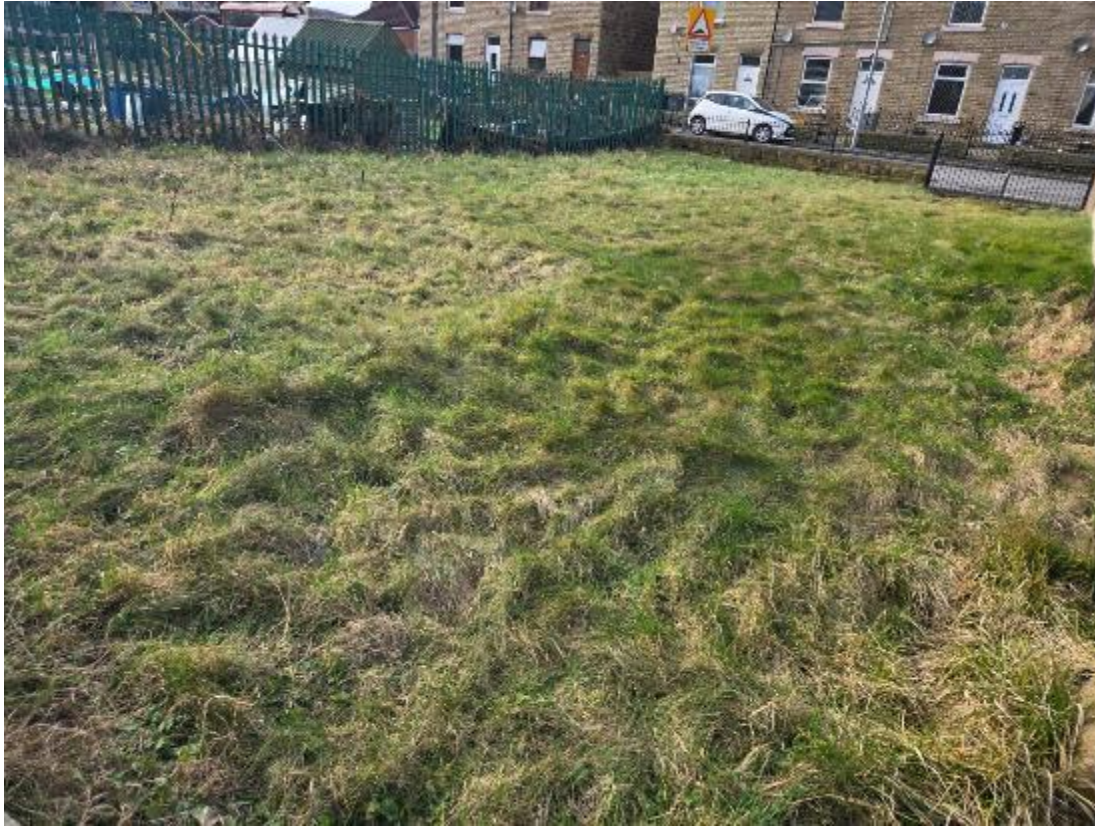
Looking across the site from northeast to southwest corner
