Arboricultural Impact Assessment

WC-443.1a

Community of the Resurrection,
Stocks Bank Road, Mirfield WF14 0BN

Report type:	Arboricultural Impact Assessment
Report reference:	WC-443.1
Revision:	a
Client:	Community of the Resurrection
Site address	Community of the Resurrection, Stocks Bank Road, Mirfield WF14 0BN
Grid reference:	SE 19026 20809
Report prepared by:	Jack Delaney MICFor MArborA
Date:	27 th March 2026

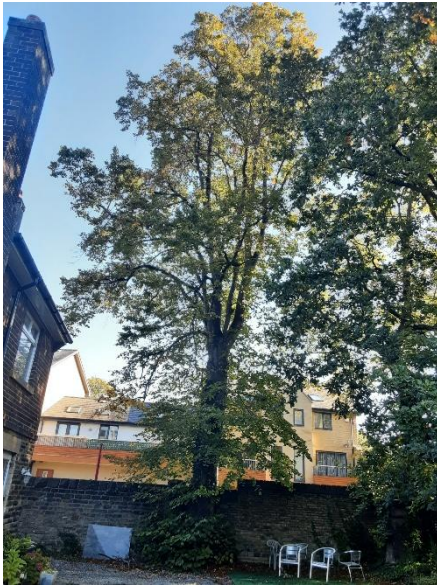
Plate 1: T001

Tree Ref:	Species	Age	SULE	Ht.	DBH	CS				CC	Comments	PC	SC	BS 5837: 2012 Category	Recommendations
						N	E	S	W						
T001	Small-leaved lime <i>Tilia cordata</i>	M	40-80	24	790	10	6	6	5	2	Lapsed pollard. Asymmetrical form due to proximity with adjacent trees. Minor deadwood < 100 mm in diameter scattered throughout the crown. Dense epicormic growth on main stem up to 9 m, which partially obscures tree features and potential defects.	F	F	B2	Crown lift to 5.5 m
T002	Small-leaved lime <i>Tilia cordata</i>	M	40-80	21	720	9	4	5	5	1.5	Asymmetrical form due to proximity with adjacent trees. Bifurcates at 9 m into two co-dominant stems; the angle of this branch union is > 25°, and therefore, it is unlikely to contain included bark. Major deadwood > 100 mm in diameter scattered throughout the crown. Dense epicormic growth	F	F	B2	No works recommended

Tree Ref.	Recommendations
T001	<ul style="list-style-type: none"> • Crown lift to provide a minimum clearance of 5.5 m above ground level
T003	
T005	
T017	<ul style="list-style-type: none"> • Remove trees
T018	
T019	
G001	<ul style="list-style-type: none"> • Partial removal of group (refer to Tree Constraints Plan in Appendix 4)
H003	<ul style="list-style-type: none"> • Remove hedges
H004

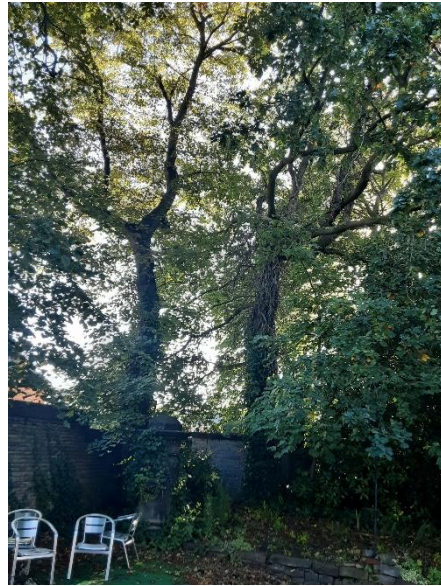
Plate 2: T002 (left) & T003 (right)

Tree Ref:	Species	Age	SULE	Ht.	DBH	CS				CC	Comments	PC	SC	BS 5837: 2012 Category	Recommendations
						N	E	S	W						
											on main stem up to 9 m, which partially obscures tree features and potential defects.				
T003	Sessile oak <i>Quercus petraea</i>	M	40-80	19	700	1	9	10	7	1.5	Asymmetrical form due to proximity with adjacent trees. Dense ivy <i>Hedera helix</i> established on main stem and first order branches, which obscures tree features and potential defects.	F	F	B2	Crown lift to 5.5 m
T004	Wych elm <i>Ulmus glabra</i>	SM	10-20	9	210	6	2.5	1	1.5	2	Asymmetrical form due to proximity with adjacent trees. Approaching age where Dutch elm disease <i>Ophiostoma novo-ulmi</i> is likely to impact.	F	F	C1	No works recommended
T005	Sessile oak <i>Quercus petraea</i>	SM	40-80	15	320	1	4	8	8	1.5	Asymmetrical form due to proximity with adjacent trees.	F	F	B1	Crown lift to 5.5 m
T006	Red horse chestnut <i>Aesculus x carnea</i>	M	10-20	14	690	4	4.5	5	6	2.5	Bifurcates at 2m into two co-dominant stems; the angle of this branch union is < 25°, and therefore, it may contain included bark. Multiple bacterial target cankers on main stem and first order branches, which is a typical feature of the species type. Dense ivy <i>Hedera helix</i> established on the main stem and first order branches, which obscures tree features and potential defects.	F	PD	C1	No works recommended

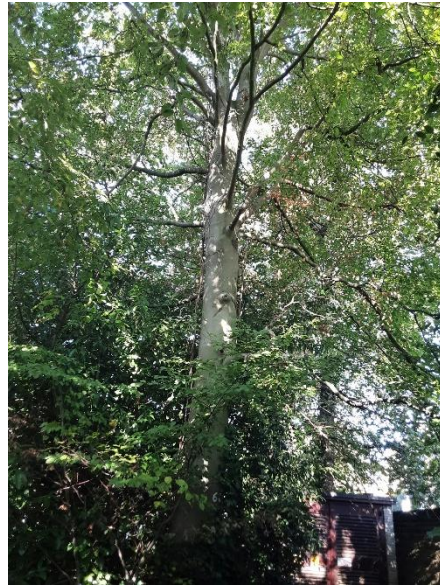
Plate 6: T007

T007	European beech <i>Fagus sylvatica</i>	M	40-80	22	640	7	6	6	6	2	Minor deadwood < 100 mm in diameter scattered throughout the crown	F	G	B2	No works recommended
T008	European beech <i>Fagus sylvatica</i>	EM	40-80	19	470	5	7	6	4	1	Asymmetrical form due to proximity with adjacent trees. Minor deadwood < 100 mm in diameter scattered throughout the crown	F	F	B2	No works recommended
T009	Sycamore <i>Acer pseudoplatanus</i>	M	40-80	21	590	9	6	4.5	5	11	Asymmetrical form due to proximity with adjacent trees. Branch cavity at 2 m on north aspect of main stem, approx. 25 cm (h) x 25 cm (w), and probed to 40 cm. Dense ivy <i>Hedera helix</i> established on main stem and first order branches, which obscures tree features and potential defects.	F	PD	B2	No works recommended

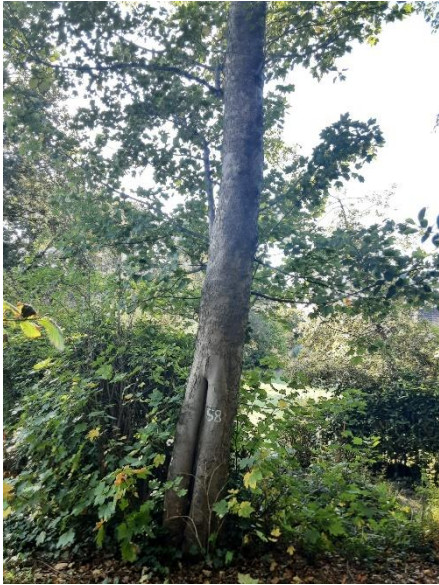
Plate 9: T010

Tree Ref:	Species	Age	SULE	Ht.	DBH	CS				CC	Comments	PC	SC	BS 5837: 2012 Category	Recommendations
						N	E	S	W						
T010	Sycamore <i>Acer pseudoplatanus</i>	EM	20-40	20	560	6	5	6	6	2	Historic mechanical damage to base of main stem, from ground level to 2 m; some visible decay to the exposed ripewood, though with extensive wound wood forming around margins of defect. Minor deadwood < 100 mm in diameter scattered throughout the crown	F	PD	B2	No works recommended
T011	Wych elm <i>Ulmus glabra</i>	SM	10-20	13	310	5	4.5	3	3	2	Dense ivy <i>Hedera helix</i> established on main stem and first order branches, which obscures tree features and potential defects. Approaching age where Dutch elm disease <i>Ophiostoma novo-ulmi</i> is likely to impact.	F	G	C1	No works recommended
T012	Common holly <i>Ilex aquifolium</i>	SM	20-40	5	100 100 100 100	3	3	2	3	0	Multiple-stemmed tree. No obvious significant defects, though of limited arboricultural merit, and lacks the necessary qualities for higher BS 5837 categorisation.	F	F	C1	No works recommended

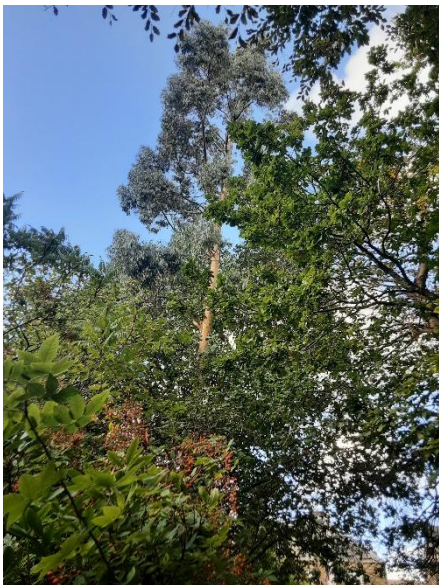
Plate 15: T016

T016	Eucalyptus cider gum <i>Eucalyptus gunnii</i>	EM	20-40	22	470	3.5	5	4	3	8	No obvious significant defects, though lacks the necessary qualities for higher BS 5837 categorisation.	G	G	B2	No works recommended

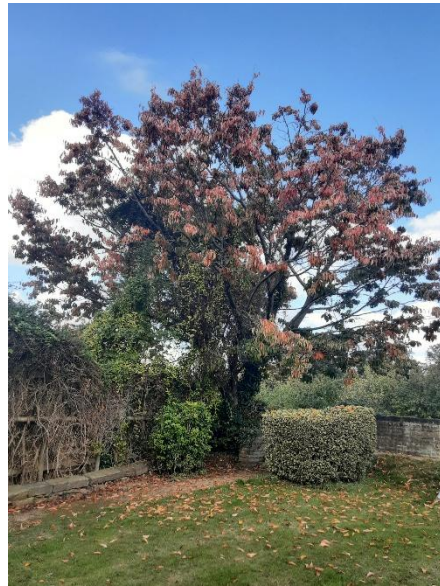
Plate 20: T023

T023	Japanese cherry <i>Prunus serrulata</i>	EM	20-40	10	440	5	5	6	6	2	Bifurcates at 2 m into multiple co-dominant stems; the angles of these branch unions are all < 25°, and therefore, they may contain included bark.	F	F	B1	No works recommended
T024	Silver birch <i>Betula pendula</i>	EM	40-80	12	420	4	4	4	4	0	No obvious significant defects, though lacks the necessary qualities for higher BS 5837 categorisation.	G	G	B2	No works recommended

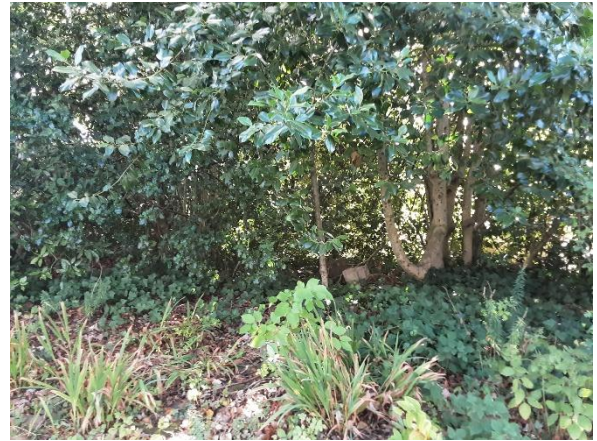
Plate 22: G001

Group Ref:	Species Composition	Age	SULE	Mx. Ht.	Mx. DBH	Approx. No. of Stems	CC	Comments	PC	SC	BS 5837:2012 Category	Recommendations
G001	Sycamore <i>Acer pseudoplatanus</i> European beech <i>Fagus sylvatica</i> Common ash <i>Fraxinus excelsior</i> Common holly <i>Ilex aquifolium</i> Laurel cherry <i>Prunus laurocerasus</i> Elder <i>Sambucus nigra</i> English yew <i>Taxus baccata</i> Wych elm <i>Ulmus glabra</i>	Y SM	20-40	8	230	40	0	Dense understorey group. No obvious significant defects, though of limited arboricultural merit and lacks the necessary qualities for higher BS 5837 categorisation.	F	F	C1	No works recommended
G002	Summer lilac <i>Buddleia davidii</i> Hazel <i>Corylus avellana</i> Common holly <i>Ilex aquifolium</i> Laurel cherry <i>Prunus laurocerasus</i> Rhododendron <i>Rhododendron ponticum</i> English yew <i>Taxus baccata</i> Wayfaring tree <i>Viburnum lantana</i>	Y SM	20-40	8	240	30	0	Dense understorey group. No obvious significant defects, though of limited arboricultural merit, and lacks the necessary qualities for higher BS 5837 categorisation.	F	F	C1	Partial removal of group (refer to Tree Constraints Plan in Appendix 4)
