2024.00373.000

# George Hotel Refurbishment (Planning & LBC) LBC – HAKI access stair \_ V3 Block A – Design and Access Statement

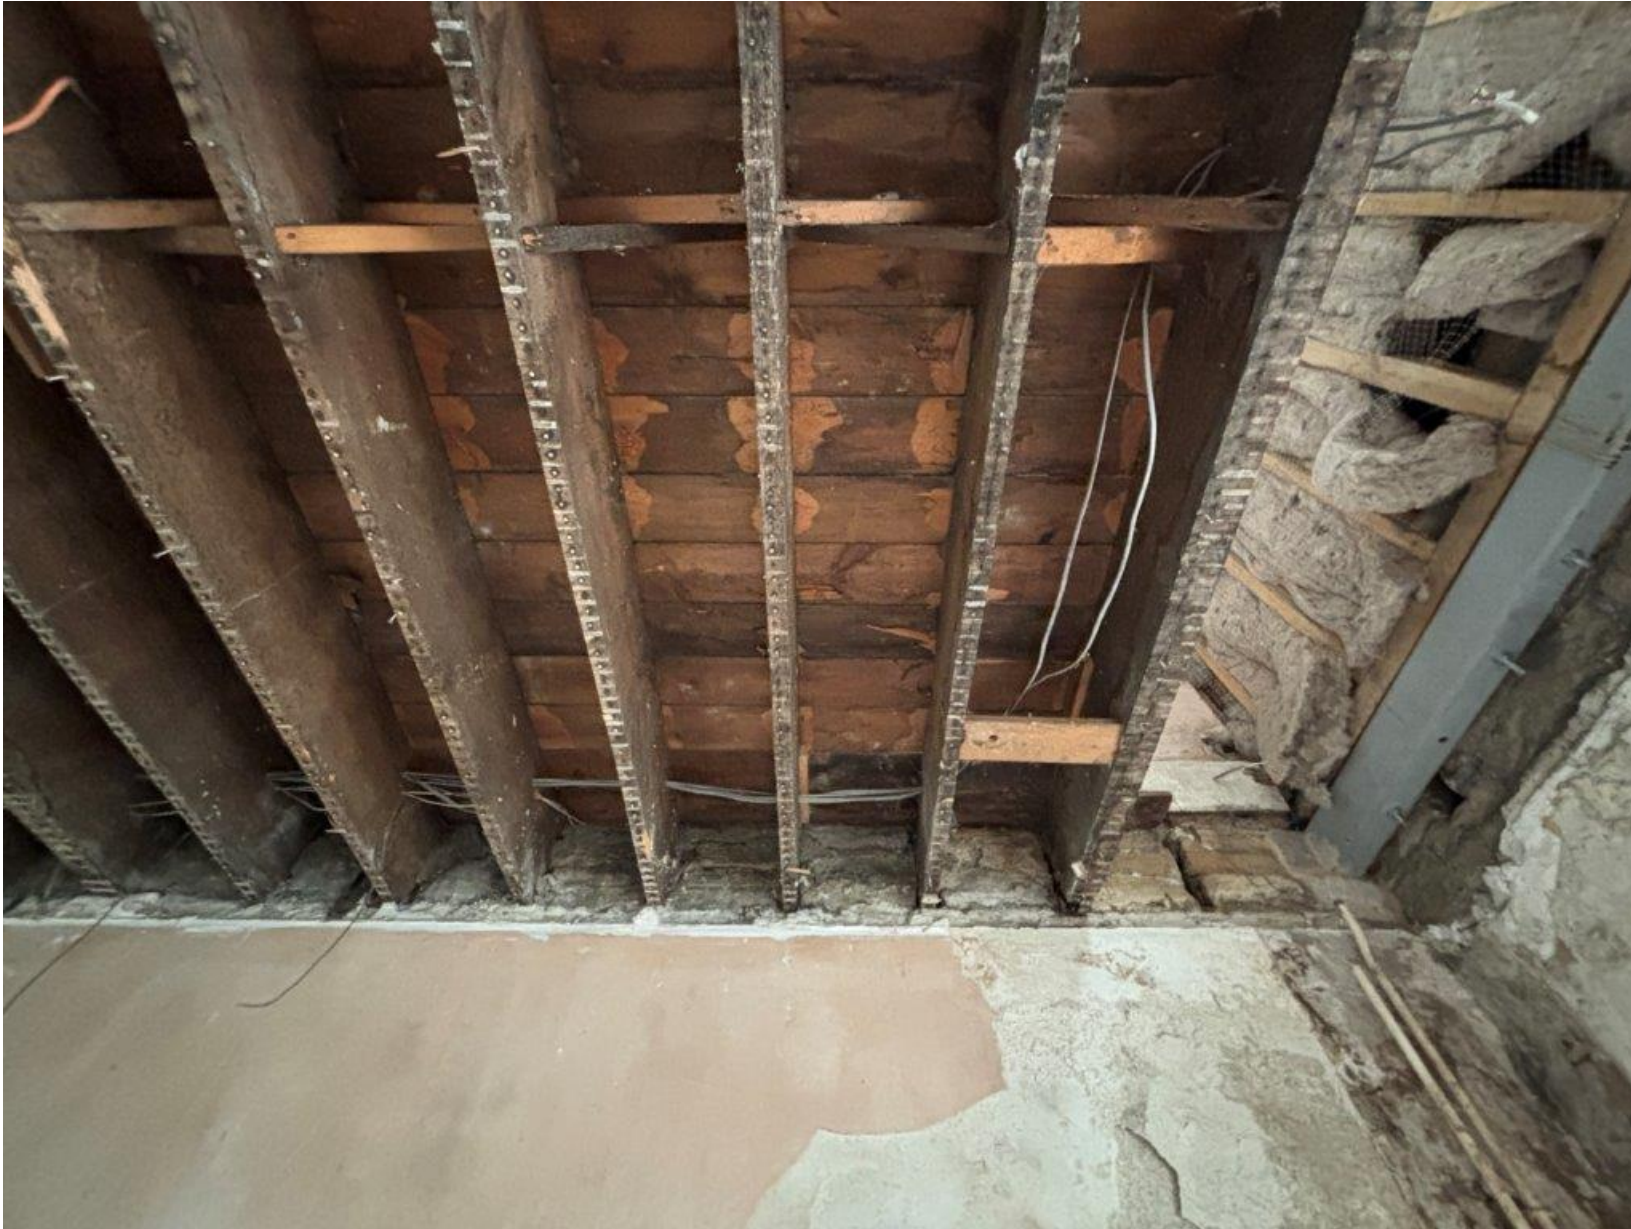
IMG\_4394 - 4<sup>th</sup> floor (U/S) as viewed from 3<sup>rd</sup> floor (Room 181)  
Note: 5nr slim joists (from right of image) ends rotten – limited repair option due to joist slenderness.

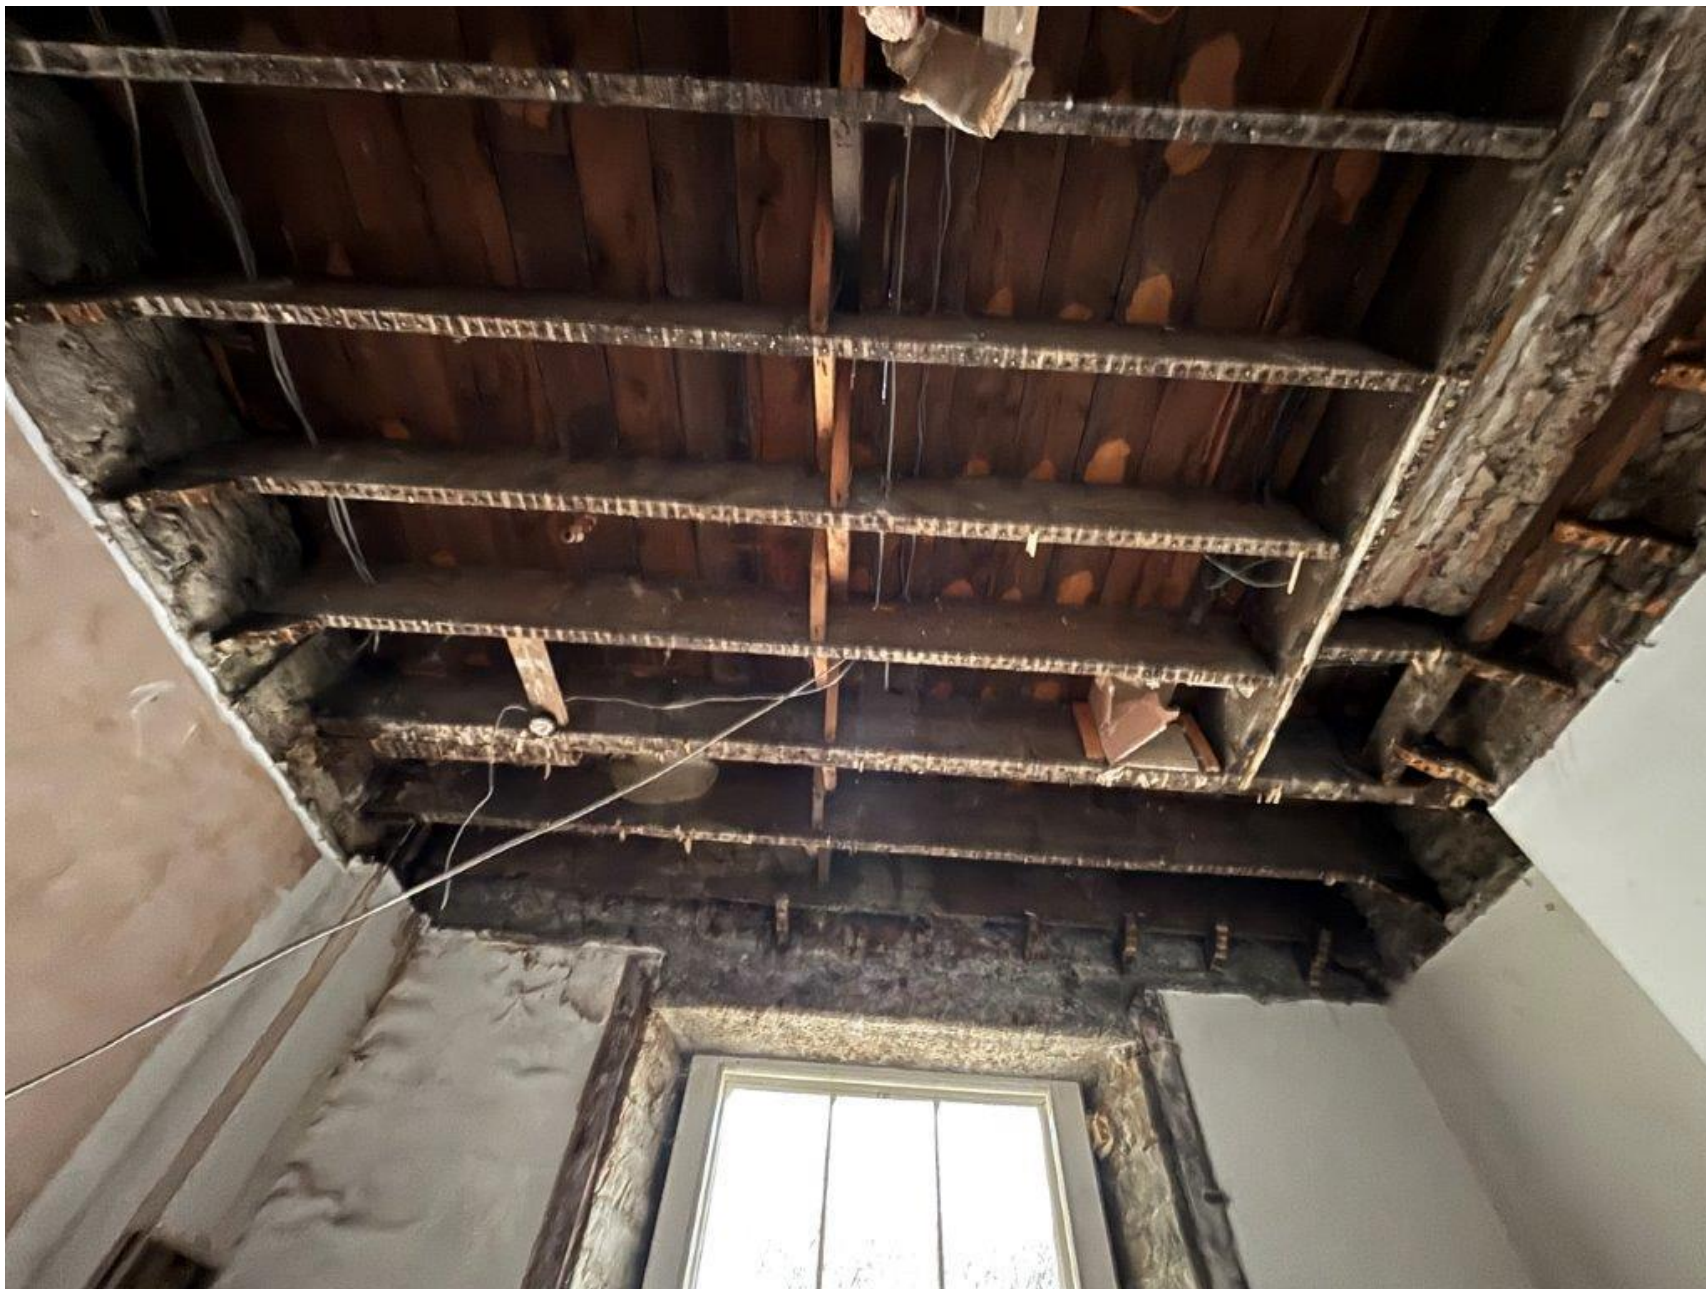
IMG\_4396 – 3<sup>rd</sup> floor (U/S) as viewed from 2nd floor (Room 140)  
Note: extensive timber staining (historic water ingress) & Unsupported hearth Vault

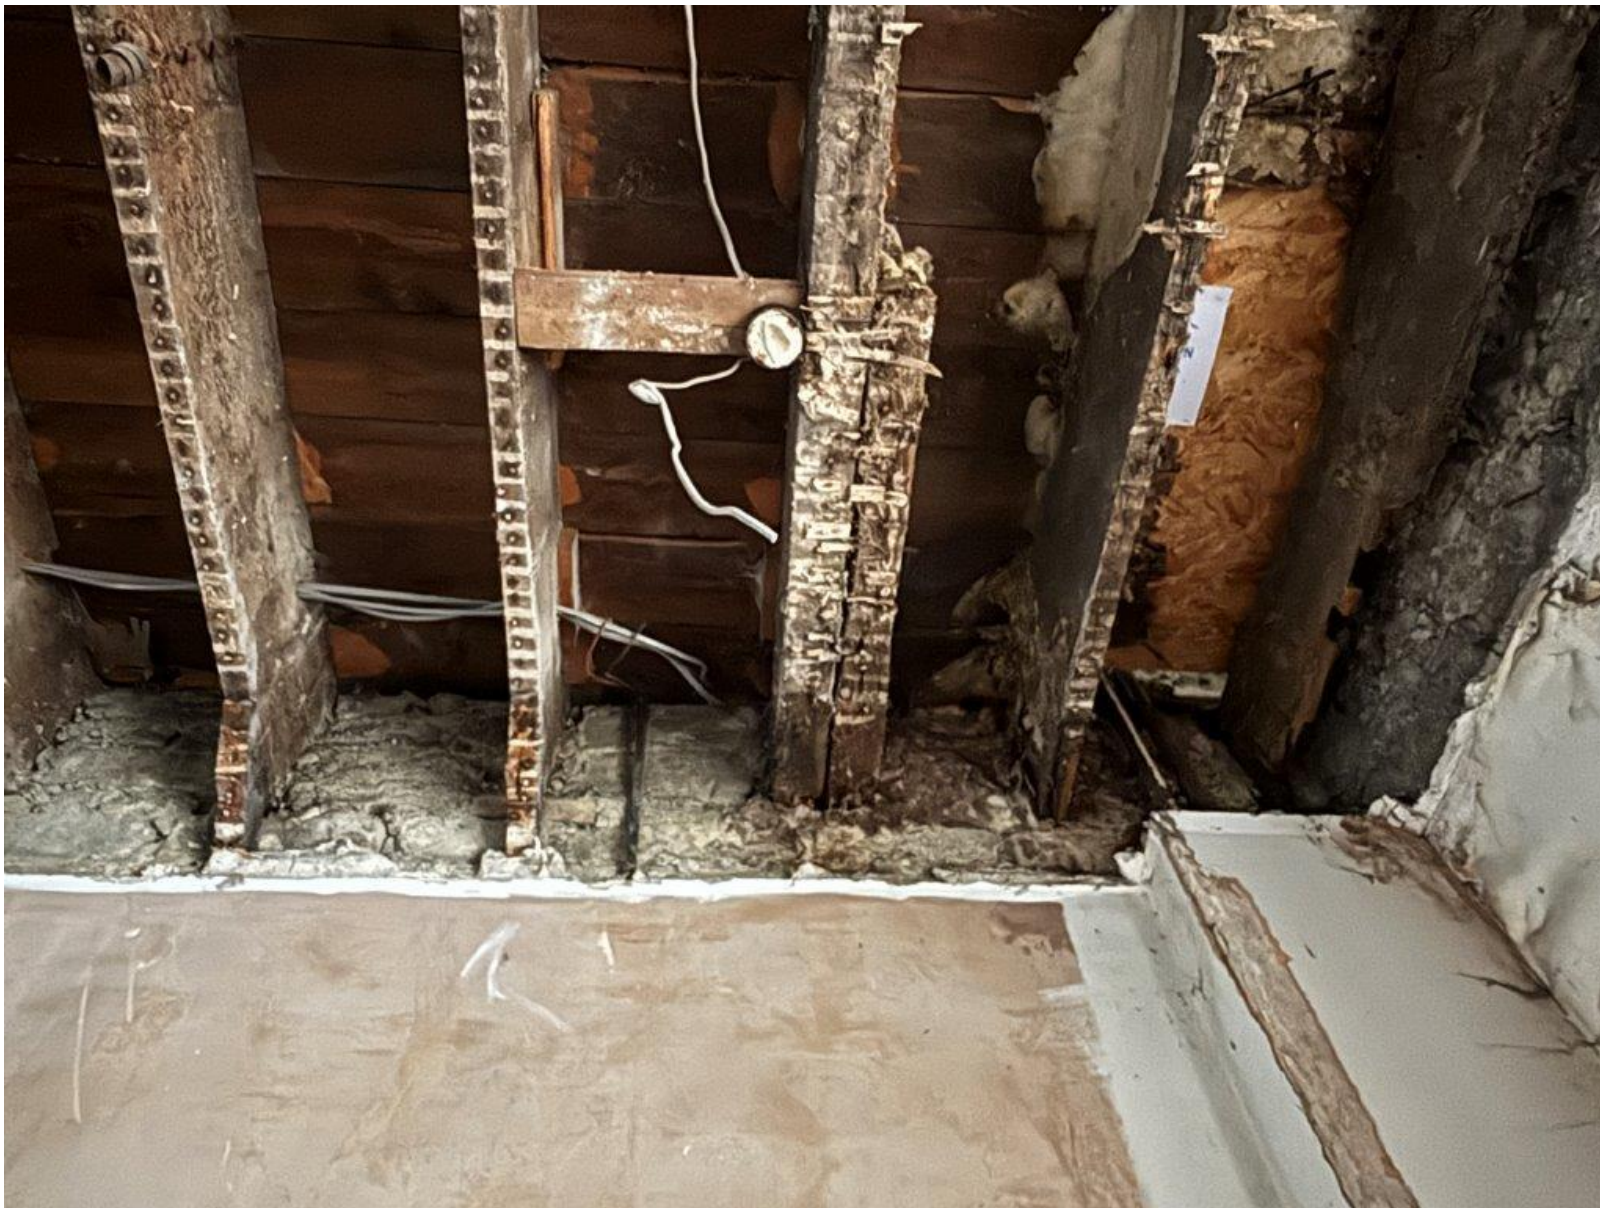
IMG\_4397 - 3<sup>rd</sup> floor (U/S) as viewed from 2<sup>nd</sup> floor (Room 140)  
Note: 4nr joists from external wall end failure – limited repair option due to joist slenderness and historic water damage.  
Note: fruiting bodies in timber.

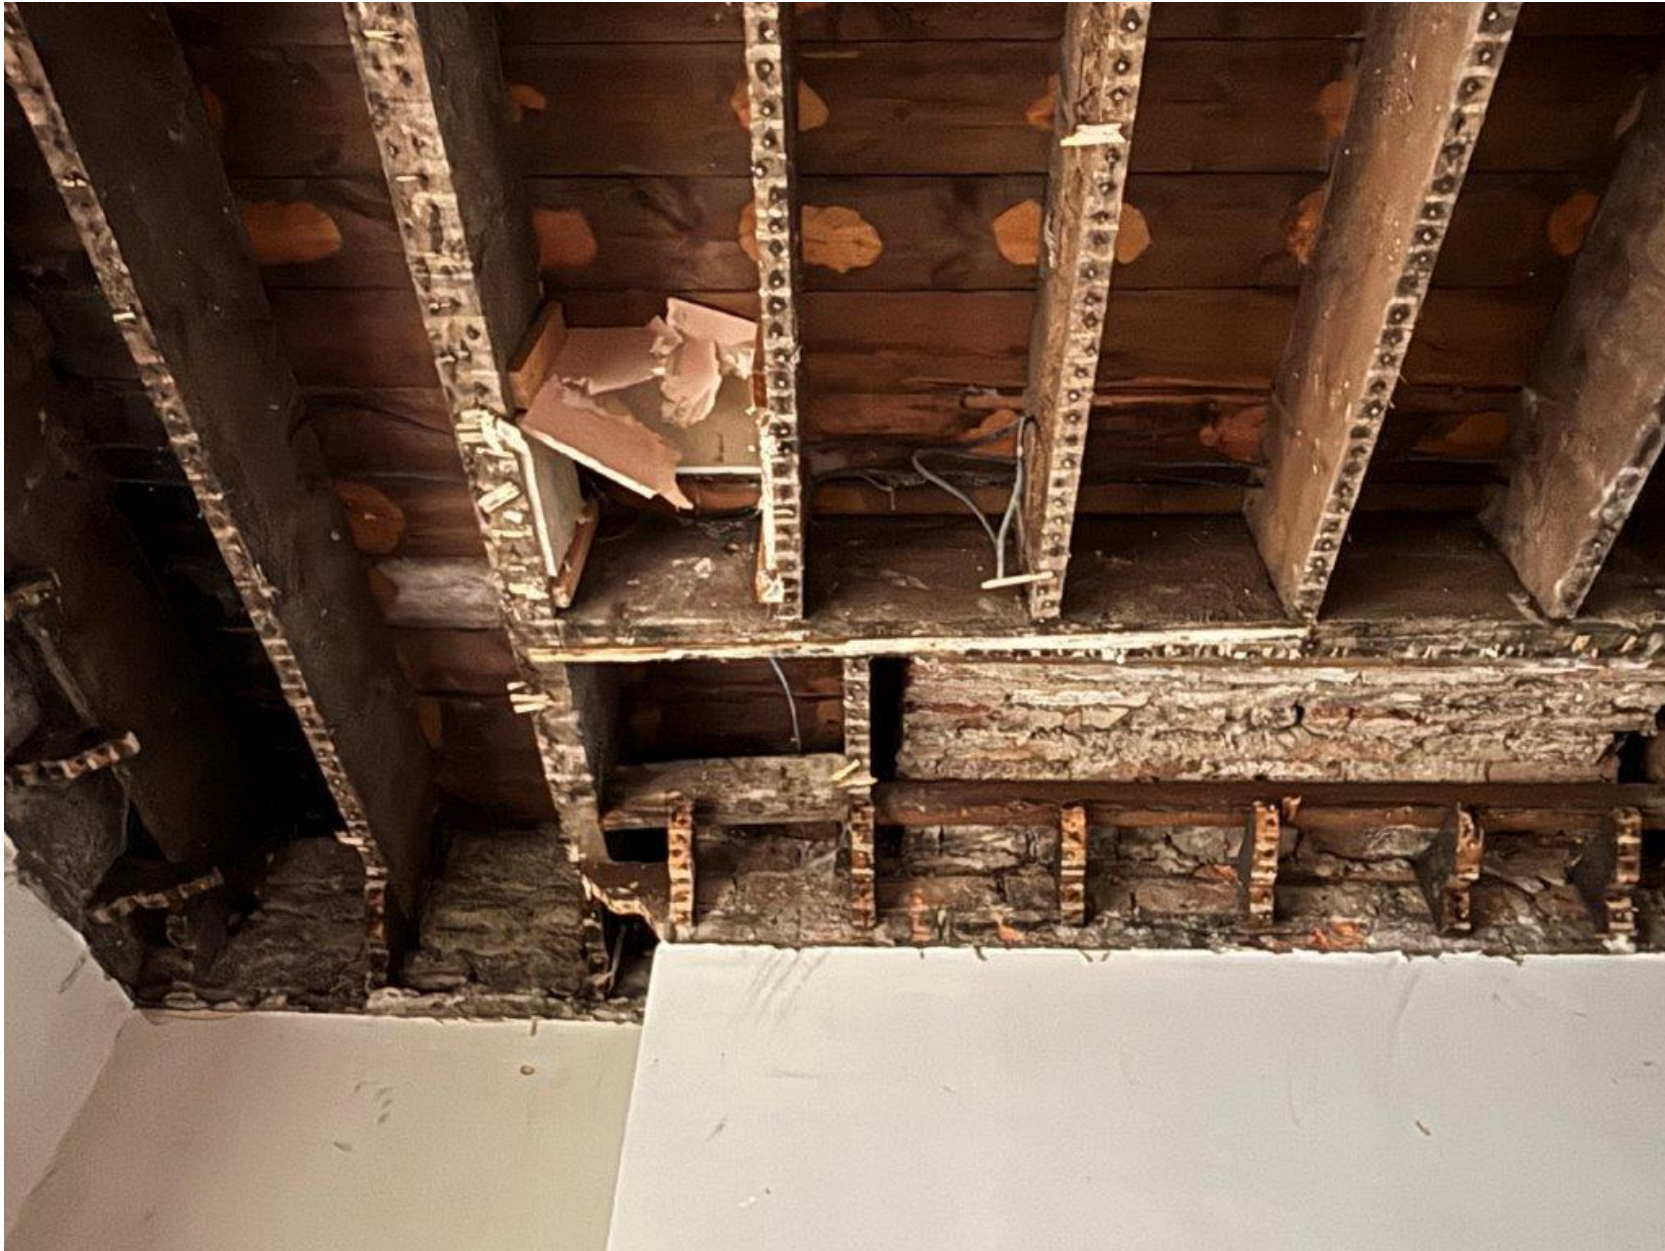
IMG\_4398 - 3<sup>rd</sup> floor (U/S) as viewed from 2nd floor (Room 140)  
Note: other end of timber joist with unsupported hearth vault support (lack).

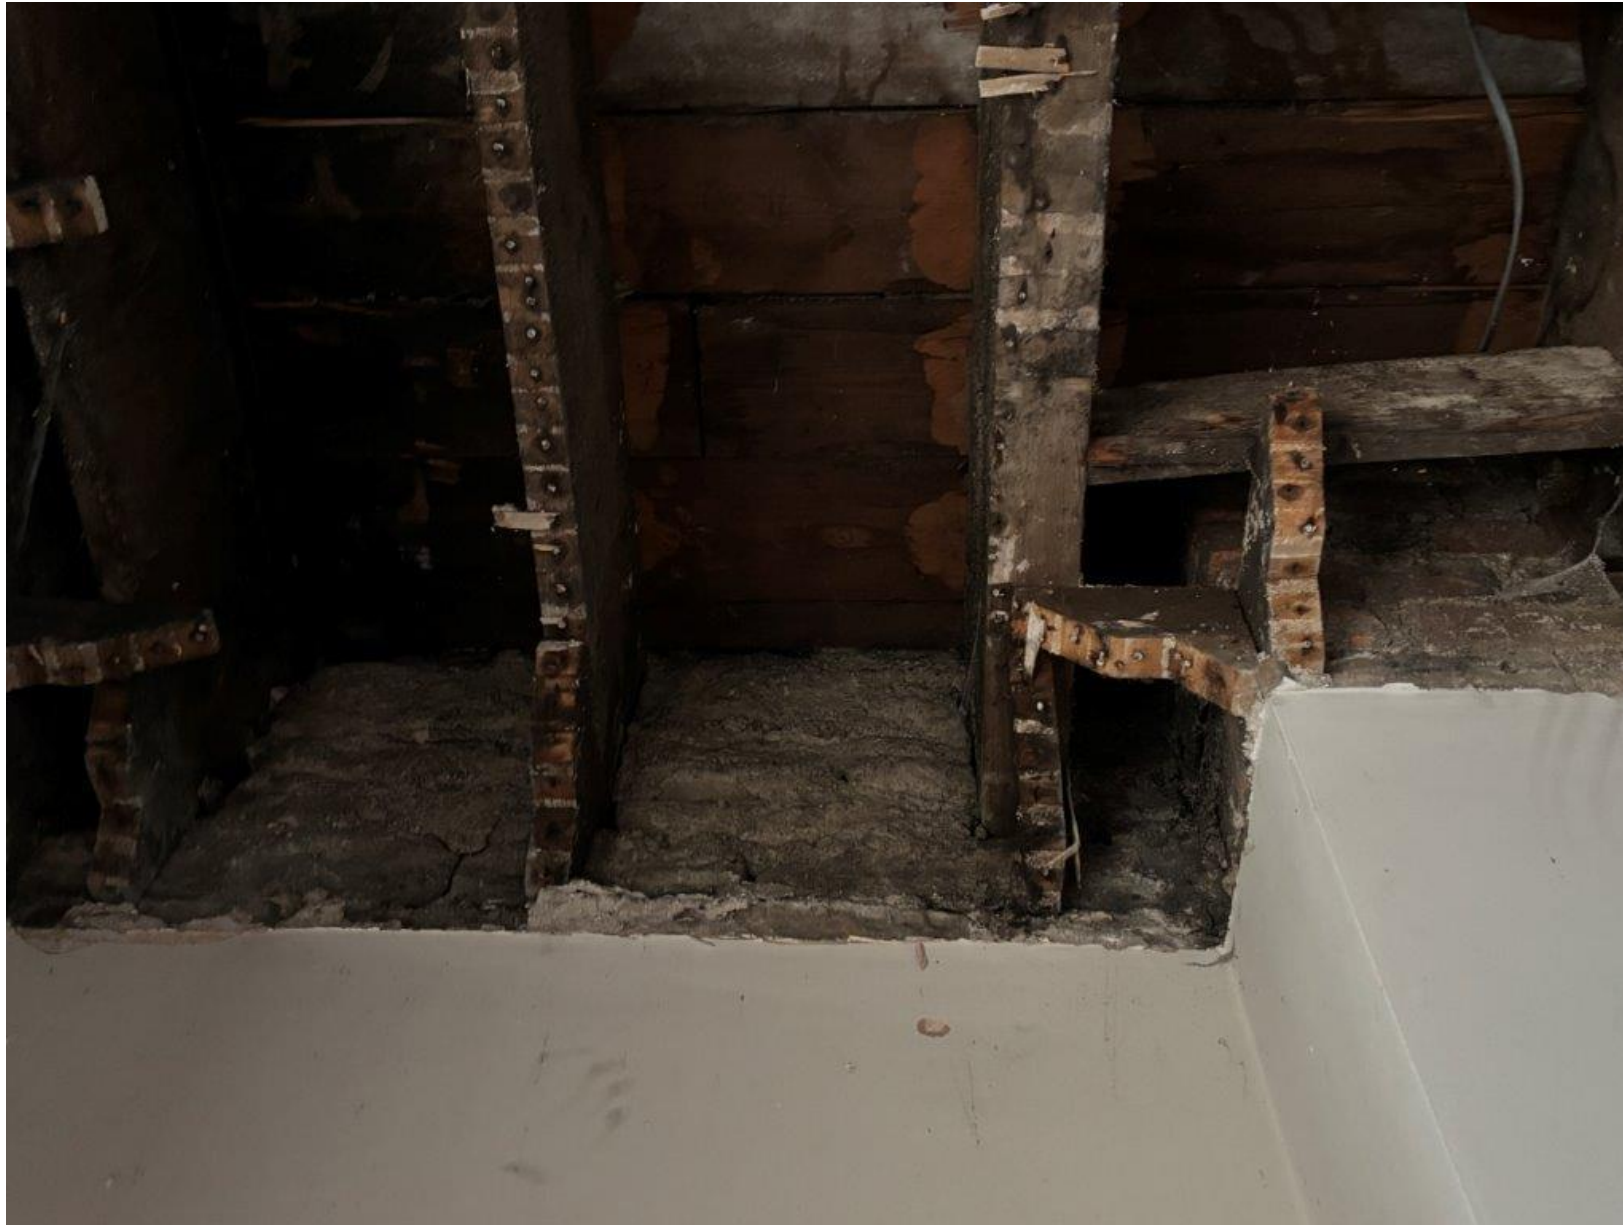
IMG\_4399 - 3<sup>rd</sup> floor (U/S) as viewed from 2nd floor (Room 140).  
Closeup – extremely slender pockets limiting replacement/ end repair approaches.

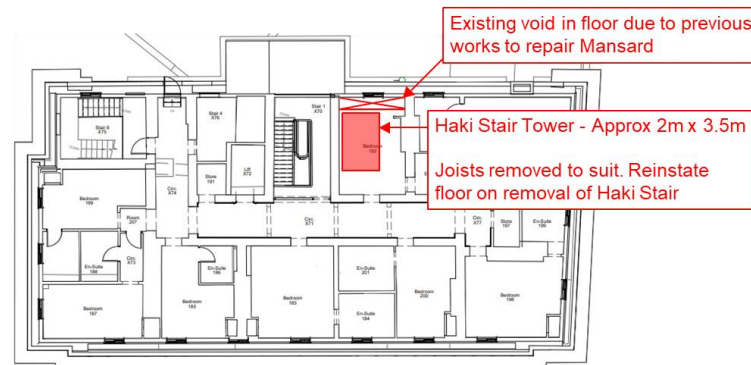
Existing void in floor due to previous works to repair Mansard
