## Design and Access Statement & Heritage Statement Combined

Woodley School and College  
Dog Kennel Bank  
Huddersfield  
HD5 8JE

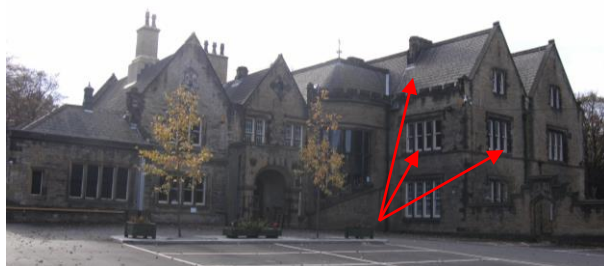
The New Hall building is a listed asset and has been affected by ongoing water ingress, which has led to deterioration of roof coverings, timber structures, and internal finishes.

Photo 1 – Area of window and roof repairs to the New Hall Building

At the New Hall building, the proposed works include roof repairs to one elevation, involving the temporary removal of existing slate coverings, parapet copings and ridge tiles to allow for a full inspection of the underlying structural timbers, with repairs undertaken where necessary. Upon completion, all elements will be reinstated.

Windows affected by rot will be replaced with new softwood units to match the existing profile and appearance. Internally, the works focus on addressing decay through localised opening-up, treatment of masonry and timber where required, replacement of defective structural lintels, and the reinstatement of ceilings and associated finishes.

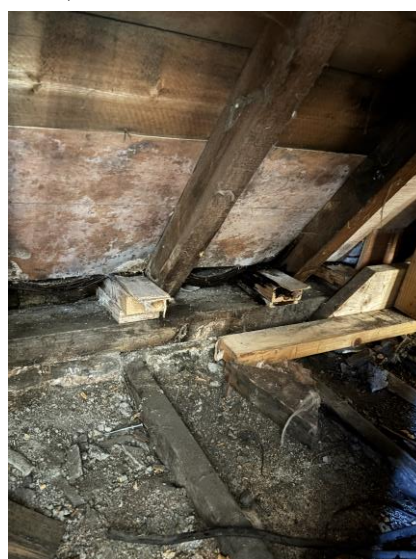
Photo 2 – Area of water ingress from box gutter

Due to blockages of gutters and downpipes the existing lead box gutter has failed, allowing water ingress to occur over time. The ingress has led to severe deterioration of the timber structure beneath the lead which has exacerbated the onset of dry rot which has spread to surrounding timbers and are in need of repair works to mitigate against catastrophic failure.

The existing gutter linings will be replaced with new 18mm marine plywood, finished with a new lead sheet lining.

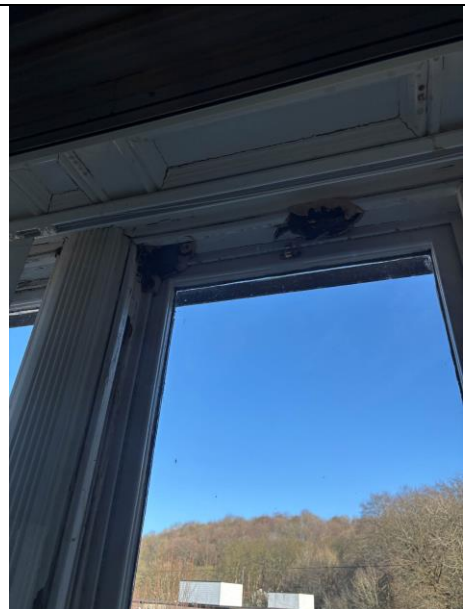
Photo 3 – Area under box gutter and window decay.

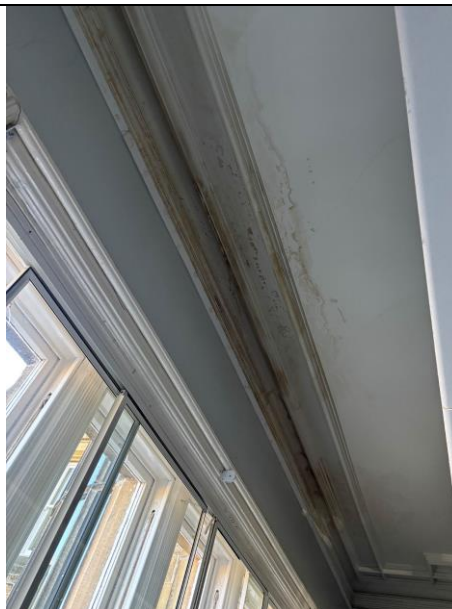
Photo 4 – Area under box gutter showing dry rot extent

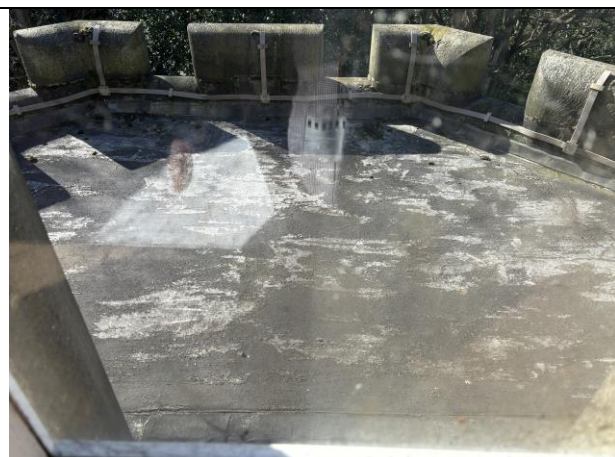
The flat asphalt roof covering located to the west of the site shows evidence of multiple previous repairs, including the application of a liquid membrane. This membrane has since deteriorated significantly, resulting in water ingress to the areas below.

Photo 5 – Asphalt deterioration

To the west flat roof, the existing covering will be stripped back to the deck, which will be inspected, and a new thermally improved asphalt roof covering installed.

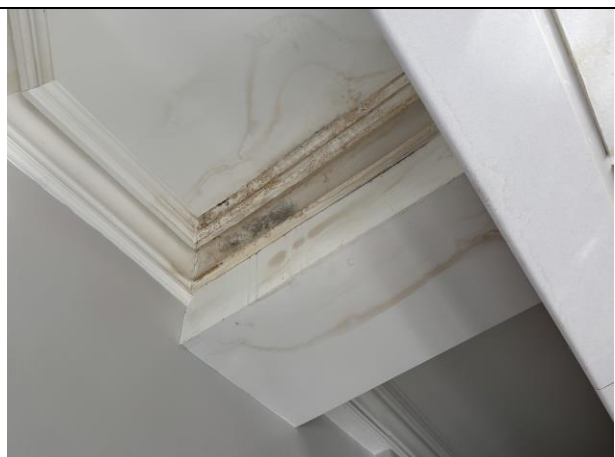
Photo 6 – Internal leak

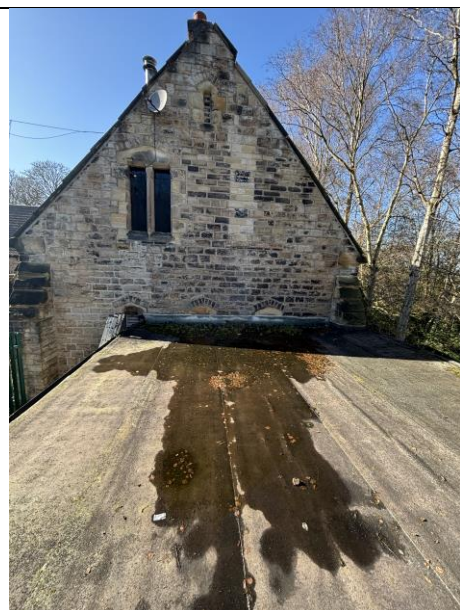
At the stable block, the existing felt roof system has exceeded its life span and is leaking internally.

Photo 5 – Pooling water

At the stable block, the works involve complete renewal of the flat roof covering, including removal of existing materials, installation of a new insulated 3 layer felt roof system, replacement of fascias and soffits, and installation of new aluminium heritage rainwater goods to match existing profile. Localised alterations are also proposed to improve weathering details.

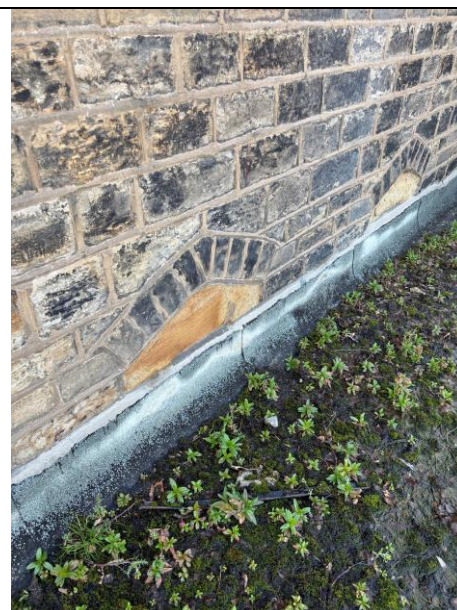
Photo 6– Stable block upstand deterioration.
