# Arboricultural Impact Assessment

## WC-517.1a

Huddersfield Bus Depot, Old Fieldhouse Lane,  
Huddersfield HD2 1AG

| <b>Report type:</b> | Arboricultural Impact Assessment |

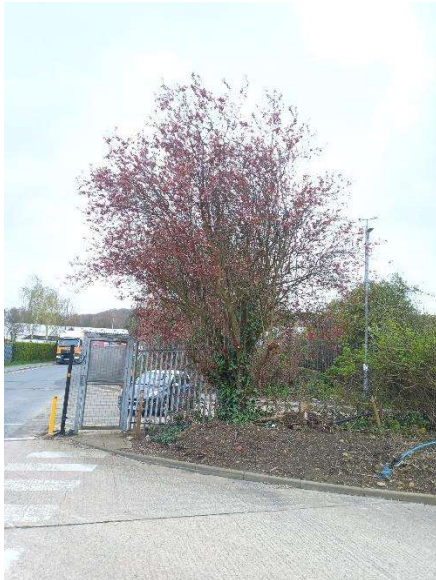
**Plate 1:** T001

| Tree Ref: | Species | Age | SULE | Ht. | DBH | CS | | | | CC | Comments | PC | SC | BS 5837: 2012 Category | Recommendations |
|---|---|---|---|---|---|---|---|---|---|---|---|---|---|---|---|
| T001 | Purple cherry plum<br><i>Prunus cerasifera</i> 'Pissardi' | SM | 20-40 | 7 | 110<br>100<br>140<br>90<br>90<br>80 | 3.5 | 3.5 | 3.5 | 3 | 3 | Multiple-stemmed tree. No obvious significant defects, though of limited arboricultural merit and lacks the necessary qualities for higher BS 5837 categorisation. | F | F | C1 | No works recommended |

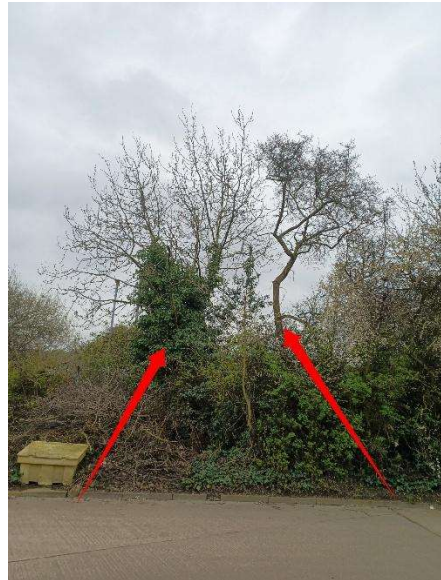
**Plate 2:** T002 (left) & T003 (right)

| Tree Ref: | Species | Age | SULE | Ht. | DBH | CS | | | | CC | Comments | PC | SC | BS 5837: 2012 Category | Recommendations |
|---|---|---|---|---|---|---|---|---|---|---|---|---|---|---|---|
| T002 | Common ash<br><i>Fraxinus excelsior</i> | SM | 40-80 | 9.5 | 200# | 4 | 3.5 | 4 | 3.5 | 3.5 | Unable to access base of main stem due to dense understorey vegetation. Dense ivy <i>Hedera helix</i> established on main stem and first order branches, which obscures tree features and potential defects. | F | G | B1 | No works recommended |

| Tree Ref: | Species | Age | SULE | Ht. | DBH | CS | | | | CC | Comments | PC | SC | BS 5837: 2012 Category | Recommendations |
|---|---|---|---|---|---|---|---|---|---|---|---|---|---|---|---|
| T003 | Sea buckthorn<br><i>Hippophae rhamnoides</i> | SM | 10-20 | 9 | 200 | 3 | 1 | 2 | 3 | 5.5 | Asymmetrical form due to proximity with adjacent trees. Minor deadwood < 100 mm in diameter scattered throughout the crown. | F | F | C1 | No works recommended |

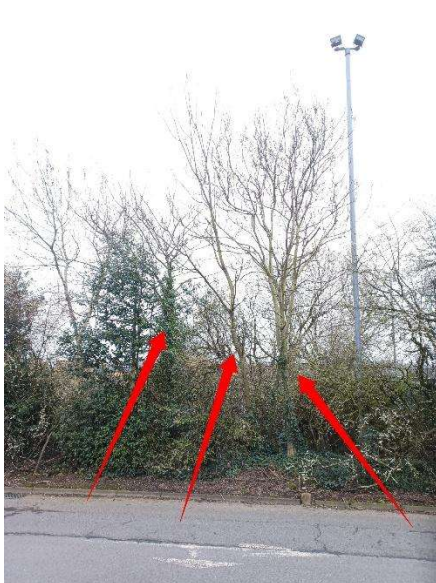
**Plate 3:** T004, T005, & T006 (left to right)

| Tree Ref: | Species | Age | SULE | Ht. | DBH | CS | | | | CC | Comments | PC | SC | BS 5837: 2012 Category | Recommendations |
|---|---|---|---|---|---|---|---|---|---|---|---|---|---|---|---|
| T004 | Sycamore<br><i>Acer pseudoplatanus</i> | SM | 40-80 | 8 | 150# | 3.5 | 3 | 3 | 2 | 4.5 | Unable to access base of main stem due to dense understorey vegetation. Dense ivy <i>Hedera helix</i> established on main stem up to 4 m, which obscures tree features and potential defects. Limited arboricultural merit and lacks the necessary qualities for higher BS 5837 categorisation. | F | G | C1 | No works recommended |
| T005 | Common ash<br><i>Fraxinus excelsior</i> | SM | 20-40 | 9.5 | 140 | 3.5 | 1.5 | 1 | 1.5 | 4.5 | Asymmetrical form due to proximity with adjacent trees. Limited arboricultural merit and lacks the necessary qualities for higher BS 5837 categorisation. | F | F | C1 | No works recommended |
| T006 | Common ash<br><i>Fraxinus excelsior</i> | SM | 40-80 | 10 | 210 | 3.5 | 2.5 | 4 | 3 | 4 | No obvious significant defects, though lacks the necessary qualities for higher BS 5837 categorisation. | F | G | B1 | No works recommended |

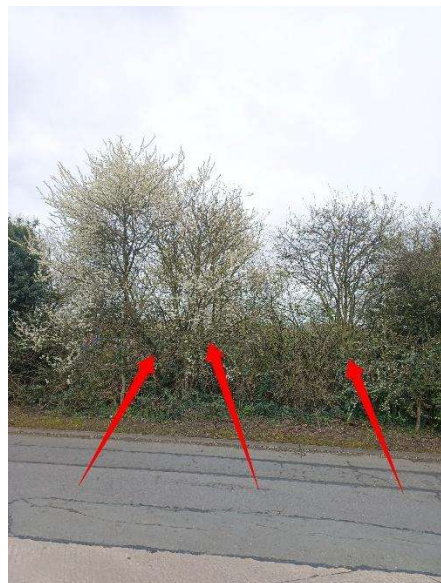
**Plate 4:** T007, T008, & T009 (left to right)

| Tree Ref: | Species | Age | SULE | Ht. | DBH | CS | | | | CC | Comments | PC | SC | BS 5837: 2012 Category | Recommendations |
|---|---|---|---|---|---|---|---|---|---|---|---|---|---|---|---|
| T007 | Blackthorn<br><i>Prunus spinosa</i> | SM | 20-40 | 6.5 | 130<br>140 | 3.5 | 3 | 5 | 3.5 | 3 | Bifurcates at ground level into two co-dominant stems. No obvious significant defects, though of limited arboricultural merit and lacks the necessary qualities for higher BS 5837 categorisation. | F | F | C1 | No works recommended |
| T008 | Rowan<br><i>Sorbus aucuparia</i> | SM | 20-40 | 5.5 | 120,<br>90 | 1 | 1 | 2 | 2.5 | 4 | No obvious significant defects, though of limited arboricultural merit and lacks the necessary qualities for higher BS 5837 categorisation. | F | F | C1 | No works recommended |
| T009 | Rowan<br><i>Sorbus aucuparia</i> | SM | 20-40 | 5 | 150 | 2.5 | 2 | 2.5 | 2.5 | 3 | No obvious significant defects, though of limited arboricultural merit and lacks the necessary qualities for higher BS 5837 categorisation. | F | G | C1 | No works recommended |

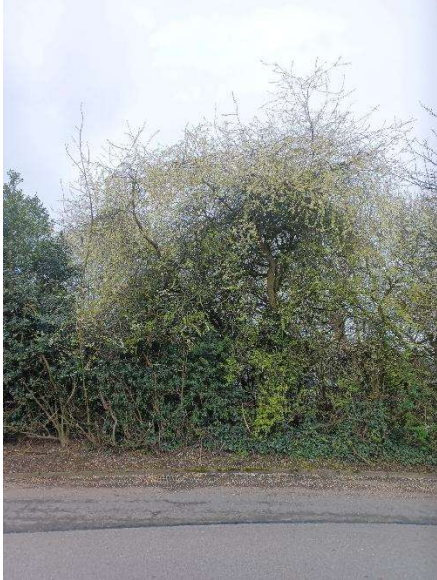
***Plate 5: T010***

| Tree Ref: | Species | Age | SULE | Ht. | DBH | CS | | | | CC | Comments | PC | SC | BS 5837: 2012 Category | Recommendations |
|---|---|---|---|---|---|---|---|---|---|---|---|---|---|---|---|
| T010 | Blackthorn<br><i>Prunus spinosa</i> | SM | 20-40 | 7.5 | 150#<br>150# | 4 | 3.5 | 4 | 3 | 3.5 | Unable to access base of main stems. Bifurcates at ground level into two co-dominant stems. No obvious significant defects, though of limited arboricultural merit and lacks the necessary qualities for higher BS 5837 categorisation. | F | F | C1 | No works recommended |

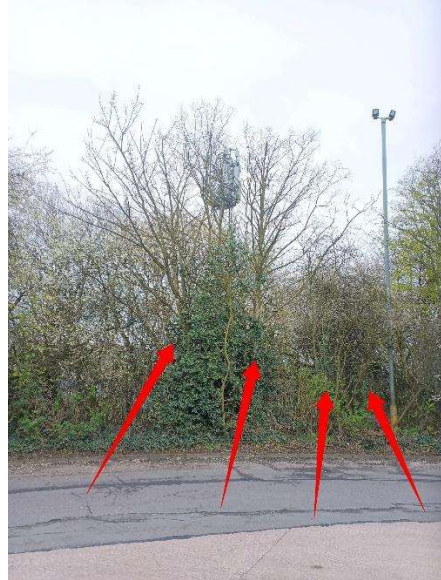
***Plate 6: T011, T012, T013, & T014 (left to right)***

| Tree Ref: | Species | Age | SULE | Ht. | DBH | CS | | | | CC | Comments | PC | SC | BS 5837: 2012 Category | Recommendations |
|---|---|---|---|---|---|---|---|---|---|---|---|---|---|---|---|
| T011 | Sycamore<br><i>Acer pseudoplatanus</i> | SM | 40-80 | 10 | 150#<br>200# | 4 | 4 | 3 | 1.5 | 4 | Unable to access base of main stem due to dense understorey vegetation. Bifurcates at ground level into two co-dominant stems. Asymmetrical form due to proximity with adjacent trees. | G | F | B1 | No works recommended |
| T012 | Grey alder<br><i>Alnus incana</i> | SM | 10-20 | 9.5 | 290<br>160 | 3.5 | 2 | 4 | 3 | 4.5 | Bifurcates at ground level into two co-dominant stems. Oozing lesions on main stem and deadwood < 100 mm in diameter scattered throughout the crown, which may indicate <i>Phytophthora alni</i> infection. | F | F | C1 | No works recommended |
| T013 | Rowan<br><i>Sorbus aucuparia</i> | Y | 10-20 | 6 | 30#<br>60#<br>90# | 1.5 | 1 | 1.5 | 1.5 | 2.5 | Unable to access base of main stem due to dense understorey vegetation. Bifurcates at ground level into multiple co-dominant stems. Minor deadwood < 100 mm in diameter scattered throughout the crown. | F | F | C1 | No works recommended |
| T014 | Blackthorn<br><i>Prunus spinosa</i> | SM | 20-40 | 5 | 140<br>150 | 1.5 | 4 | 3 | 3 | 2 | Bifurcates at ground level into two co-dominant stems. Asymmetrical form due to proximity with adjacent trees. | F | F | C1 | No works recommended |

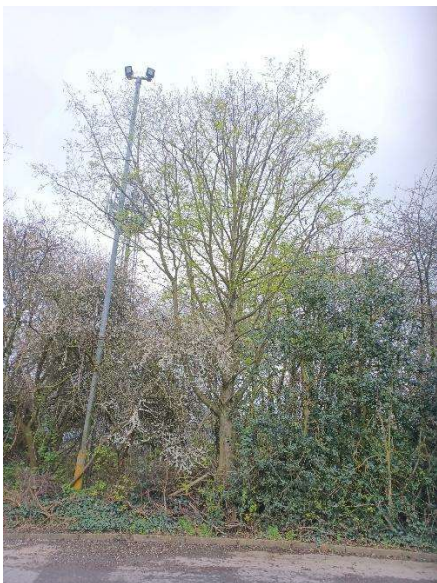
***Plate 7: T015***

| Tree Ref: | Species | Age | SULE | Ht. | DBH | CS | | | | CC | Comments | PC | SC | BS 5837: 2012 Category | Recommendations |
|---|---|---|---|---|---|---|---|---|---|---|---|---|---|---|---|
| T015 | Grey alder<br><i>Alnus incana</i> | SM | 40-80 | 11 | 360 | 4 | 4 | 4 | 4 | 5 | Minor deadwood < 100 mm in diameter scattered throughout the crown. | F | G | B1 | No works recommended |

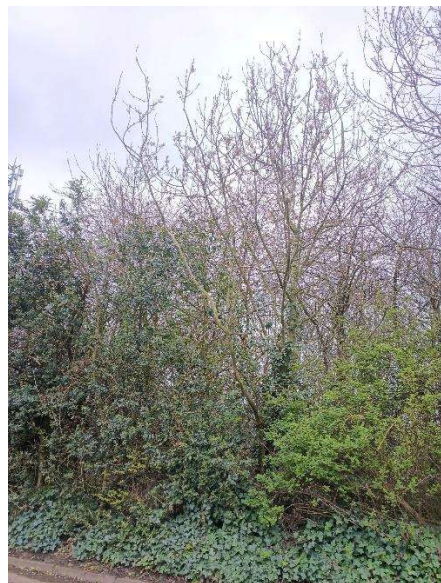
***Plate 8: T016***

| Tree Ref: | Species | Age | SULE | Ht. | DBH | CS | | | | CC | Comments | PC | SC | BS 5837: 2012 Category | Recommendations |
|---|---|---|---|---|---|---|---|---|---|---|---|---|---|---|---|
| T016 | Sycamore<br><i>Acer pseudoplatanus</i> | SM | 40-80 | 9 | 150#<br>80# | 3.5 | 3.5 | 3 | 3 | 3 | Unable to access base of main stem due to dense understorey vegetation. Bifurcates at ground level into two co-dominant stems. Asymmetrical form due to proximity with adjacent trees. | F | F | C1 | No works recommended |

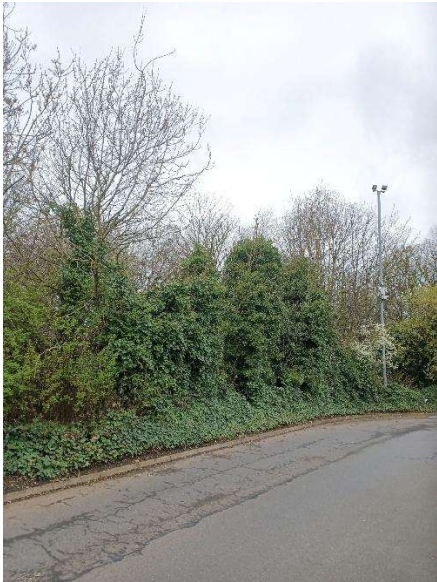
***Plate 9: G001***

| Group Ref: | Species Composition | Age | SULE | Mx. Ht. | Mx. DBH | CC | Comments | PC | SC | BS 5837:2012 Category | Recommendations |
|---|---|---|---|---|---|---|---|---|---|---|---|
| G001 | Sycamore<br><i>Acer pseudoplatanus</i><br>Silver birch<br><i>Betula pendula</i><br>Common ash<br><i>Fraxinus excelsior</i><br>Blackthorn<br><i>Prunus spinosa</i> | Y<br>SM | 40-80 | 12 | 200# | 4 | Group containing approx. 10 trees. Unable to access bases of trees due to dense understorey vegetation. Dense ivy <i>Hedera helix</i> established throughout the group, which obscures tree features and potential defects. Several standing dead trees < 100 mm in diameter are apparent within the group. | F | F | B1 | No works recommended |

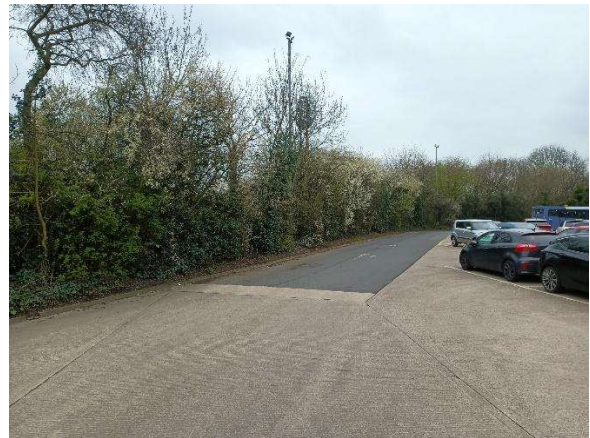
***Plate 10: G002***

| Group Ref: | Species Composition | Age | SULE | Mx. Ht. | Mx. DBH | CC | Comments | PC | SC | BS 5837:2012 Category | Recommendations |
|---|---|---|---|---|---|---|---|---|---|---|---|
| G002 | Hazel<br><i>Corylus avellana</i><br>Sea buckthorn<br><i>Hippophae rhamnoides</i><br>Common holly<br><i>Ilex aquifolium</i><br>Blackthorn<br><i>Prunus spinosa</i><br>Elder<br><i>Sambucus nigra</i> | Y<br>SM | 20-40 | 6 | 100 | 0 | Dense understorey group. No obvious significant defects, though of limited arboricultural merit and lacks the necessary qualities for higher BS 5837 categorisation. | F | F | C1 | No works recommended |

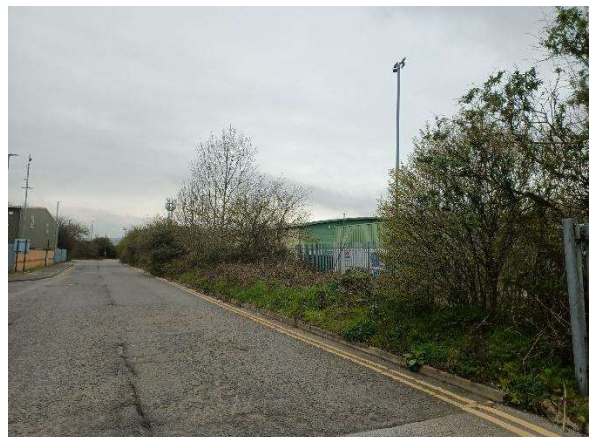
***Plate 12: G004***

| Group Ref: | Species Composition | Age | SULE | Mx. Ht. | Mx. DBH | CC | Comments | PC | SC | BS 5837:2012 Category | Recommendations |
|---|---|---|---|---|---|---|---|---|---|---|---|
| G004 | Field maple<br><i>Acer campestre</i><br>Summer lilac<br><i>Buddleia davidii</i><br>Common dogwood<br><i>Cornus sanguinea</i><br>Common hawthorn<br><i>Crataegus monogyna</i><br>Common ash<br><i>Fraxinus excelsior</i><br>Crab apple<br><i>Malus sylvestris</i><br>Rowan<br><i>Sorbus aucuparia</i> | Y<br>SM | 40-80 | 8 | 250 | 2 | Off-site group. No obvious significant defects, though of limited arboricultural merit and lacks the necessary qualities for higher BS 5837 categorisation. | F | F | C1 | No works recommended |
