2026-05-21 Rev B

Hinchliffe Mill, Water Street, Holmbridge

Report to accompany an Application to discharge Condition 4e) of Planning Application ref 2021/62/90800/W

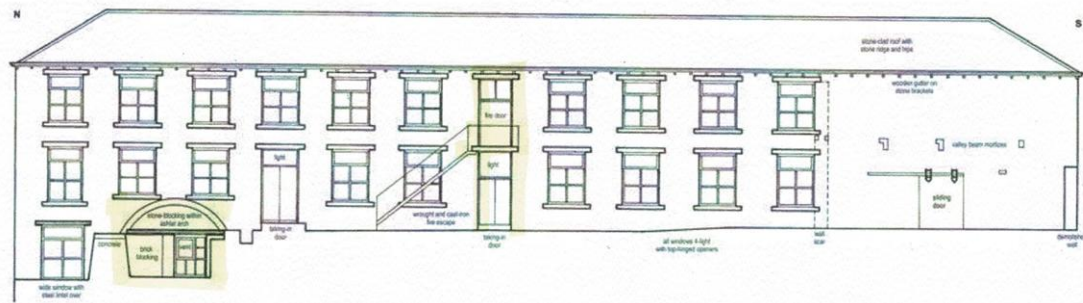
Fig. 4. West elevation

West Elevation

- The arch at the north end; This almost certainly remains from the water-powered phase of the mill's history. The later steel beam will have to be removed in any event for structural reasons, and the stone voussoirs will be repaired. The infilling masonry will need to be removed and replaced, the infilling stonework should be set back by say 25mm from the face of the arch. The windows above the will be retained and the area in front of the elevation will not be infilled to adjacent ground level.

- Loading doors; The loading door openings will be retained and differentiated from the other window openings.
- The cast iron landing will be retained, strengthening works will be undertaken to an Engineer's satisfaction. If the balcony cannot be repaired, it will be replaced with a like-for like copy. An appropriate secondary guarding balustrade will be added to comply with the Building Regulations. The rather crude steel stairs will be removed.

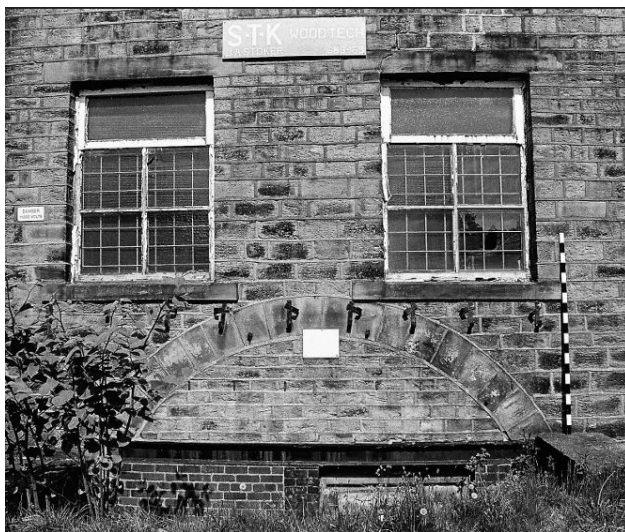
Photo. 2. Arch at north end of west elevation

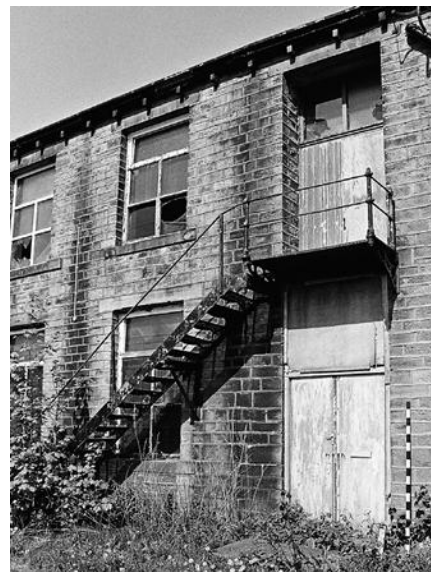
Photo 3. Loading doors and landing

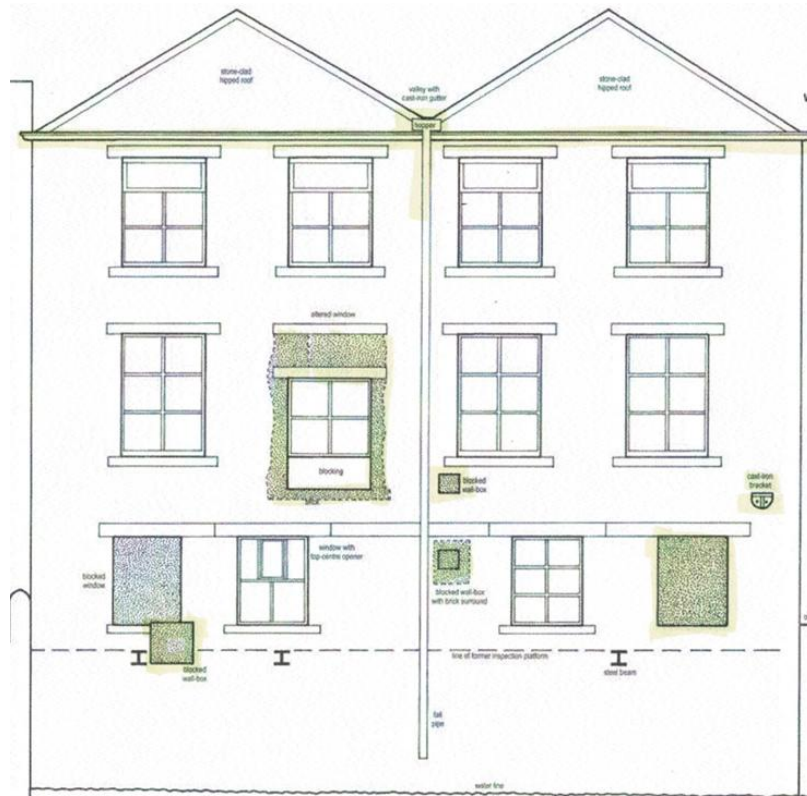
Figure. 5. North Elevation

North Elevation

- The windows at lower ground and ground floor level; there were 4 windows at each level, some of which have been blocked and altered. The brick infilling will be removed and the jambs and cills returned to their original form on the ones highlighted. The eastern window on the ground floor will be remain blocked in stone to preserve the bearing box
- The cast iron bracket to the right of the westernmost lower ground floor window will be retained.
- The cast iron gutter at the valley gutter position will also be retained, and will retain its function at the head of a downpipe.
- The bearing boxes which do not conflict with retained window openings will be retained

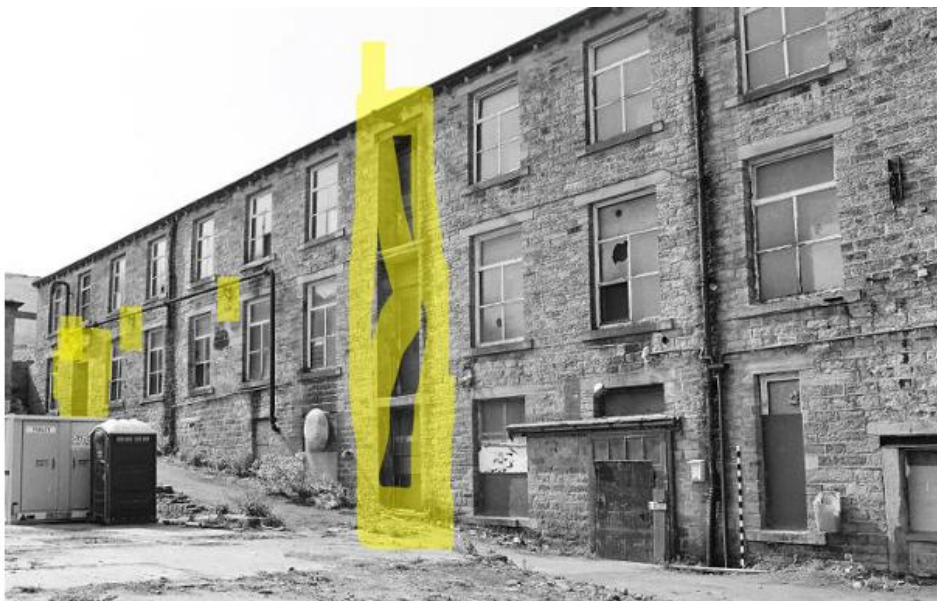
Photo. 4. East elevation

East Elevation

- The taking-in doors; The openings will be retained and repaired at all three levels. This has required the amendment of the plan to allow another structural bay to be used as a garage entrance. The lower ground floor opening has been retained to make an entrance door. New simple doors similar to the existing will be used in the openings. None of the existing doors are original. The beam and pulley will be retained (this is not of great age, but helps to explain the function of the doors).
- The door at the south end at upper ground floor, the design already has this retained as a door, it will be treated as simply as possible (see elevations below)
- The cast iron pipe brackets will be retained.

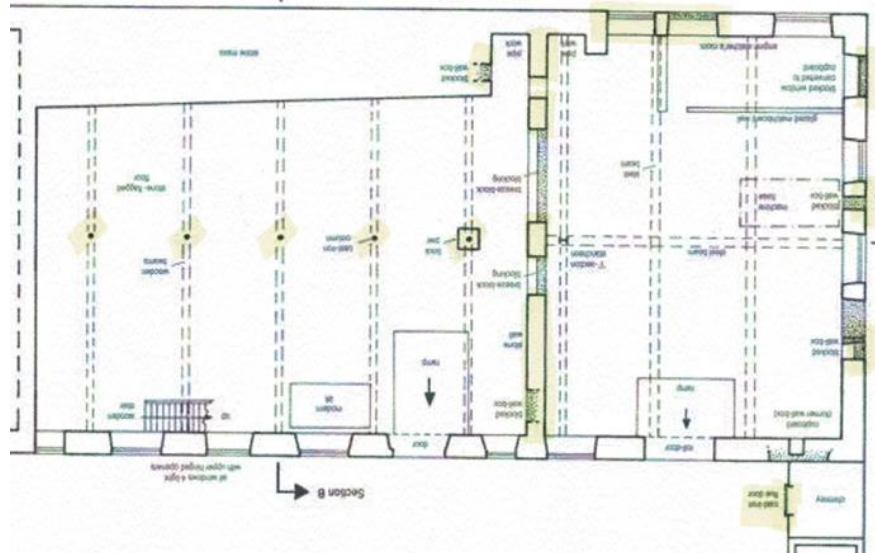
Figure 8 Lower Ground Floor Plan

Lower Ground Floor

- Structural columns and beams; The building has a simple repeated structural system (much altered), the revised design works with this to retain and expose as many structural elements as possible. These will be left on show as a structural system rather than individual elements.
The dividing walls will be offset between the units so that the columns are retained on view and the timber east-west spanning beams also retained.
- Cross-wall; as much of this wall is kept as possible, including the section where it meets the west elevation. This is also important from a structural point of view.
- Cast iron flue door in chimney; will be retained and fixed to adjacent masonry.
- Generally at all levels, the cast iron bearing wall boxes will be retained and left on view.
