**Re: Proposed demolition of existing stable block and erection of a new stable block at Copley Farm.**

## Appendix A — Site photographs

Copley Farm — existing stable block proposed for demolition

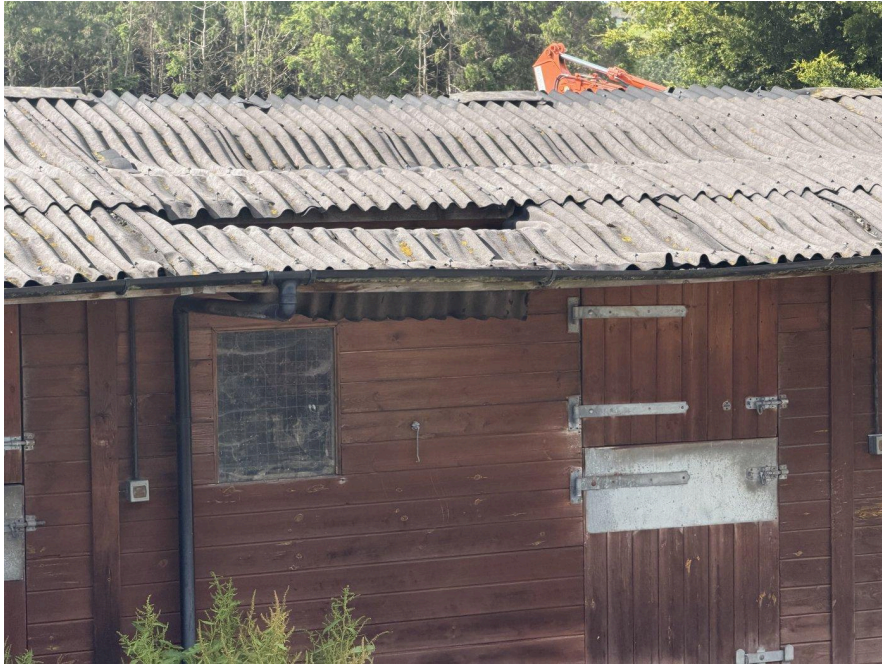
*Photograph 1 — External elevation: weathered corrugated fibre-cement roof sheets laid over timber purlins; no enclosed roof void.*

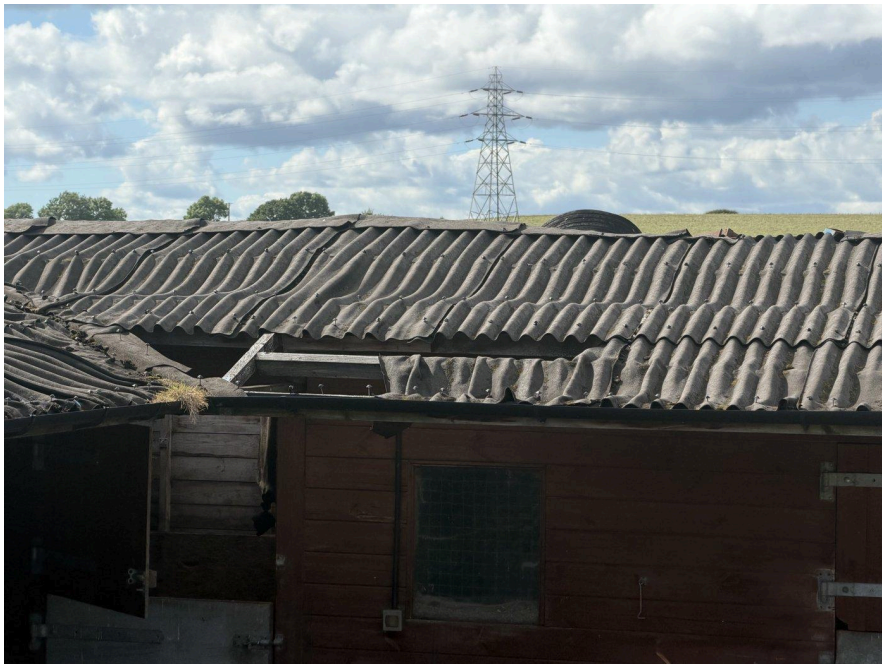
*Photograph 2 — Roof condition: weathered and locally displaced fibre-cement sheets; open, lightweight timber structure.*

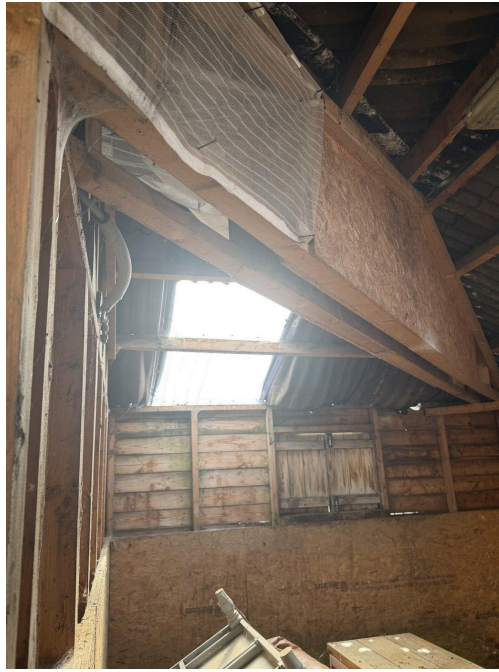
*Photograph 3 — Internal view: open underside of roof with torn lining, daylight ingress through gaps and extensive intact cobwebbing.*

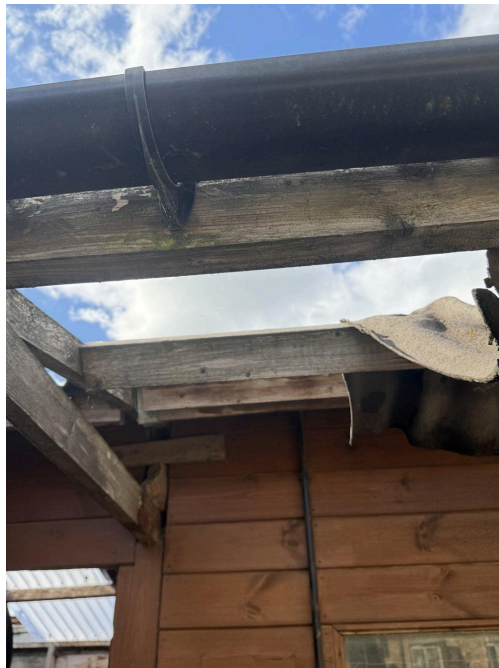
*Photograph 4 — Eaves detail: degraded, torn roofing membrane and open gaps to the sky at the roof edge.*
