**Coach House**  
TO  
Healey House

Netherton  
Huddersfield

Project 4206

**DESIGN ACCESS &  
JUSTIFICATION STATEMENT  
PLANNING & LISTED BUILDING APPLICATION**

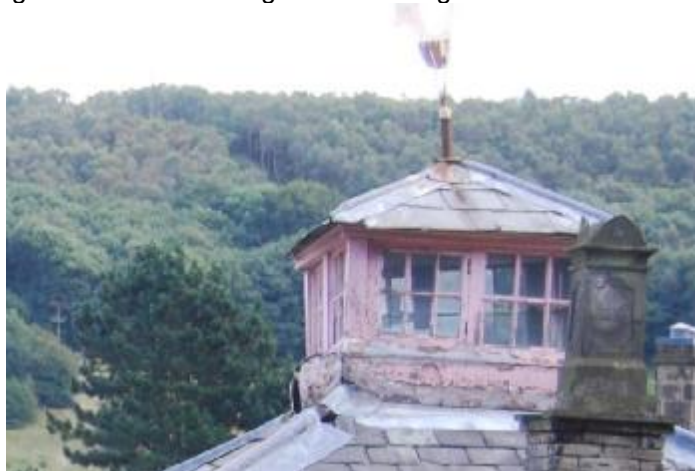
- 4.1.1. The roof structure of the main two storey coach house shows signs of significant long term deflection. There appears to have been an attempt to provide additional support to the lantern at the head of the roof given the presence of a single brick partition wall constructed from a timber beam placed on the original floor to allow the wall to support to the lantern. The original floor is deflecting as a result together with the lantern.

- 4.1.2. The main roof is of hip construction and on inspection the dragon ties (diagonal ties to the wall plate at corners) at the foot of the hips have not been included which has contributed to the settlement of the roof and lantern together with movement at the corners of the

building due to lack of horizontal tie. Additionally the joints at the head of the hips to the lantern light trimmers are not sufficiently rigid to resist differential loading of the lantern.

5.4.1. The existing lantern is in neglected condition due to the difficulties of maintenance access. It is proposed to remove the existing slates and set aside for re use and repair the existing roof structure replacing structural members as required together with new hip members suitably supported at the eaves. The timber wall plate will be bolted to a mild steel channel or angle bedded on to the wall and the base of each hip member will be supported on a dragon beam 45 degrees across each corner.

5.4.2. A new trimming frame will be constructed to support the lantern with fabricated mild steel shoes at each corner to form a ridged joint between the hip and the roof light frame. The existing chimney stack which will be taken down and rebuilt using current materials, the masonry bedded in lime mortar.

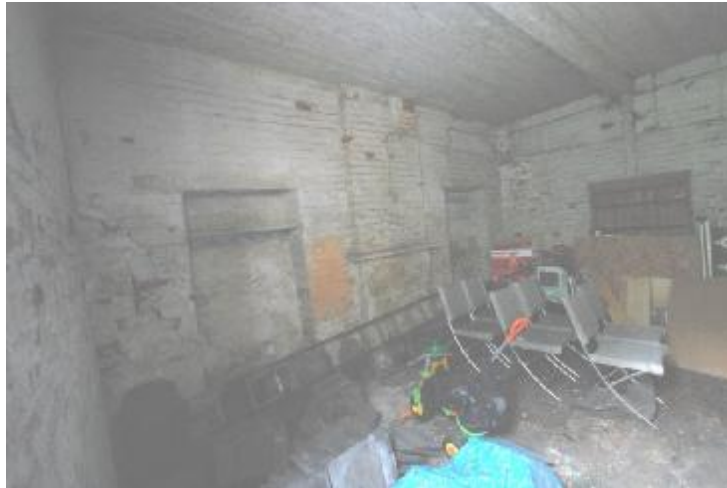
- 4.1.3. There are signs of structural movement to the North West corner probably due to leaking surface water drainage at the corner which has caused settlement and diagonal cracking due to the reduced bearing capacity of the ground. The cracks need to be re-bonded and a surface water drain provided to discharge the water away from the foundations. Any strapping required due to re-bonding will be rebated with the mortar joints.

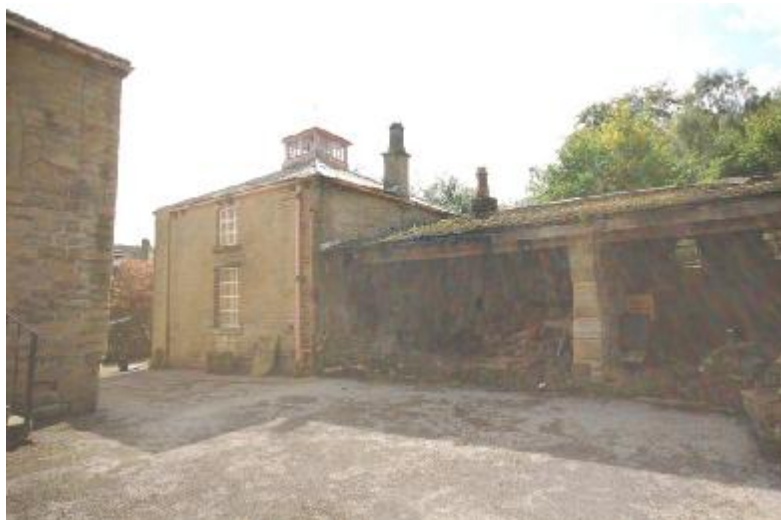
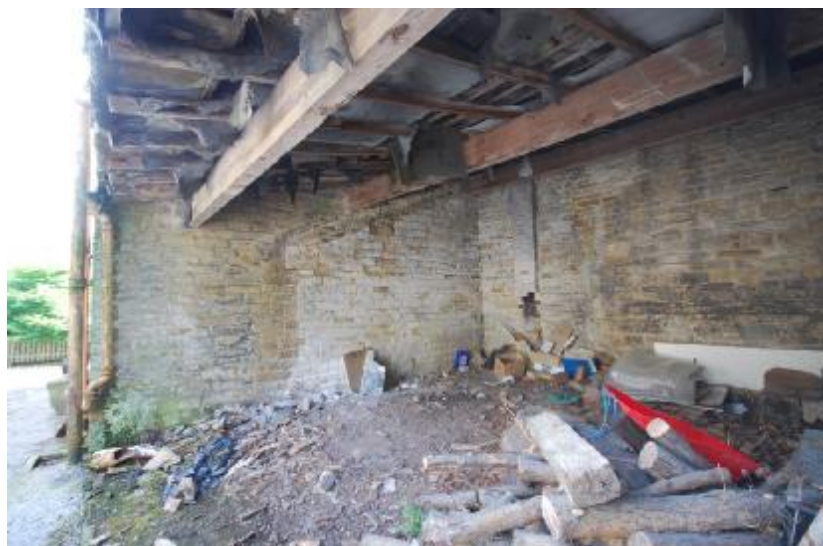
- 4.2.1. The lean to roof slope of 14 degrees is not suitable for the stone slate covering and the slope is most probably the result of the original footprint of the lean-to being widened whilst retaining the ridge and eaves height. Whilst currently the main purlins appear to be structurally sound clearly the roof slating leaks judging by the decomposed and torn under felt and decaying slate battens.

5.9.4. The existing roof is to be removed and replaced with a symmetrical roof having the same ridge height and width of the existing but allowing for steeper roof slopes to accommodate a blue slate covering. The existing timber purlins may be re used.

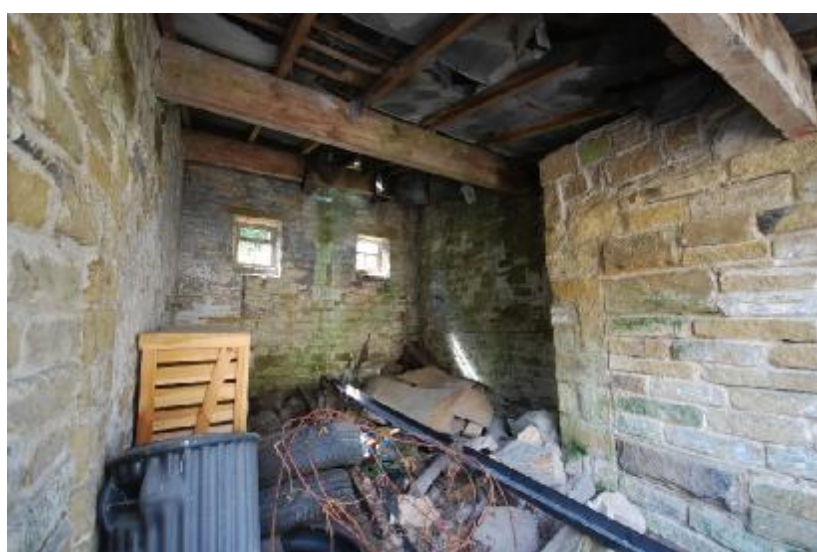
4.2.2. The original northern extent has been increased from the original footprint and the South West external wall is poorly constructed with incomplete outer wall sections resulting in poor long term stability constructed from a non-existent foundation which in parts is above floor level.

5.9.2. The existing South West wall is in parts in poor structural order with sections of the outer skin of masonry missing and generally in poor structural condition patch bonded where previously extended. The wall is founded on earth at the same level as the internal floor level of the shed.

5.9.3. It is proposed that the lean-to South West wall be taken down and rebuilt in the reclaimed stone in its current position on a good foundation incorporating the new random window positions and a door opening to allow natural light into the workshop.
