# Contaminated Land Phase One Desk Study for proposed Commercial Storage Building on land at Red Doles Lane, Leeds Road, Huddersfield, HD2 1YF.

Revised July 2026

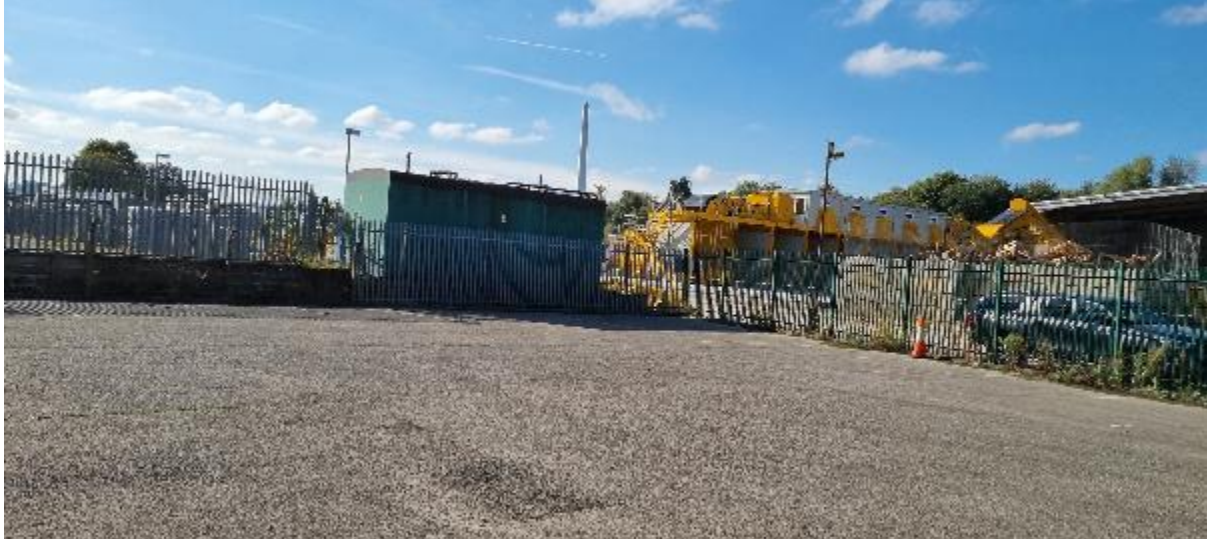
Southwest corner of the yard

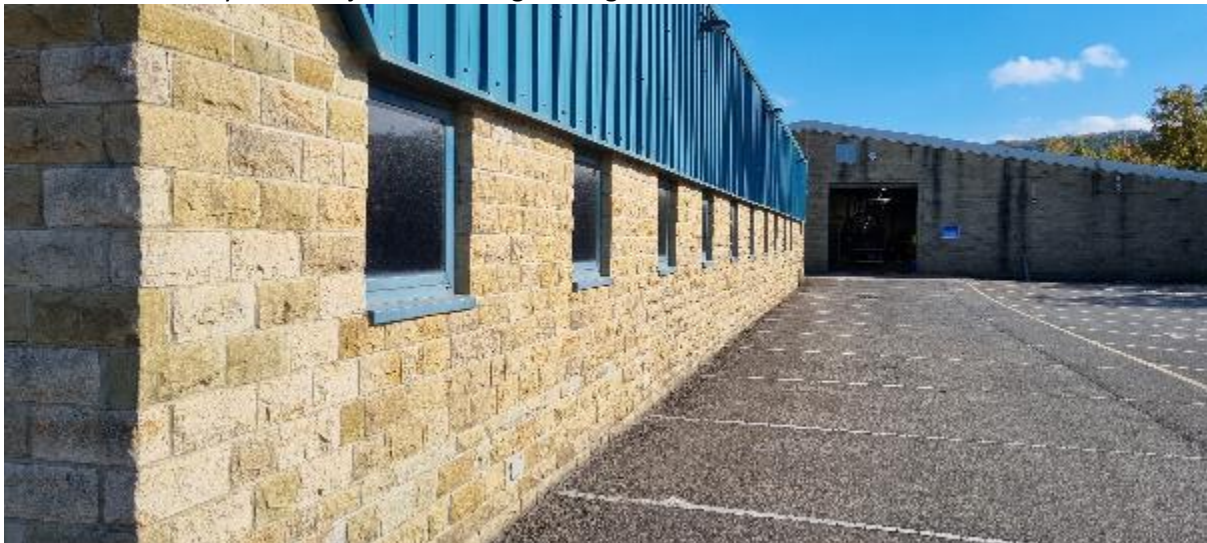
Northern boundary of the adjacent building looking east

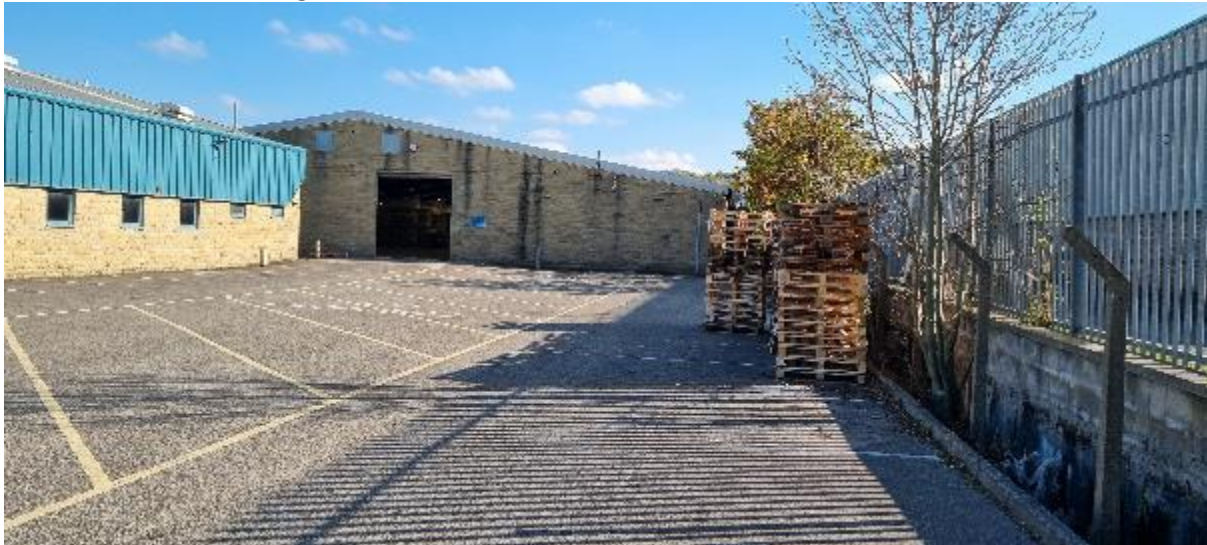
Southwest corner looking to northeast corner across the site

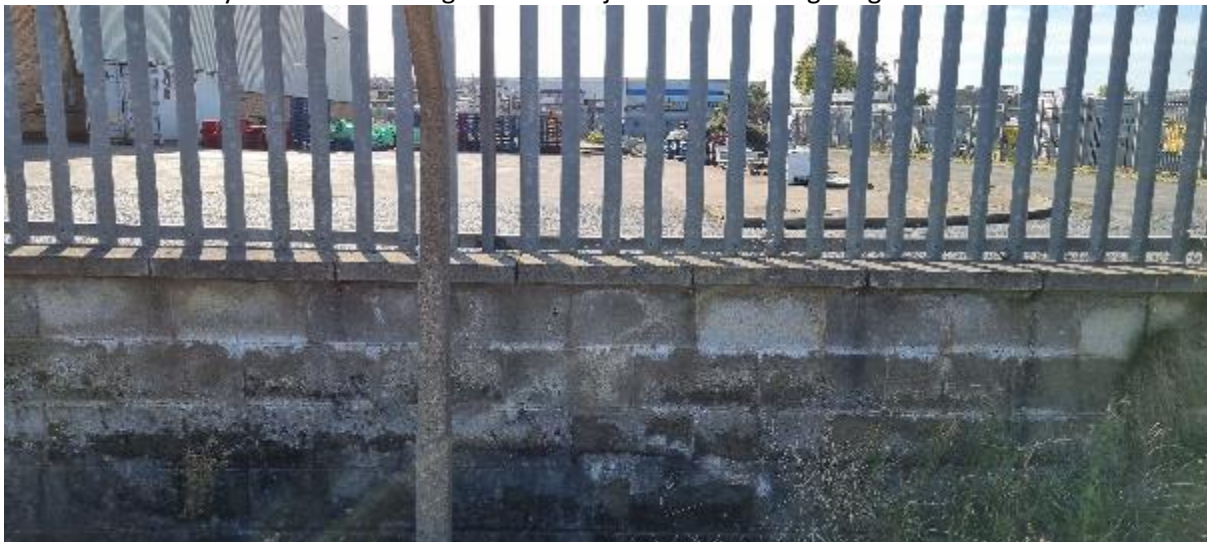
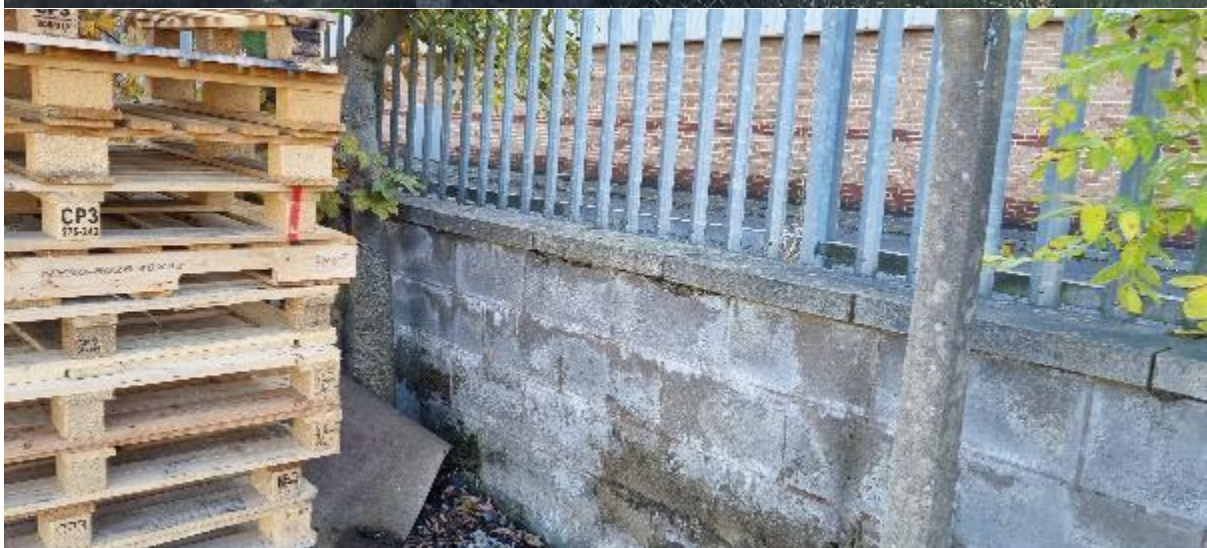
The site has been lifted and levelled during its construction as can be seen to the edge of the apron. Although the adjacent site is slightly higher.

Southern boundary of the site looking across at adjacent site and higher ground level

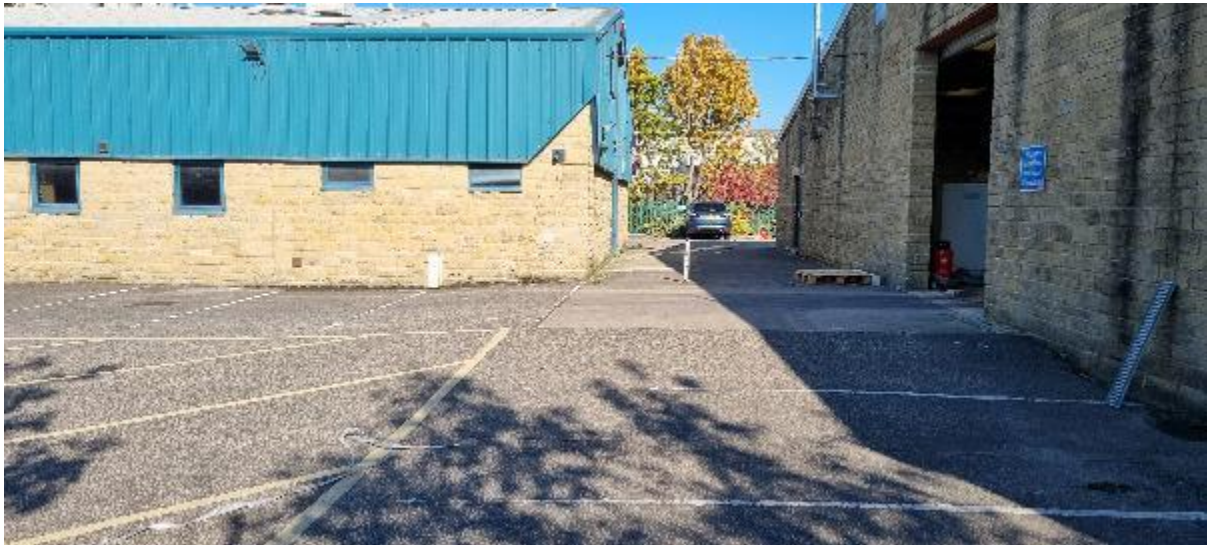
eastern boundary looking north

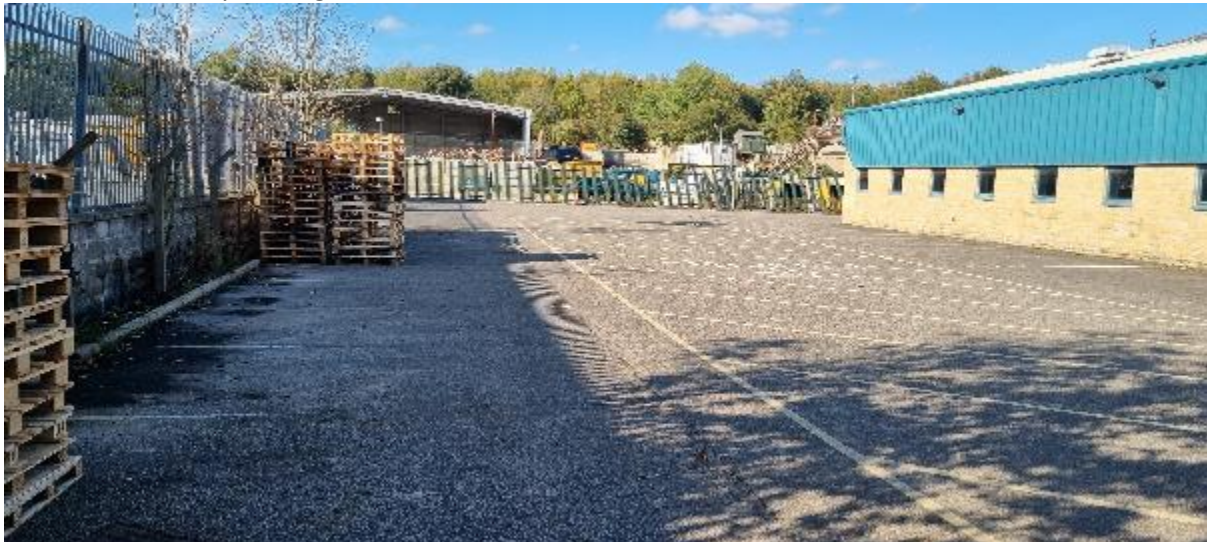
southern boundary looking west.

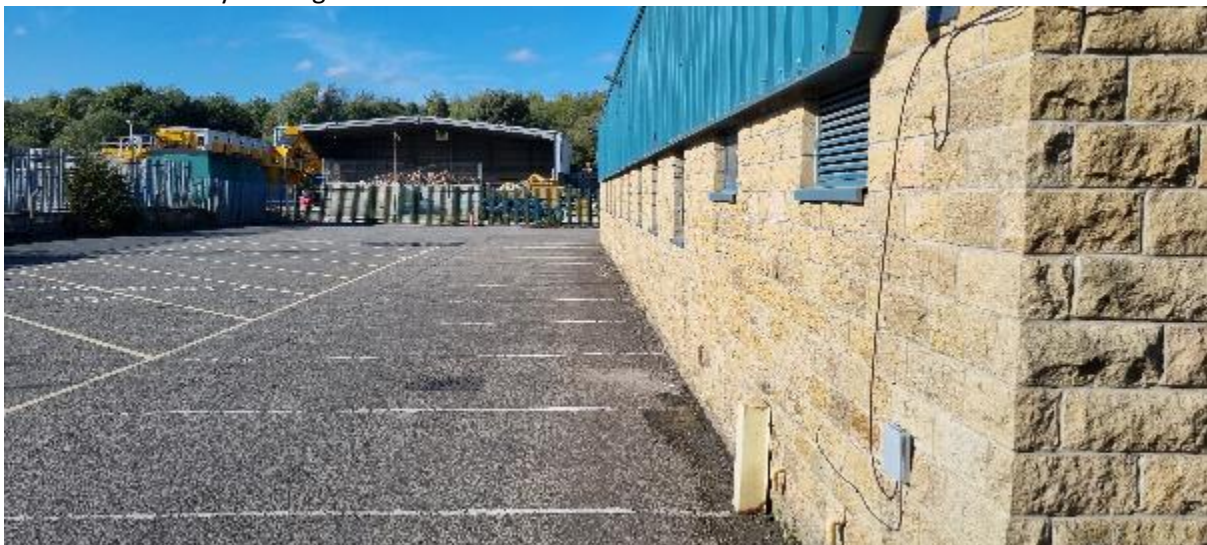
northern boundary looking west

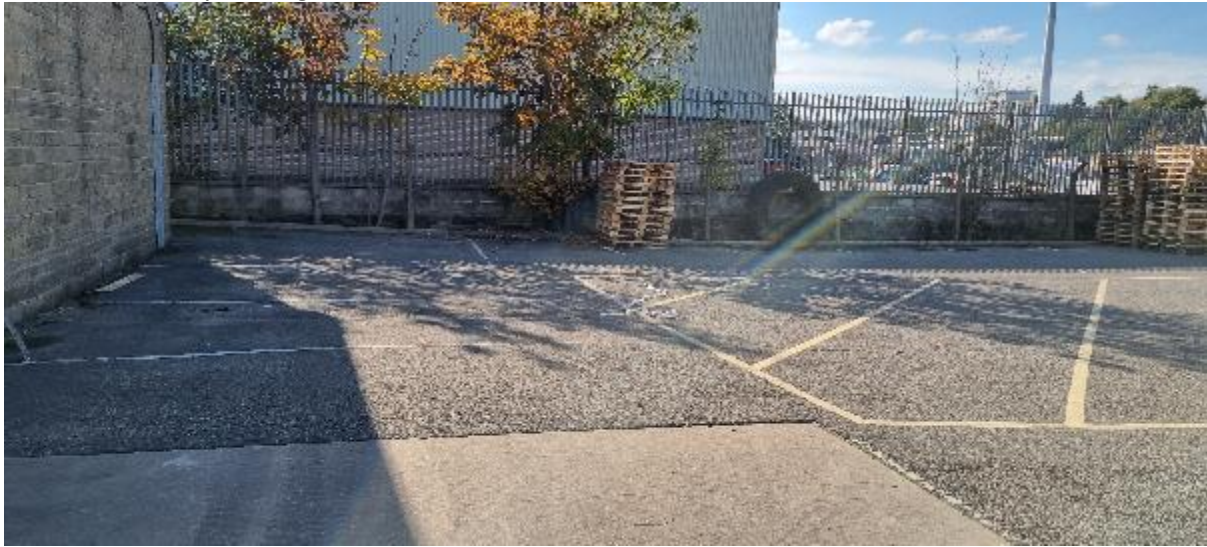
eastern boundary looking south
