# **ARBORICULTURAL REPORT & Impact Assessment to BS 5837:2012 at:**

***198 Barnsley Road,  
Denby Dale,  
Huddersfield  
HD8 8TS***

Report Date: *August 2026*

Reference: *AWA7639*

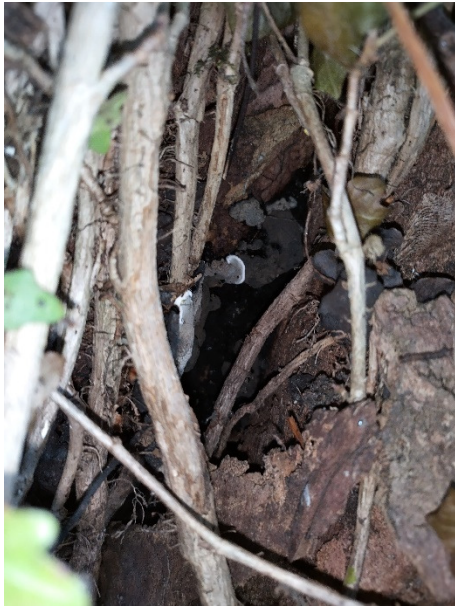
- 3.2.8 T1 is a mature Sycamore in generally good condition, however Brittle Cinder (*Kretzschmaria deusta*) is present between several major buttresses, potentially compromising the structural integrity of T1, despite the tree's otherwise good condition. This combined with the target present by the adjacent garage means that T1 has been categorised as 'U' and is recommended for removal regardless of the development.

Photo 1: Brittle Cinder between T1 buttress roots

- 3.2.11 Some trees were found to have defects and require felling regardless of any new development at the site. This includes T1 and T28 (as detailed in Appendix 4).

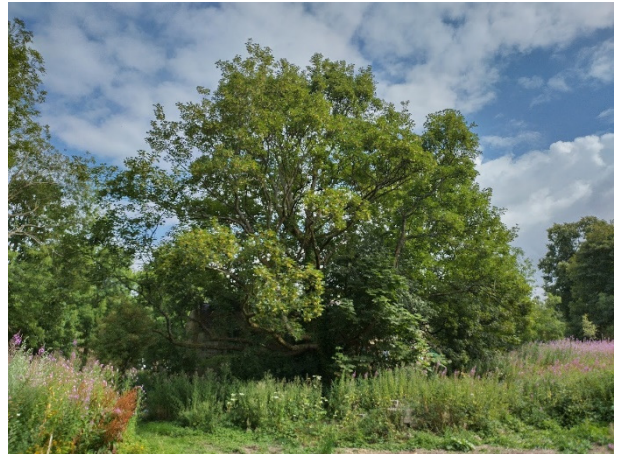
Photo 2: T1 from northwest

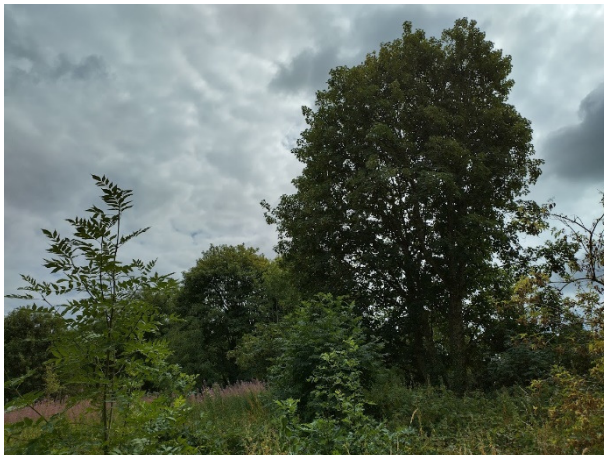
Photo 3: T11-T16 from west

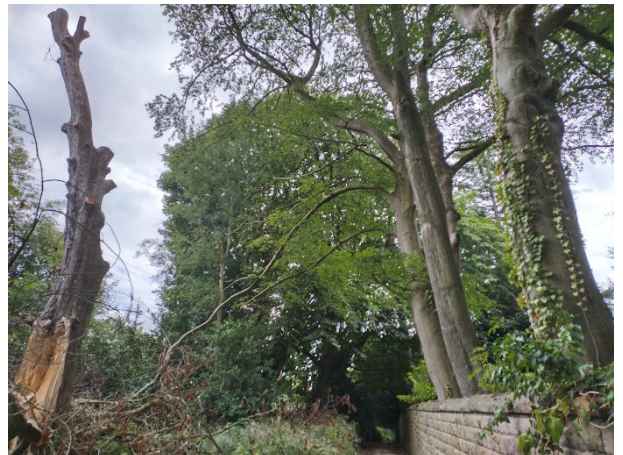
- 3.2.9 T28 is a Horse Chestnut that has suffered a major snap out and been reduced to a monolith. T28 has extensive *Ganoderma sp.* brackets at the base and is unsuitable for long-term retention.

Photo 4: T25-T28 and G31 from north

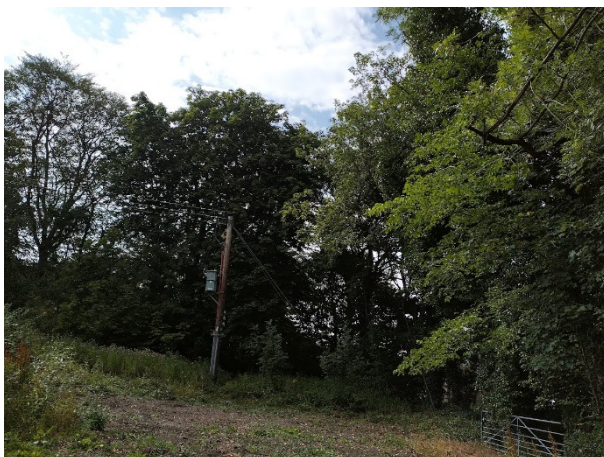
Photo 5: G29-G33 from east

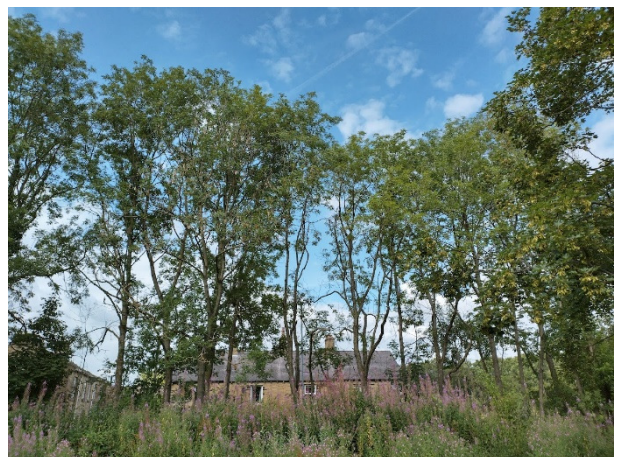
- 3.2.6 The northern edge of site is defined by roadside groups G33 and G37. G33 comprises early-mature Sycamores in reasonable condition and moderate value. G37 however, comprises younger semi-mature Ash trees showing signs of Ash dieback, which limit their long-term value and prospects.

Photo 6: G37 from south
