## **Kirklees Rural Sub-Area Matter 44 with reference to H626 : Land to the west of Bankfield Drive :**

### **Hearing Statement**

**Photographs to support Hearing Statement-  
H626 Land to West of Bankfield Drive**

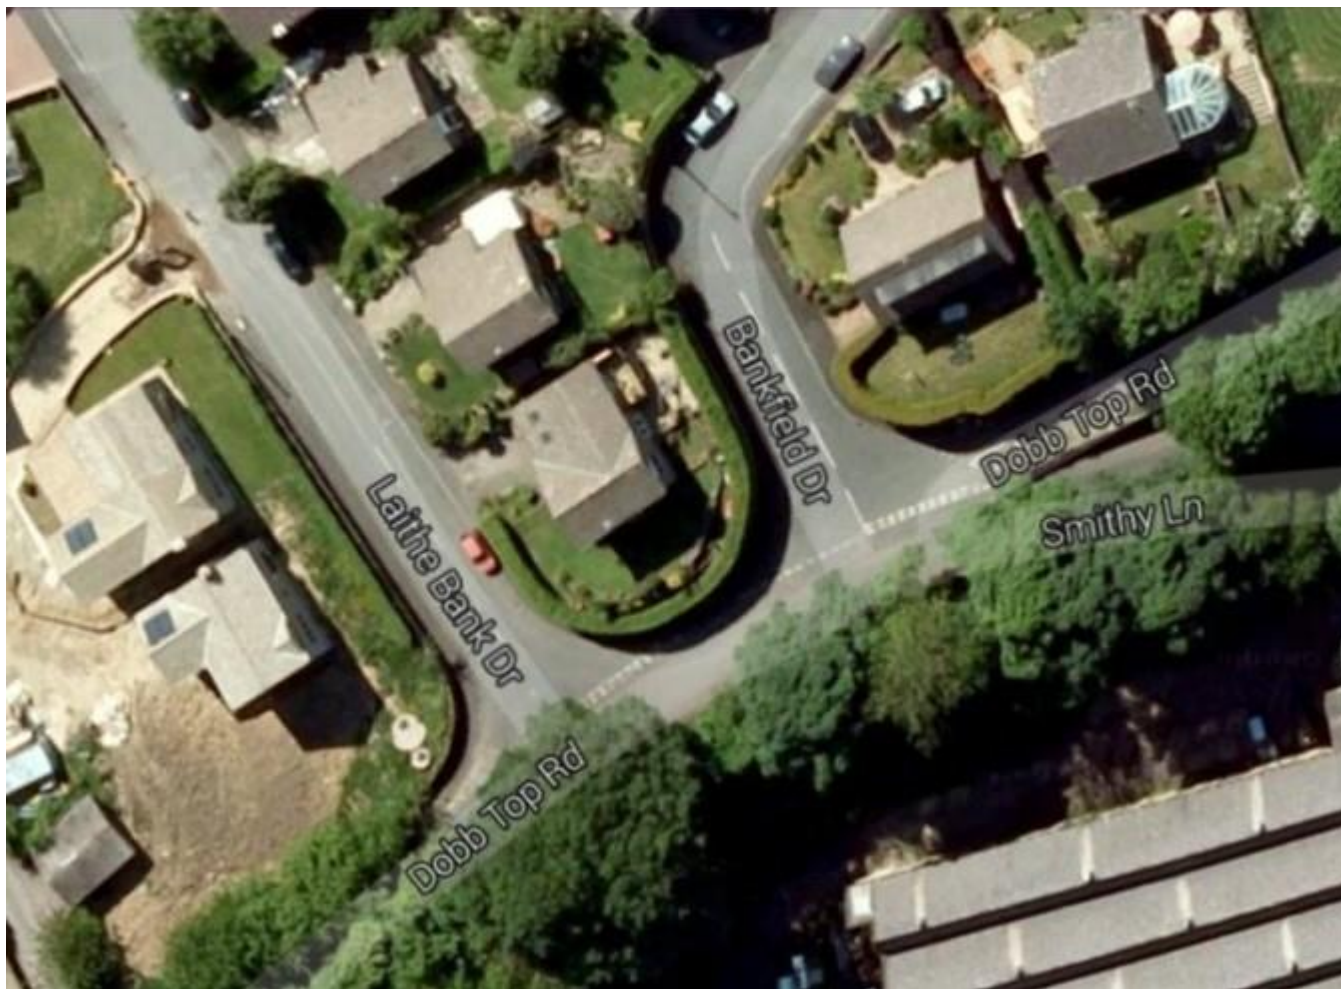
Photo 1 shows the road layout at the bottom of Bankfield Drive and Laithe Bank Drive. The high wall which blocks visibility when pulling out of Bankfield Drive is shown on the right under the Dobb Top Rd sign. Smithy Lane is only 4.7 metres wide wall to wall and traffic has to give way to single file.

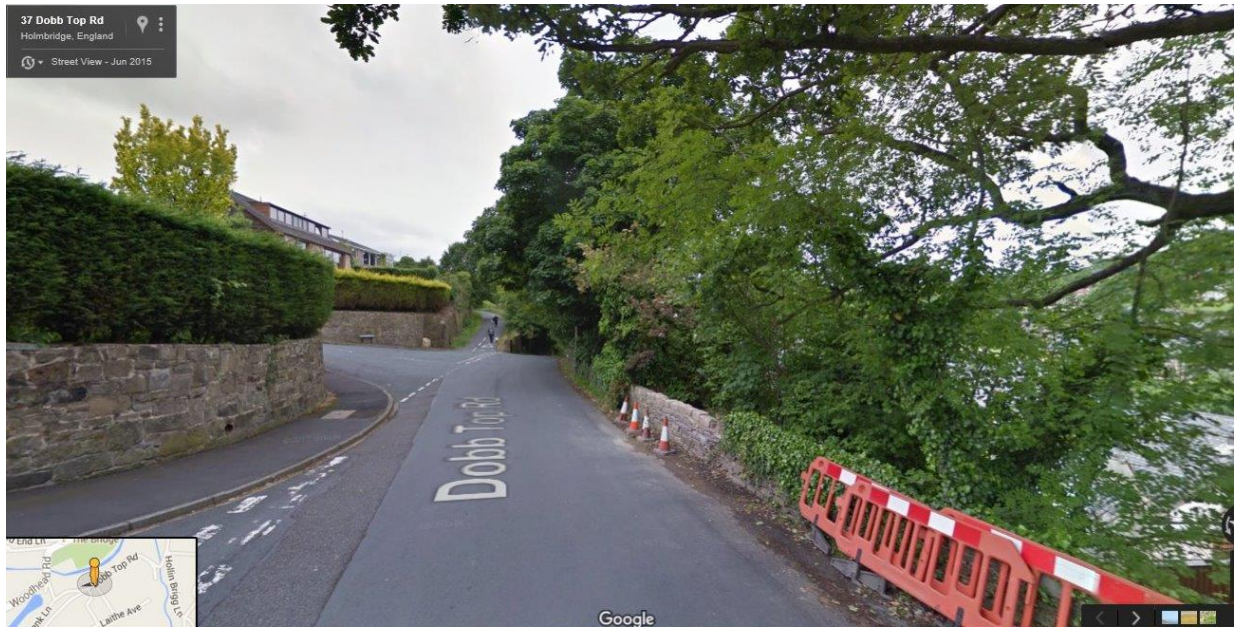
Photo 2 shows the barriers protecting a hole in the wall on Dobb Top Road after a car slid down Laithe Bank Drive. The cones further up the road show the site of another incident. Taken from Google maps 2015.

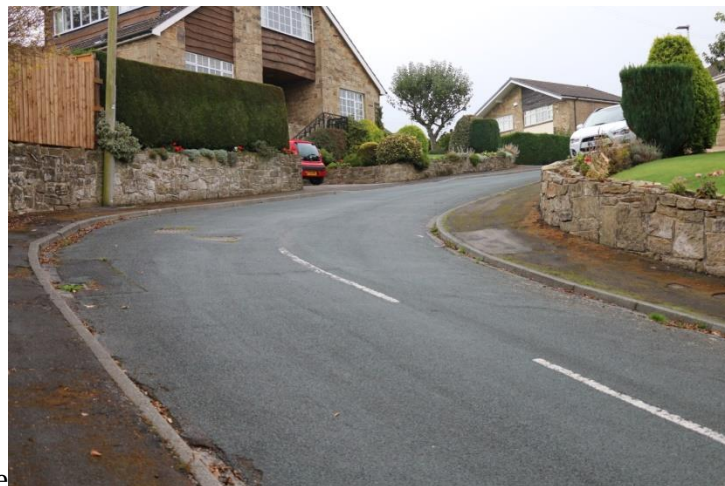
Photo 3 Bankfield Drive

Photos 3 and 4 This is Bankfield Drive – a 20% gradient and quickly becomes unusable in ice or snow. Bankfield Drive meets Dobb Top Road, which has no pavements and there is no room to build them.

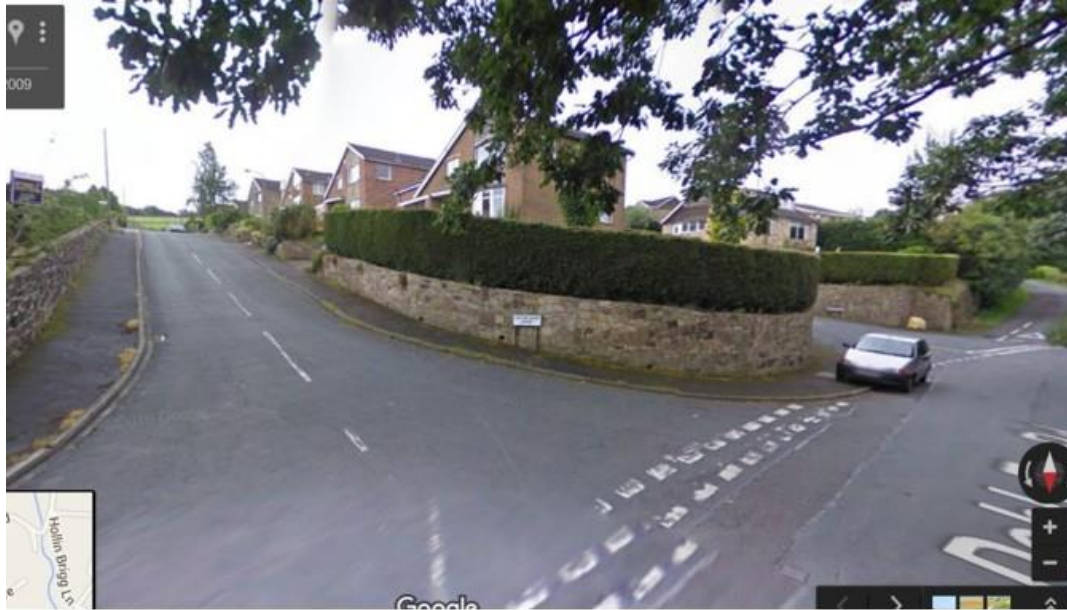
Photo 5 – the 1:6 gradient of Laithe Bank Drive and the complex junctions.

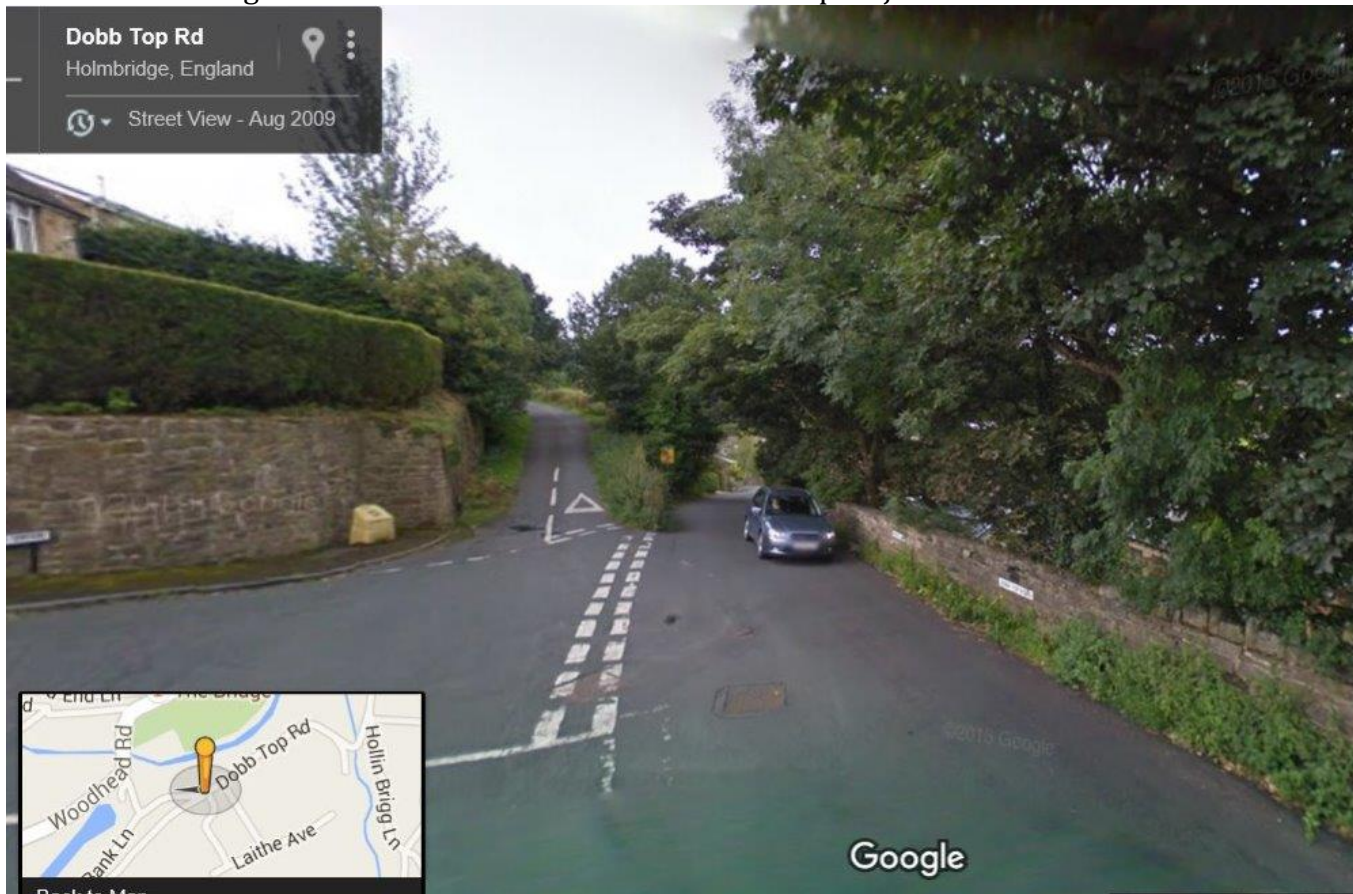
Photo 6 showing the junctions of Bankfield Drive, Smithy Lane and Dobb Top Road. Smithy Lane is to the right reaching into the distance. Where the car is on the photo is 4.7 metres wide wall to wall with room for only 1 vehicle to pass.

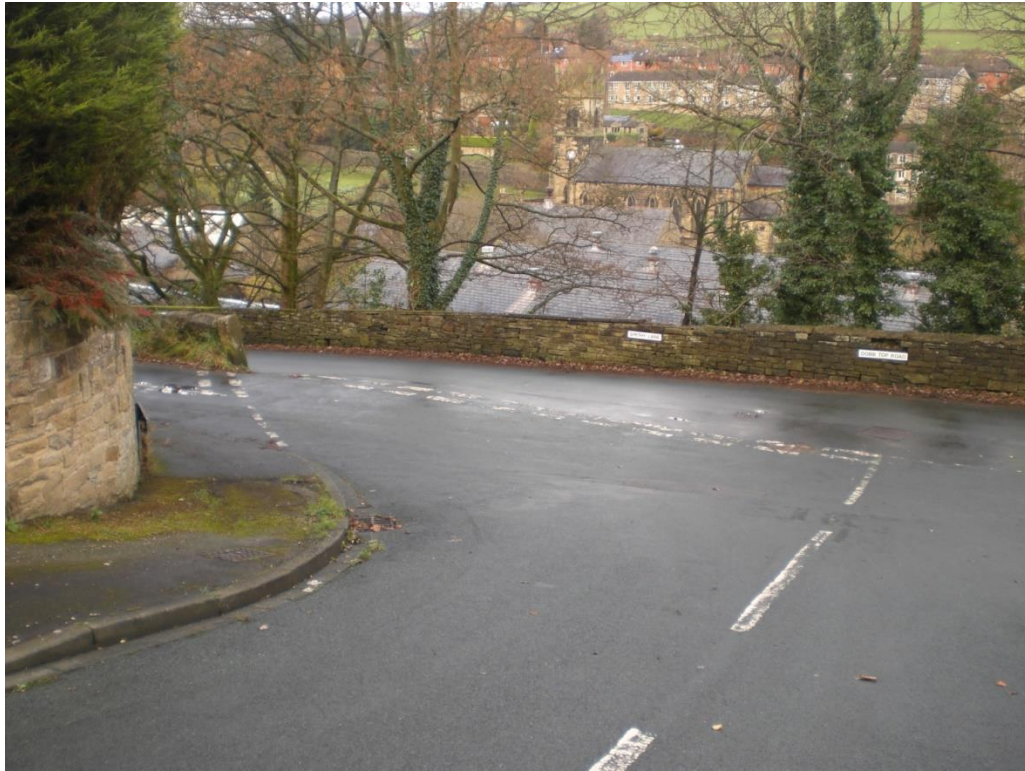
Photo 7 Taken 2.4metres from the Bankfield Drive junction and showing the wall which obstructs the view down Smithy Lane, second on left. There is a drop of approx. 30 metres beyond the wall shown along Dobb Top Road.

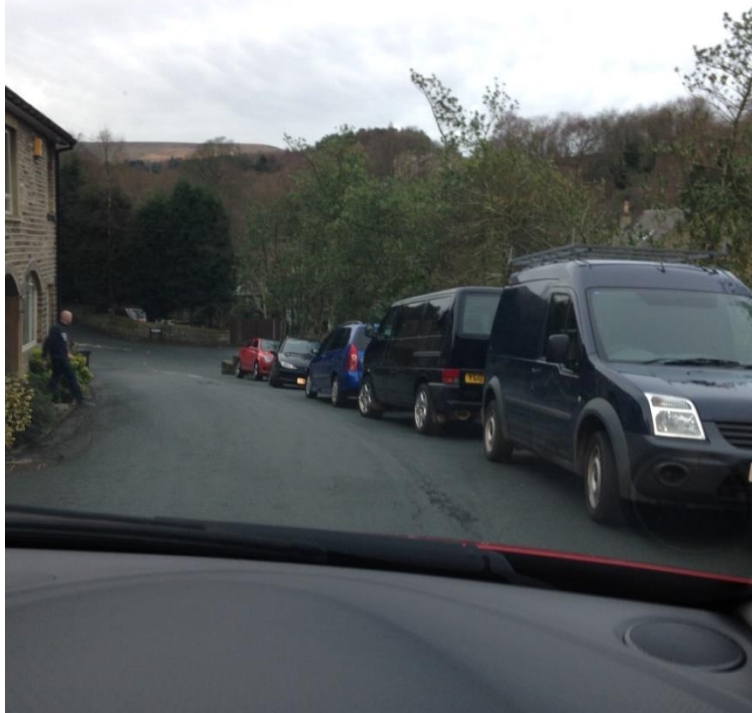
Photo 8 , parked cars restricting the width of Smithy Lane. There are often vehicles also parked on the left hand side of this road at the bottom of the hill.

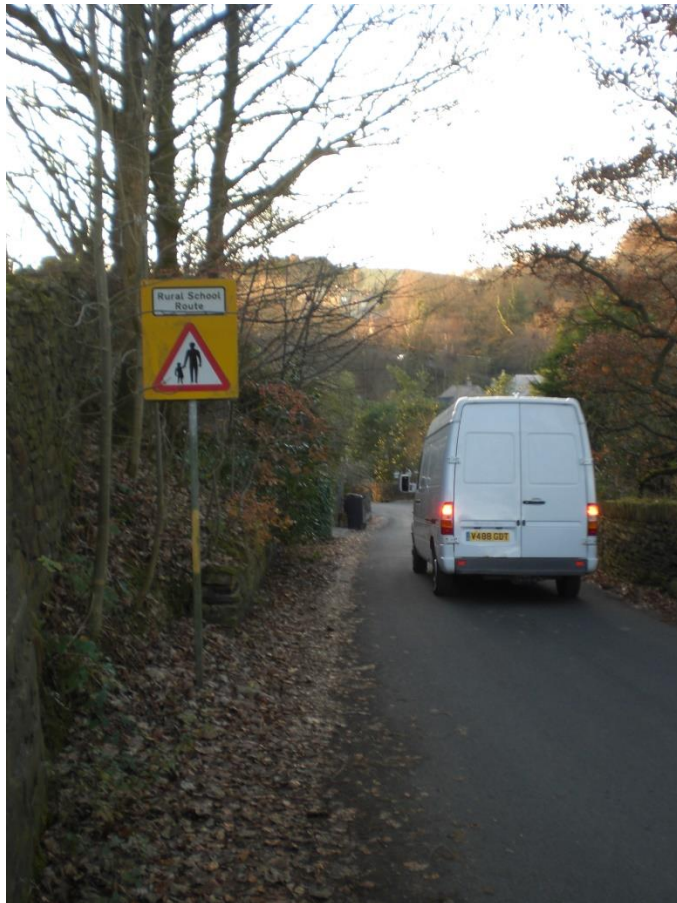
Photo 9 Smithy Lane is a steep and narrow road with parked cars – only passable by 1 vehicle at a time. This is the route to Hinchliffe Mill School – note the Rural School Route sign. There are no footways and nowhere to build any.

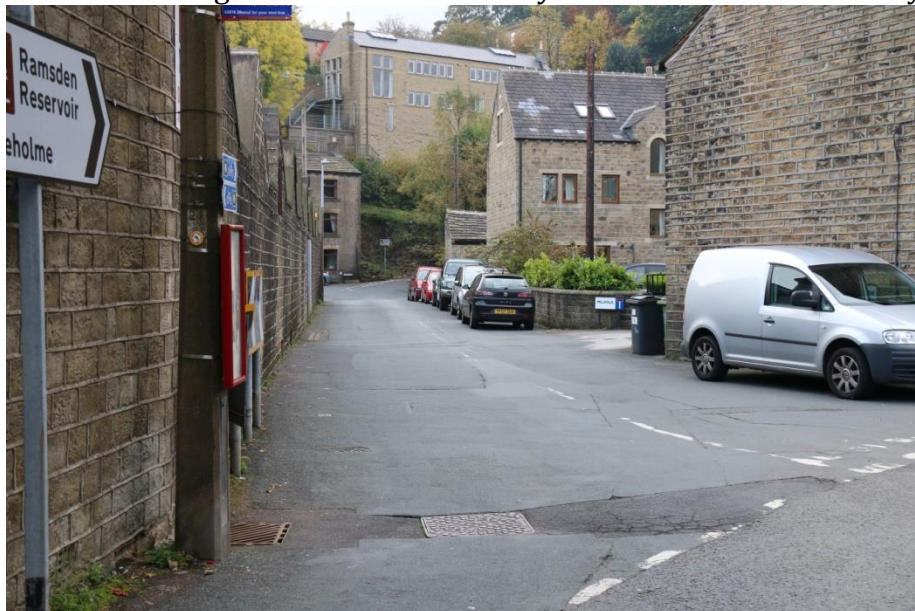
Photo 10 above This is Bank Lane. Exit from site H626 is via Bankfield Drive, Smithy Lane and Bank Lane turning out onto the A6024 with very poor visibility. Again parked cars mean that only 1 vehicle can pass at a time. There are no footways and no room to build any.

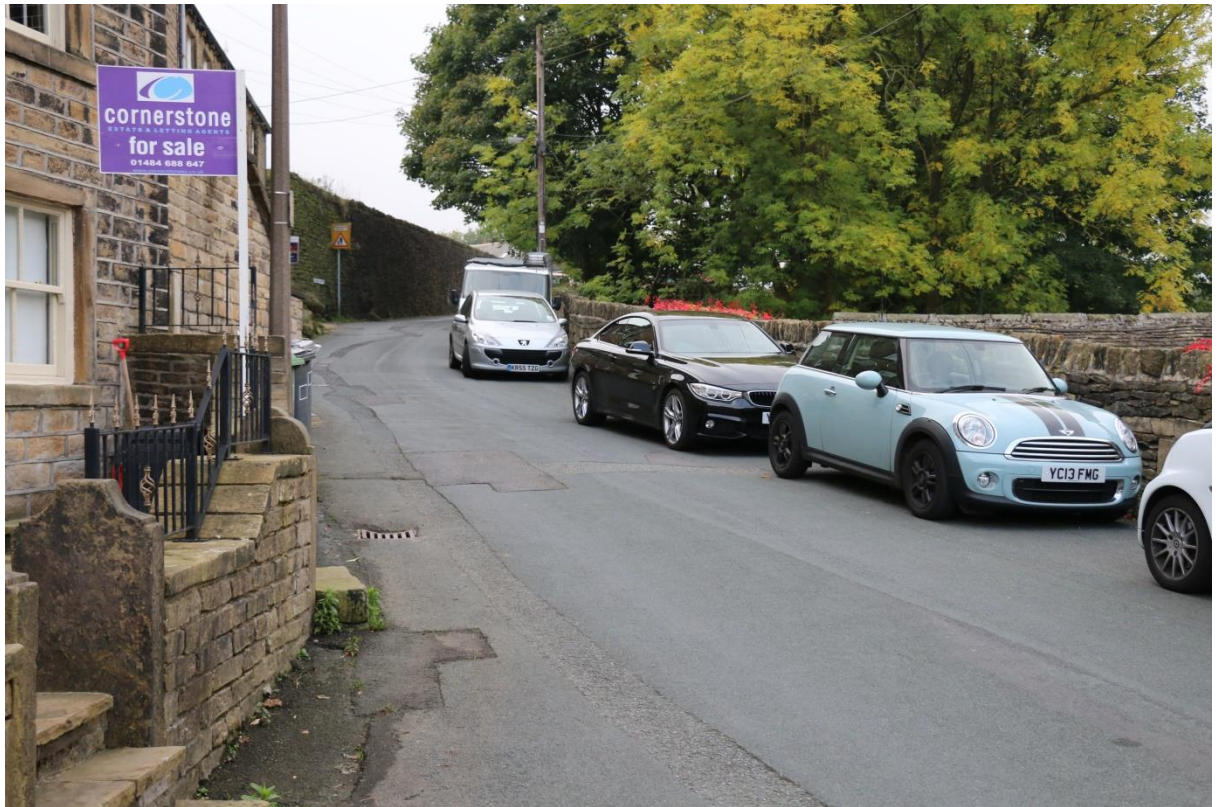
Photo 11 above is Dobb Lane - This is the other approach to the site from Co-op Lane via Dobb Top Road is extremely narrow and twisty again with no footways
